Crown hole development in the sandstone caves of Nottingham

A. C. Waltham

Civil Engineering Department, Nottingham Trent University, Nottingham, NG1 4BU, UK

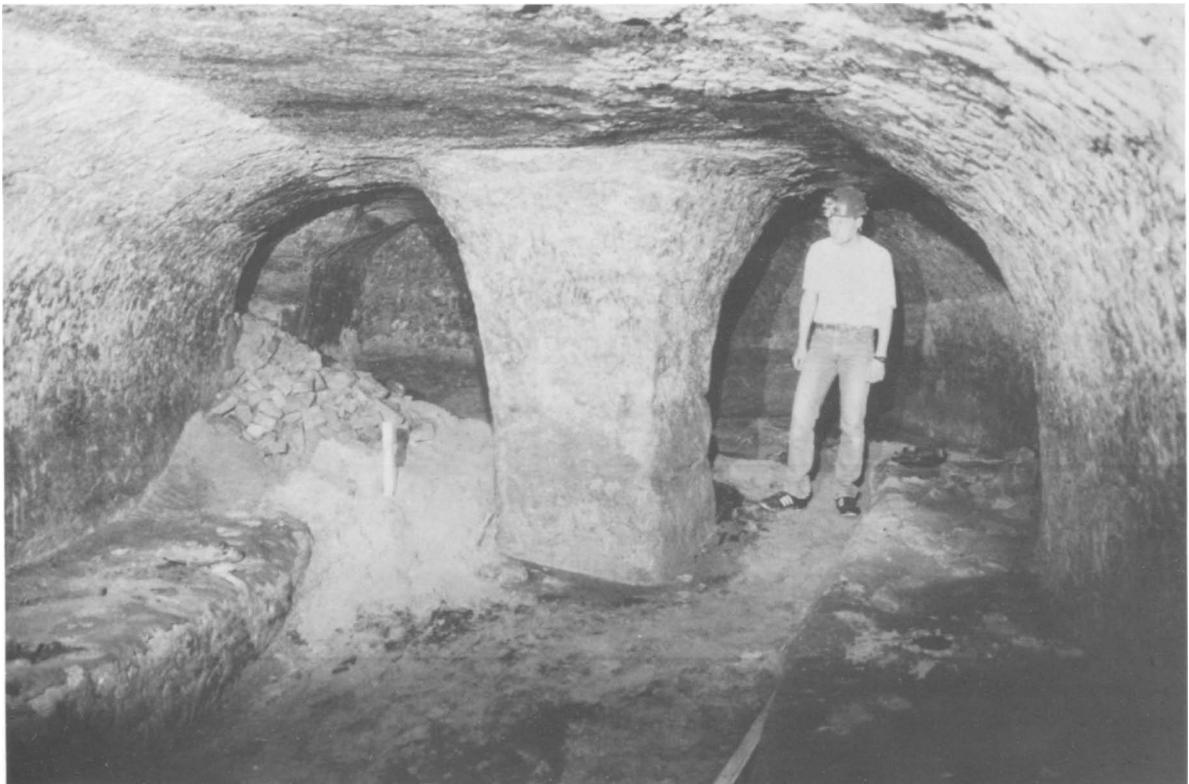
FIG. 1. A typical Nottingham cave—one of the old beer cellars beneath the Corner Pin public house. The flat roof section in front of the rock pillar subsequently failed (see Fig. 7).

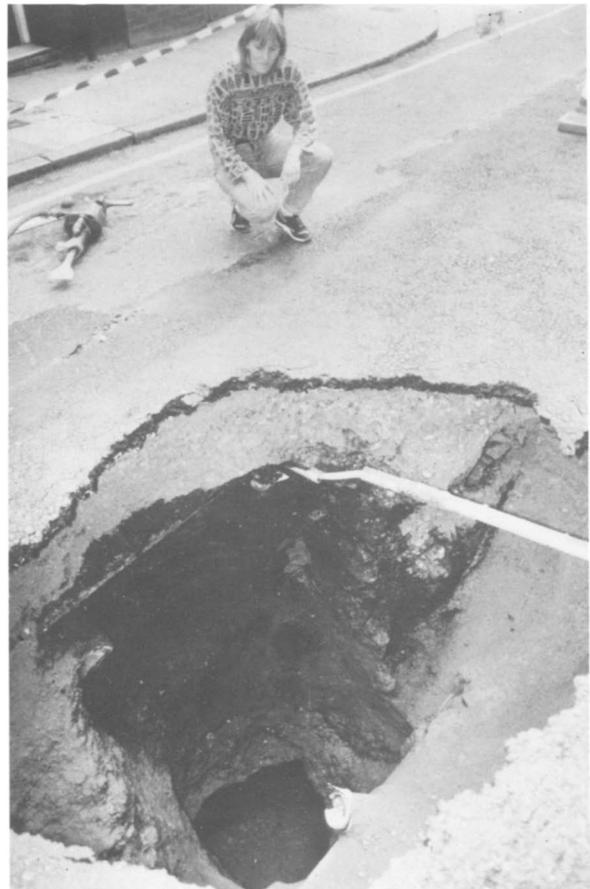
A typical crown hole failure occurred in the road surface of Stanford Street (Fig. 2) in June 1990 (Fig. 3). As the cave had been blocked many years previously, the early stages were not observed but progressive roof failure, at an unknown rate, eventually caused the 1.3 m thick sandstone bedrock to fall

away, exposing rockhead within the cavity (Fig. 4) adjacent to a deep drain trench. Subsequent ravelling of the soil and trench fill would have been more rapid, the road surface finally breaking under the wheel of a slowly moving lorry.

FIG. 3. Crown hole above the failed roof of the Stanford Street cave in June 1990.

The cave at the bottom of the crown hole had a roof with an unusually high arch, almost semi-circular in profile. The failure was close to its axis and left an almost cylindrical shaft with little flare at its base (Fig. 5); the fallen plug of rock was buried beneath debris and fill. Water from a nearby leaking main was still emerging from the soil at rockhead level and trickling down the side of the hole. The entire cavity was subsequently filled with concrete to rockhead level.

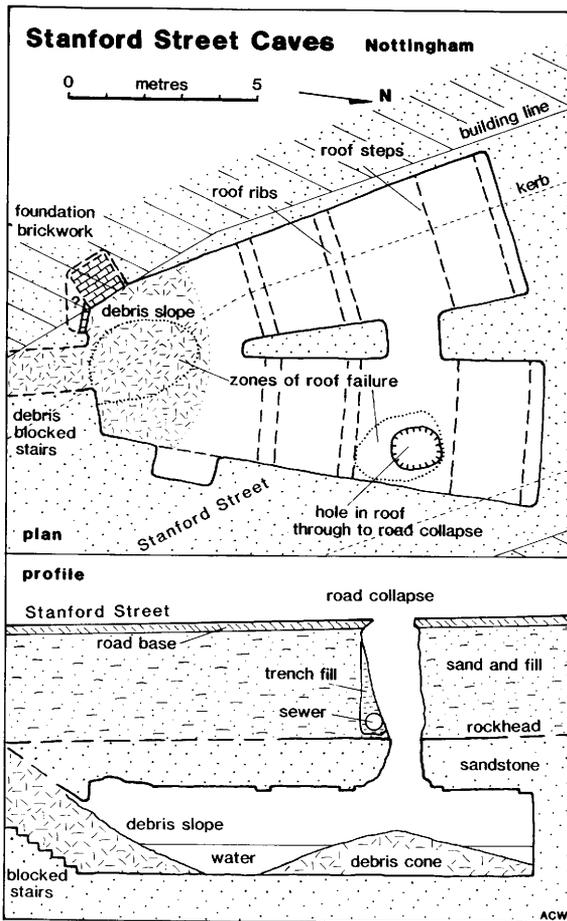
FIG. 4. Plan and profile of the Stanford Street 'caves'.

When the Stanford Street cave was entered through its crown hole in 1990, a second zone of roof failure was found at the southern end (Fig. 4). The roof was breaking away in thin beds over an area nearly 3 m x 2 m. Thin slabs of sandstone lay where they had fallen onto a bank of debris blocking the original

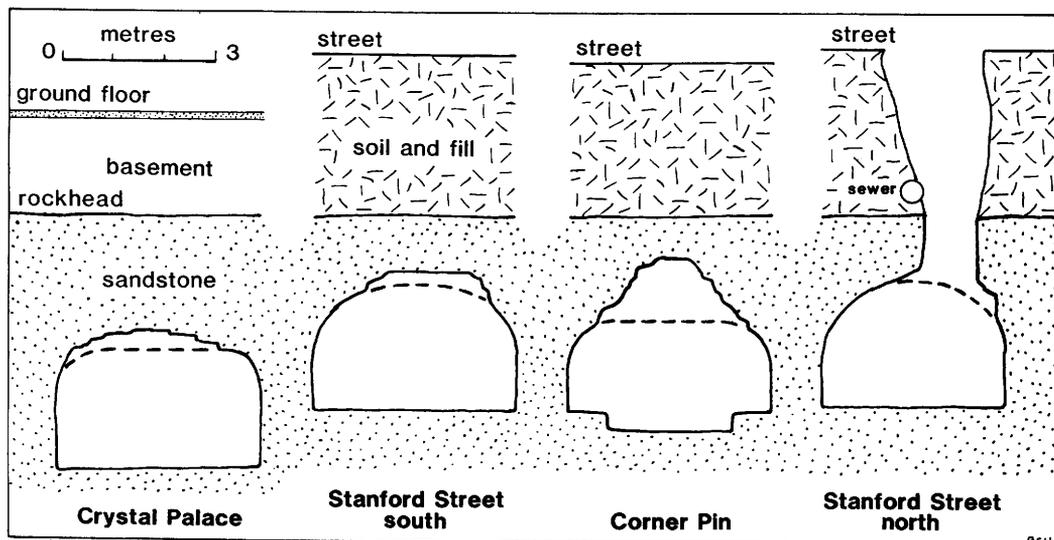
A beer cellar of the old Crystal Palace public house (Fig. 2) now lies disused beneath shop basements. Part of its sandstone roof has fallen away, to a maximum thickness of 350 mm (Fig. 5). The timing of the failure is not known, but the fallen debris rests on top of recent floor material. This area has been monitored since December 1990 and no new falls have occurred. The stepped profile of the break reveals bedding planes only 20 mm apart. A fracture cuts across one edge of the failed area and water drips from this on some occasions. It would appear that the roof has now developed an arched profile which is more stable than the original almost flat cut roof, although some of the exposed cantilevered beds are continuing to sag as the beds dilate.

FIG. 5. Cross sections through four 'caves', demonstrating progressive stages of roof failure, including the ultimate crown hole development at the north end of the Stanford Street caves.

There is no complete record of the rate of roof failure and evidence from different caves suggests that there is considerable variation. The failures in the Stanford Street (south end) and Crystal Palace caves (Fig. 5), together with others where the height of break is less than 300 mm, indicate slow progressive failure as the sandstone falls away in thin beds. By contrast, the failures at the Corner Pin (Fig. 5) and Wollaton Hall caves were larger and more than a metre of rock fell in a single event.

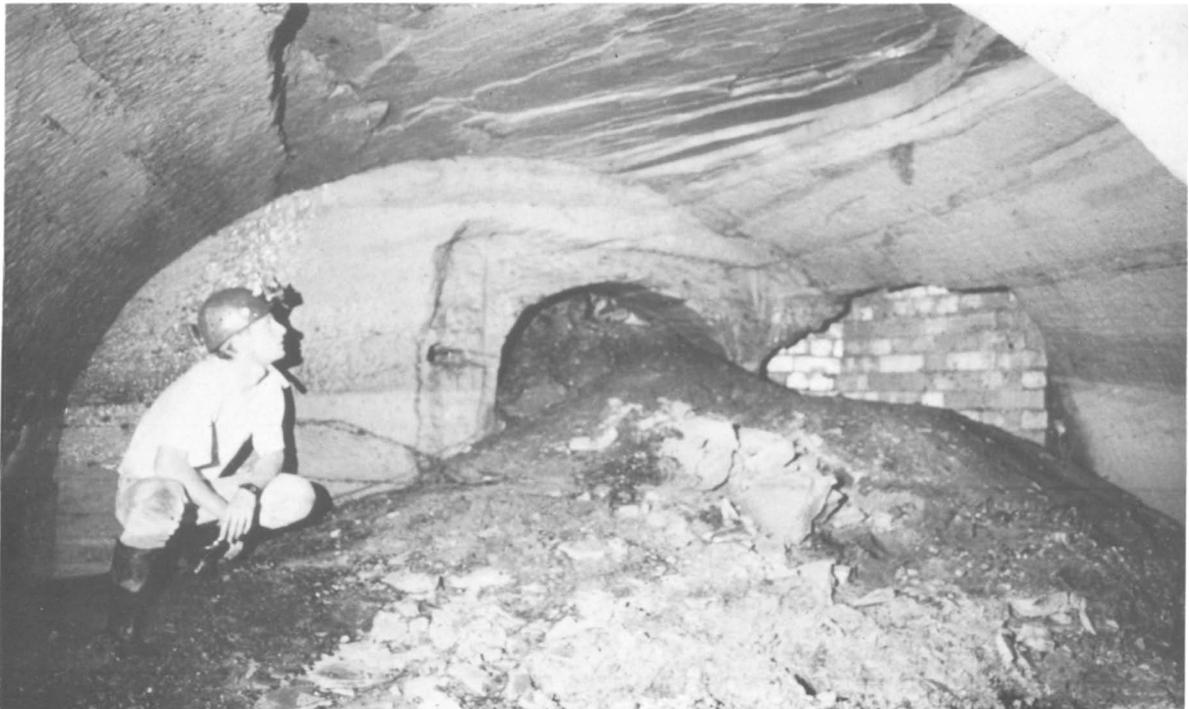
FIG. 6. (above) Saturated sandstone breaking into thin beds and falling away from the roof arch at the southern end of the Stanford Street caves. The light material on the debris pile is fallen roof, some remaining in thin slabs, other broken to sand on impact.

entrance (Fig. 6) while more could be dislodged from the roof at only a finger's touch. The roof now steps up to a wide, flat bedding plane, with a profile less stable than the original cut arch (Fig. 5). With water seeping through the roof sandstone, this appears to be an 'active' zone of roof failure, in the early stages of developing into a crown hole, perhaps larger than its neighbour. As this site also lay under the road the cavity was completely infilled with concrete.

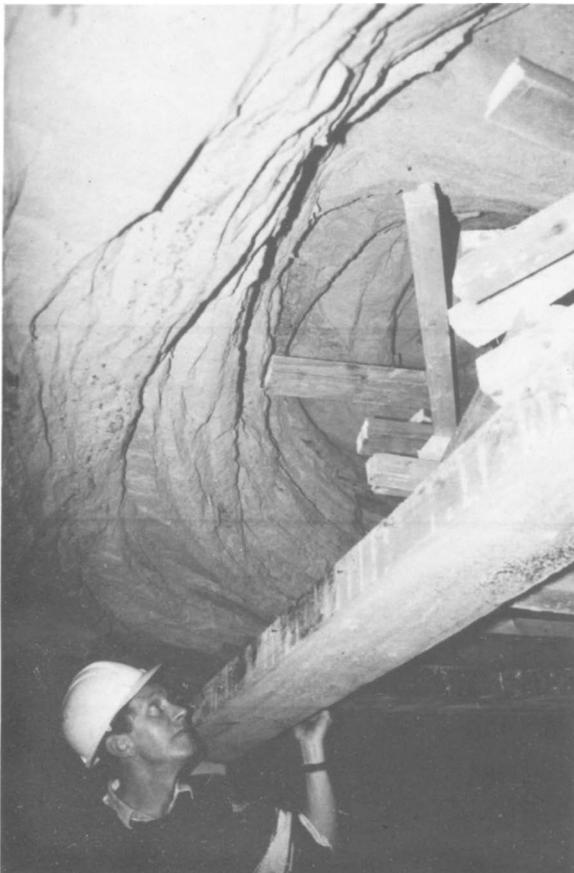
FIG. 7. (left) The roof failure in the Corner Pin cave, with temporary timbering to prevent any immediate further collapse.

Redevelopment of the site of the Corner Pin public house (Fig. 2) revealed a large group of caverns which were entered for the first time in many years in 1990 (Waltham 1992). One 4 m wide room extended out under Parliament Street, its roof having a central flat section 2 m wide beneath a cover of 5 m, consisting of 2 m of rock and 3 m of soil. There was no sign of any previous failure, although water had entered the cave at various points at some time in the past. The roof had been bored through from above at four points so that rock anchors could be placed in the floor in order to prevent rotation of temporary works on the site above. Probably during the drilling operation, a prism of rock nearly 3 m across and 1.2 m high fell away from the roof, approximately 2 m away from the nearest borehole. This created a high arch stepped roof profile (Fig. 5). As access to the cave was still required, temporary support was immediately provided using timber and Acrow props (Fig. 7). No further failure occurred and a few weeks later the whole cavity was filled with concrete.

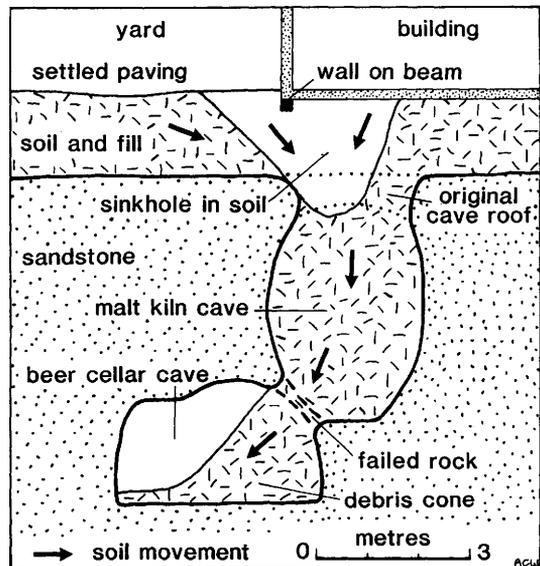
FIG. 8. (below) Cross section of the failure at the Black's Head caves, showing the debris pile and the sinkhole into the upper malt kiln cave, revealed beneath the building floor and yard paving.

In 1991, settlement of paving slabs behind some offices was found to be related to a debris cone from a hole in the roof of the old Black's Head cellar cave (Fig. 2). Excavation revealed a previously unknown malt kiln cavern and intimated a more protracted failure mechanism. The medieval malt kiln cave had been abandoned and filled with soil and rubble by about 1600. Probably a hundred years later, the cellar cave was excavated from an adjacent cliff, by chance leaving about 200 mm of rock between the two cavities (Fig. 8). Some time later the malt kiln was unroofed and backfilled to the surface; the building above being placed on beams and columns to span the cave fill. Seeping water and leaking drains later saturated the fill and the rock beneath, causing its failure into the lower cellar hollow. Subsequent ravelling of the fill created the sinkhole which was revealed when the paving slabs were removed.

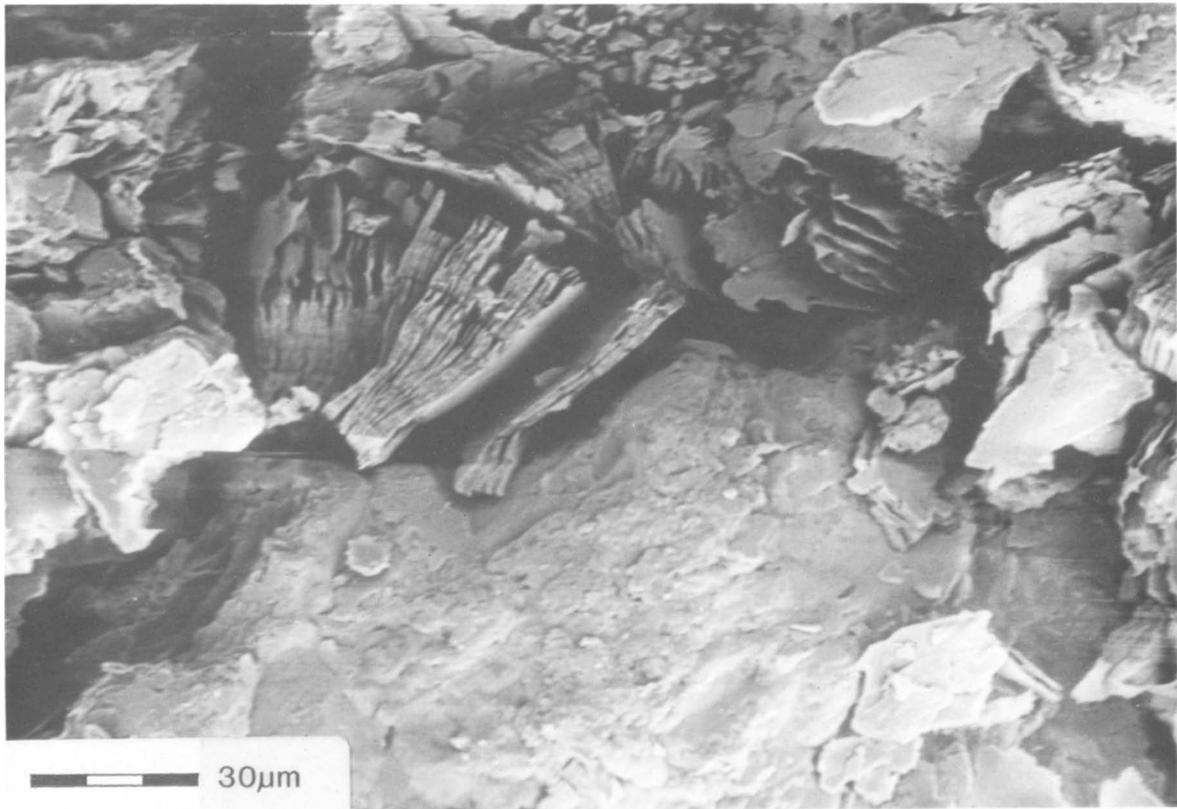
FIG. 9. Scanning electron microscope image (at magnification $\times 900$) of sandstone from the Mansfield Road sand mines. Books of authigenic kaolinite have grown in the pore space between quartz grains and now constitute the only cementing material.

saturation. Clay forms up to 15% of the bulk rock and the electron microscope reveals its role as an interstitial binding material. Authigenic clay minerals can be seen bridging between the sand grains (Fig. 9). Most of the clay minerals are kaolinite, with some occurring in small books, but flaky and cellular smectite are also seen. No soluble cementing material which can be lost to percolation water can be detected. Such a loss of strength on saturation is characteristic of locked sands (Dusseault & Morgenstern 1979) and some of the sandstones have pitted grains and high relative density indicative of partial locking.

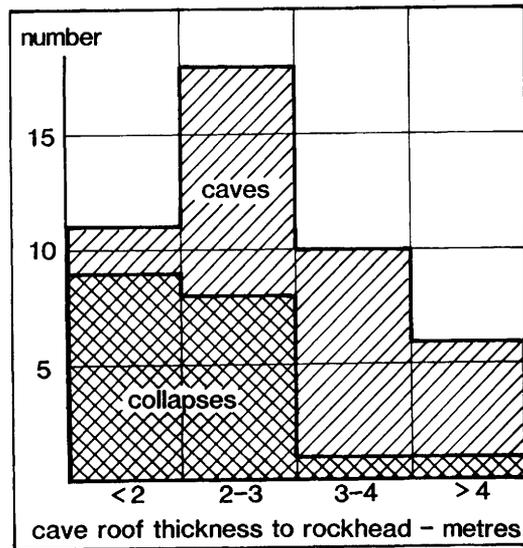
FIG. 10. Distribution of rock roof thicknesses over caves and without collapse.

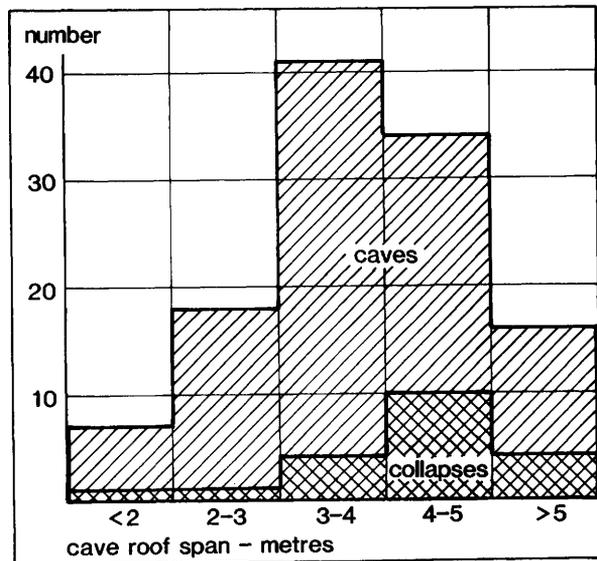
FIG. 11. Distribution of roof span widths in caves with and without collapse.

In Nottingham, the roof spans vary between 1 and 7 m with most averaging 4 m. Figure 11 shows the wider spans to fail more frequently. Roof profile varies considerably and their structural competence is not easily assessed. Two similar caves at the Corner Pin site were drilled through and it was noted that the one with a flatter roof remained intact, while the one with
