## REPORT

## The Christmas Day landslide at Nottingham Castle

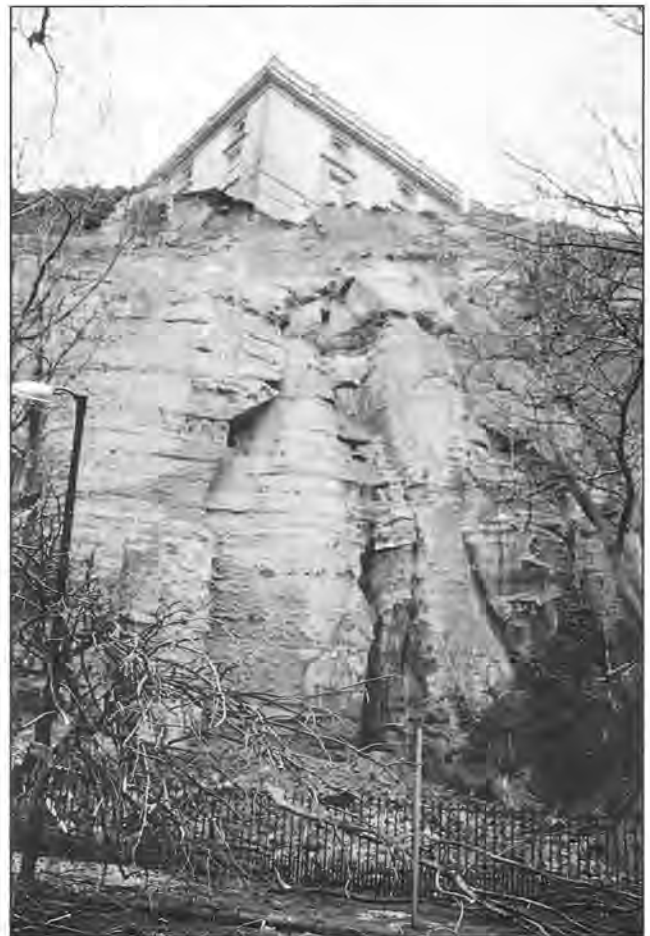
The site of the failure seen from the foot of the cliff on 27th December, before the loose debris was removed, and with the fallen tree and lamp post still leaning across Peveril Drive (photos by Tony Waltham).

The wall, the fill and the paving all fell to the foot of Castle Rock. Nearly 100 cubic metres of soil and masonry, weighing around 200 tons, lay piled on the strip of garden below. Most of it remained behind the iron fence, though the odd block of stone had bounced across Peveril Drive, where a sheet of sand and silt was also washed out. A plane tree was hit by the debris, so that it was laid across the road, where it bent a lamppost to a bizarre angle.

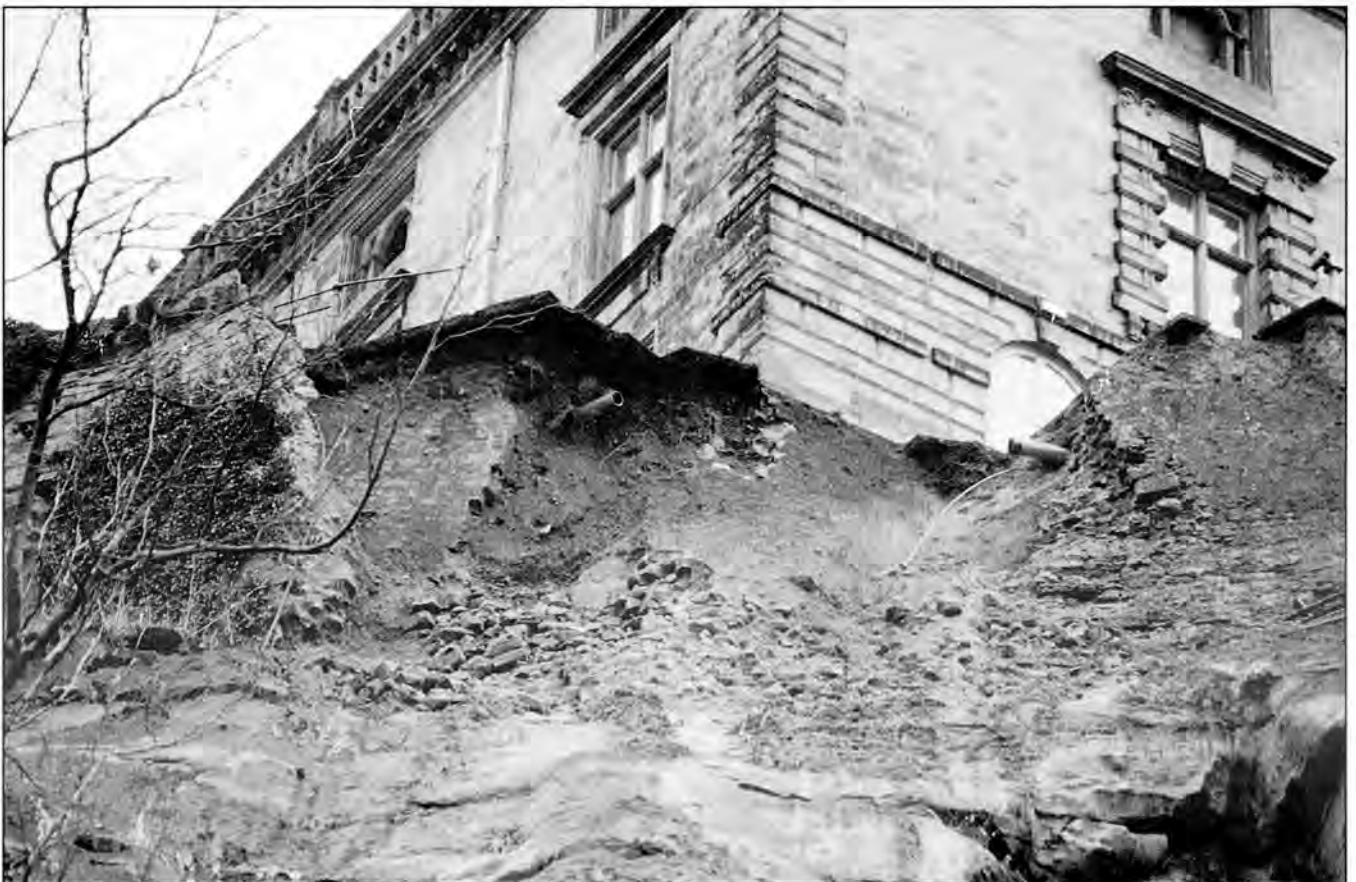
Up above, there was a yawning gap where about 10m of the wall had fallen away. With it had gone most of the soil and old masonry that had originally been held behind it. None of the bedrock sandstone had failed. The wall and artificial fill, and perhaps some remnants of natural soil, had merely slipped off the rock, with a slip surface at the rockhead. Fortunately the massive stone foundations of the Castle Museum had been built up from solid sandstone bedrock behind the rim of the steeper

Closer view of the slide scar, with the masonry of the Norman wall visible beneath the overhanging terrace paving; undisturbed sandstone is exposed at the foot of the picture.

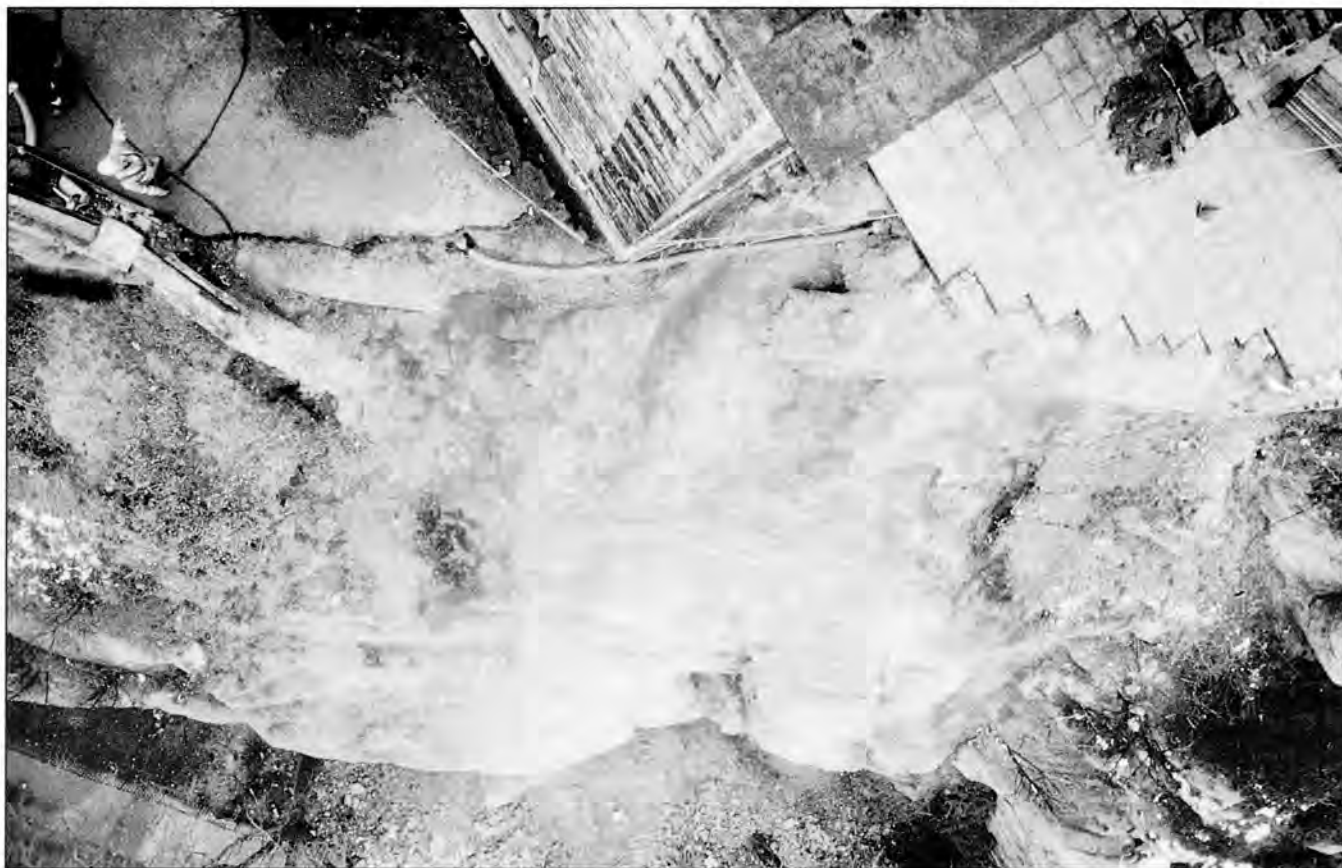
The landslide site seen from almost vertically above, after the loose debris had been cleared off. The straight line of the Norman wall is clearly exposed, as very little of it had fallen away; the gap in it dates almost entirely from about 1680, when space was created for the mansion foundations.

One incidental benefit of the landslide has been the exposure of a medieval wall, perhaps of Norman origin, which had lain buried under the paved terrace for over 250 years. A section of this was removed in about 1680, to make room for the foundations of the new mansion. A little more seems to have fallen away in the new landslide, but two cross sections through the rough sandstone stonework remain in either side of the slip scar. Repair work started in January. A temporary platform is supported on scaffolding columns which stand in vertical holes drilled a metre into the exposed sandstone. This working platform allows placement of rock anchors to tie the remaining walls and the museum foundations back to the sound sandstone. Designs for the renovated terrace have come down to two options. One has a new concrete wall, standing on and anchored to the exposed sandstone; behind it, a rubble or gravel fill re-buries the Norman wall, and carries the flagstone paving of a restored terrace. The concrete wall is faced with masonry blocks from the original wall, rescued from the debris below, so that the restored site will look as

before. Alternatively, the hole in the terrace is left open to expose the different foundations and wall remnants, now stabilised, and a cantilevered viewing platform will complete the terrace walkway by spanning the gap. Aesthetics and costs are the two factors which must determine the choice, hopefully to be made in time to complete the main works before the 1998 summer visitor season.

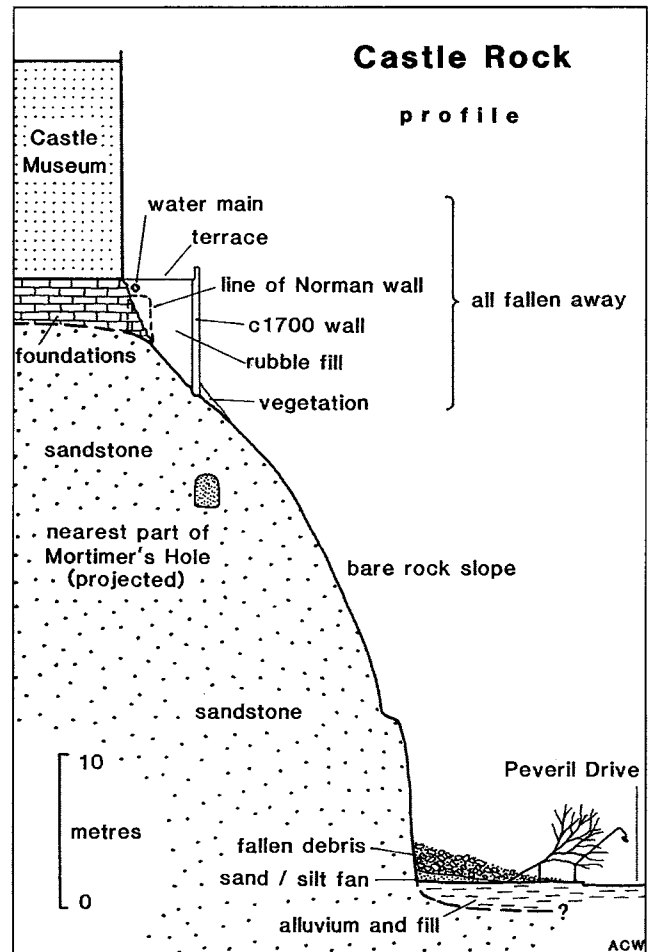
The Christmas Day collapse provided a classic example of the failure of a retained soil which had become saturated by a sudden input of water from a broken pipeline. Water has a devastating influence on a soil structure, and increased water has three separate effects. First, the raised water pressure within the ground acts laterally as an increased force pushing the retaining wall outwards. Second, the raised pressure of the interstitial water within the soil forces the soil particles apart; soil strength is largely due to its internal frictional resistance to shear, which depends on the force pressing the grains together, so the strength is reduced by increased water pressure, and yet more load is cast onto the retaining wall. Third, flowing water washes the finest particles out of the soil, in a process which increases until all the soil is washed out along the drainage route to create a piping cavity, which ultimately collapses. The sequence of events at the Castle clearly shows that all three processes were active through the 18 hours between first sight of the water leak and the final collapse.

Profile of the southern end of Castle Rock, on the line of the 1996 landslide. The wall and terrace fill around the edge of the museum building fell away to expose the foundation, while the rock slope remained intact.
