# Feature

## St Francis: the world's worst dam site

**Lying just north of Los Angeles, the total collapse of the St Francis Dam in 1928 has been described as America's worst civil engineering disaster of the twentieth century. Although poorly remembered among today's residents of Los Angeles, the event is better known to engineering geologists. The dam's failure was largely due to the geology of its site, which was inappropriate to the point of disastrous, in more ways than one.**

### Tony Waltham

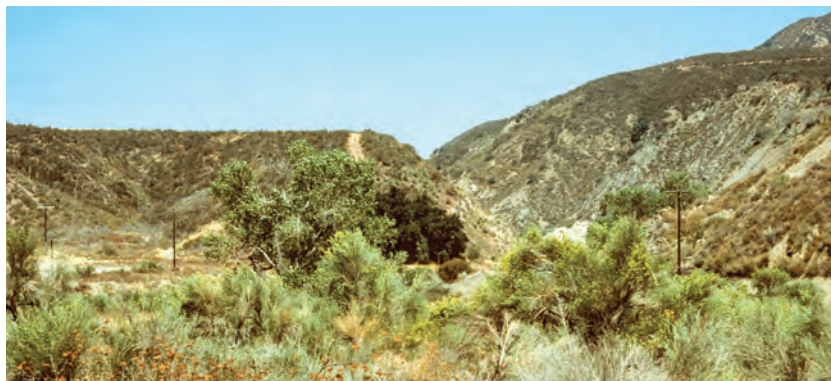
**Fig. 1.** The San Francisquito Canyon as it appeared in 1979. The dam had been built in the V-shaped section to the right of the natural spur of rock extending from the left. On the far right, on what was the eastern abutment, the scar of the main landslide is a slope of grey schist with sparser vegetation than on the slope above.

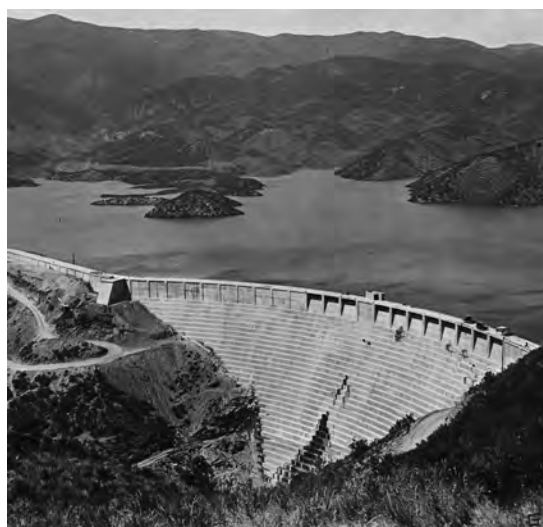
**Fig. 3.** One of the few photographs of the reservoir after filling and of the dam before failing.

Aqueduct water was first re-directed to start filling the reservoir in March 1926 (Fig. 3). During filling, the first of many vertical cracks were seen to develop

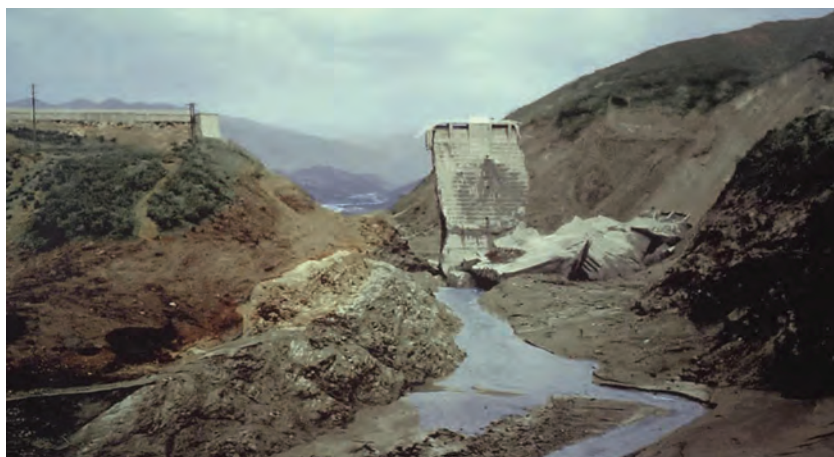
**Fig. 4.** The remains of the St Francis Dam after its catastrophic failure, with only the narrow middle section, subsequently known as the tombstone, still standing. The landslide scars in the eastern abutment are devoid of any plant cover on the right. On the western abutment, on the left, the reddish ground of scoured conglomerate is separated by the fault outcrop from the lower grey slopes of scoured schist. The boundary with grass-covered slopes above marks the lower level of floodwater erosion due to the delayed failure of the western part of the dam.

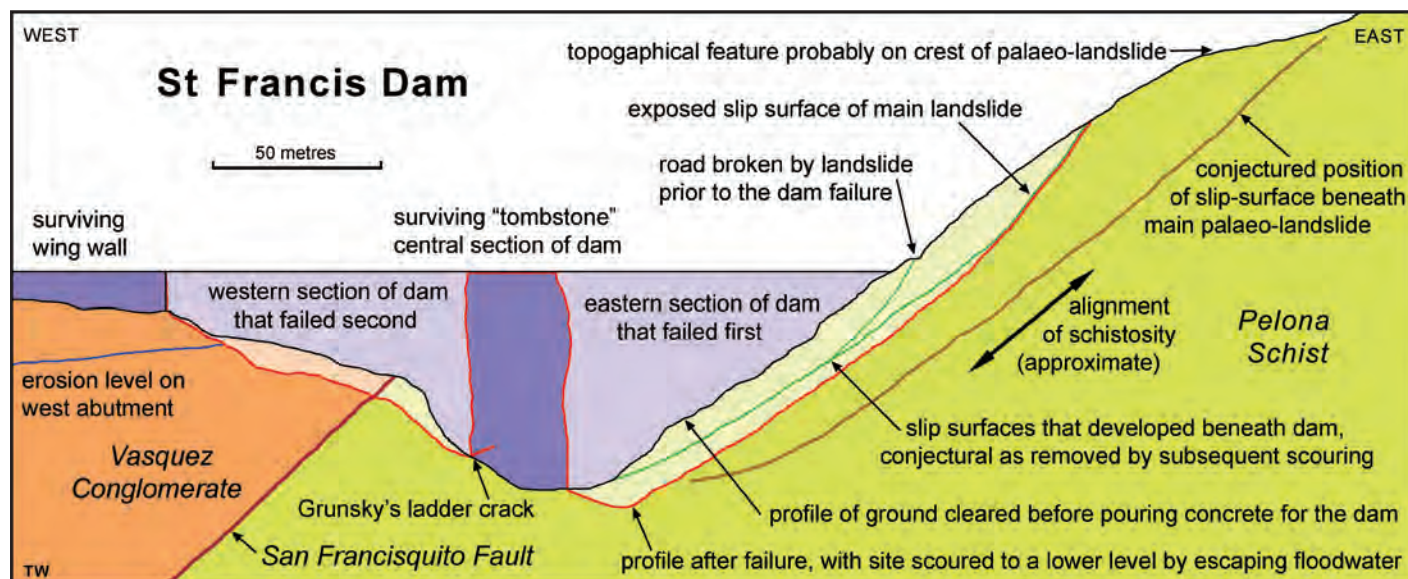
**Fig. 5.** Profile along the length of the St Francis Dam, looking upstream, with features of the ground before and after its collapse.

The location chosen for the St Francis Dam was remarkable in that its geology rendered it highly unsuitable through, not just one, but four factors (Fig. 5). The ground was so bad that it was difficult to determine which aspect of the geology was eventually responsible for the almost inevitable failure of a dam that also had inherent failings within its design. Indeed, the first commissions of enquiry came to the wrong conclusions over the geology, and it was only later that the full story of the dam failure emerged. The four factors were a fault, two rocks that each had their own weaknesses, and an ancient landslide.

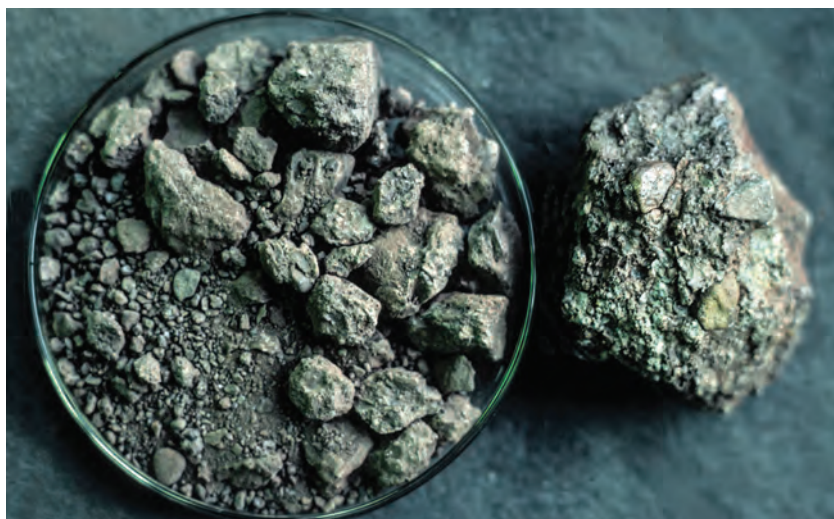
Forming most of the dam's western abutment, west of the fault, the red Oligocene Vasquez (or Sepse) Conglomerate is a seriously weak rock. With a dry unconfined compressive strength of about 1.5 MPa, it barely warrants description as a rock, and in a wet state was described as being so soft that it lost almost all rock characteristics. Much of its groundmass cement is clay that absorbs large amounts of water and thereby exhibits conspicuous swelling. Repeat surveys of the surviving wing wall on the western abutment indicated uplift of 5–15 cm, all or part of which may be ascribed to swelling of the conglomerate beneath it. This clay cement also accounted for the slaking of the material, whereby it virtually disintegrated when saturated in water (Fig. 6). Furthermore, the conglomerate was laced with micro-veins of gypsum,

**Fig. 6.** A pair of fist-sized specimens of the Vasquez Conglomerate were collected in 1979 from the hillside where the St Francis Dam had once stood. One specimen was then placed in a beaker of water for 15 minutes, before being drained and dried, by which time it had completely fallen apart.

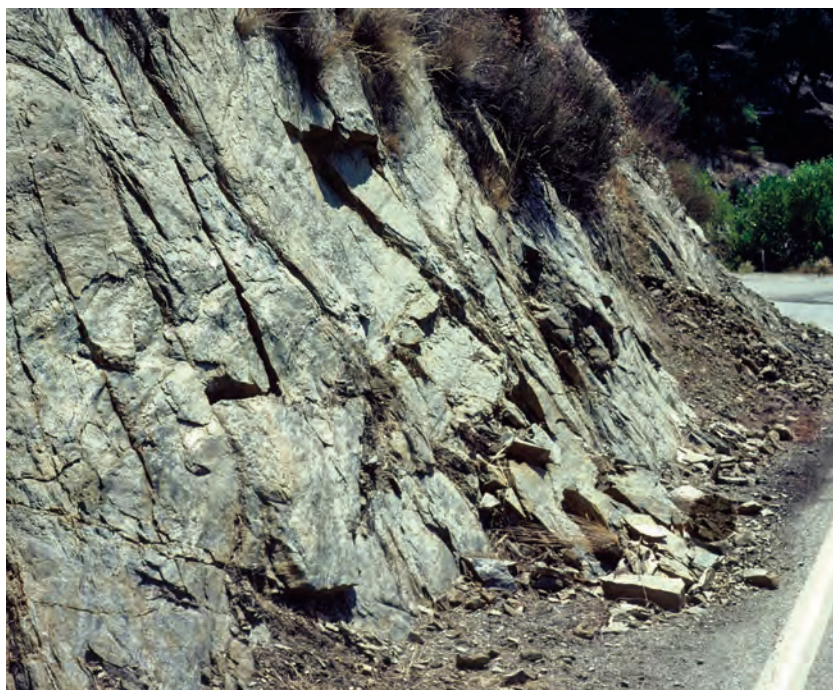
**Fig. 7.** Post-collapse, road-side exposure of the Pelona Schist remaining beneath the scoured channel at almost exactly the position of the dam.

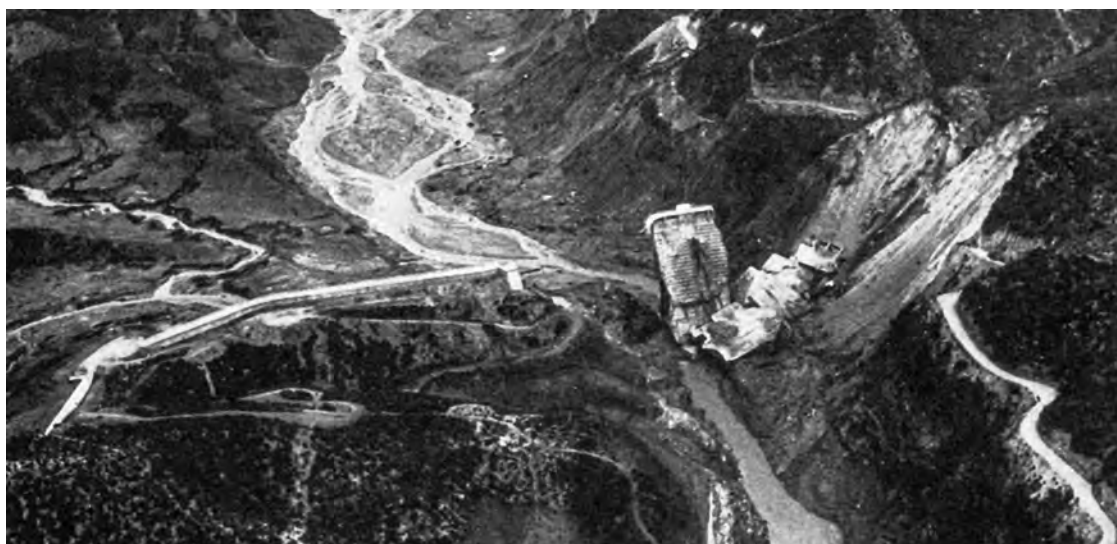
**Fig. 8.** The remains of the St Francis Dam very soon after its almost total collapse. The largest blocks of concrete were not moved far by the floodwaters and lie beside the central, tombstone remnant that survived. The landslide scars are conspicuous on the eastern abutment, on the right. The western wing wall still stands along the crest of the natural rock spur left of the breached dam.

Then just a few minutes before midnight, the critical event was a much larger landslide in the eastern abutment (Fig. 8). Details of this will never be known as the entire slide mass, along with some of the bedrock beneath it and a large part of the dam, were carried away by the ensuing flood through the massive breach in the dam. Although the sheer weight of the dam, braced against the opposite side of the valley, had effectively been holding any potential slide mass in place, the entire hillside had been destabilized from the joint water pressures generated by the adjacent reservoir. With three directions available for displacement to occur, it is difficult to determine the scale and sequence of different movements.

scale could be appreciated after the event by its head scar extending up the hillside to a level 40 metres above that of the dam's crest (Fig. 8). However, part of that new head scar could have been secondary development after the toe of the slide had been removed by the floodwaters; the exact size of this destructive landslide cannot be determined, but it was clearly a major feature.

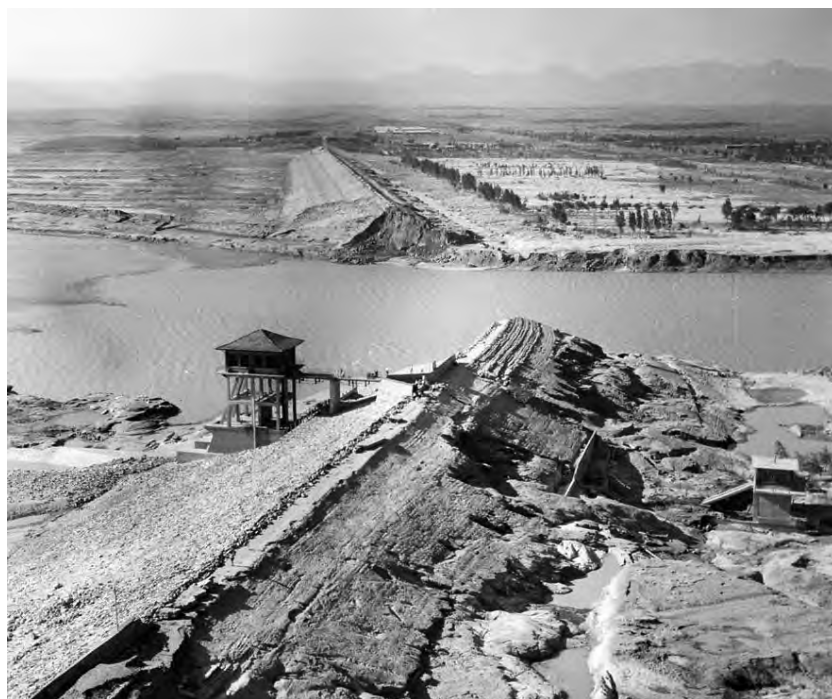
**Fig. 9.** Remains of the failed Banqiao Dam in eastern China.

There are many parameters by which to assess dam disasters and thereby determine the worst in the world. The leader has to be the Banqiao Dam, in the Henan Province of eastern China. This earth dam was overtopped, scoured and destroyed after a major rainstorm event in 1975 (Fig. 9). Around 26 000 lives were lost in seven towns inundated by the escaping floodwaters, and another 145 000 died during the subsequent famine created by the lost farmland. Little information was released by the secretive government of that time, but the failure was clearly due to the dam having only a cost-saving five sluice gates and spillways, instead of the twelve that were needed.
