Sinkhole hazard case histories in karst terrains

T. Waltham

Abstract

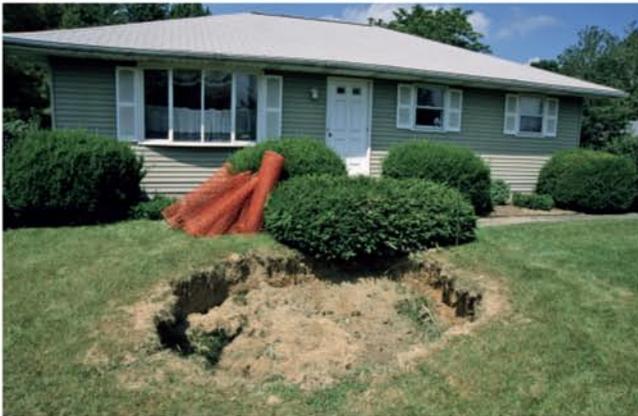
Fig. 2. A small subsidence sinkhole that was a dropout in the front lawn of a house in Pennsylvania affected by de-watering of a nearby quarry.

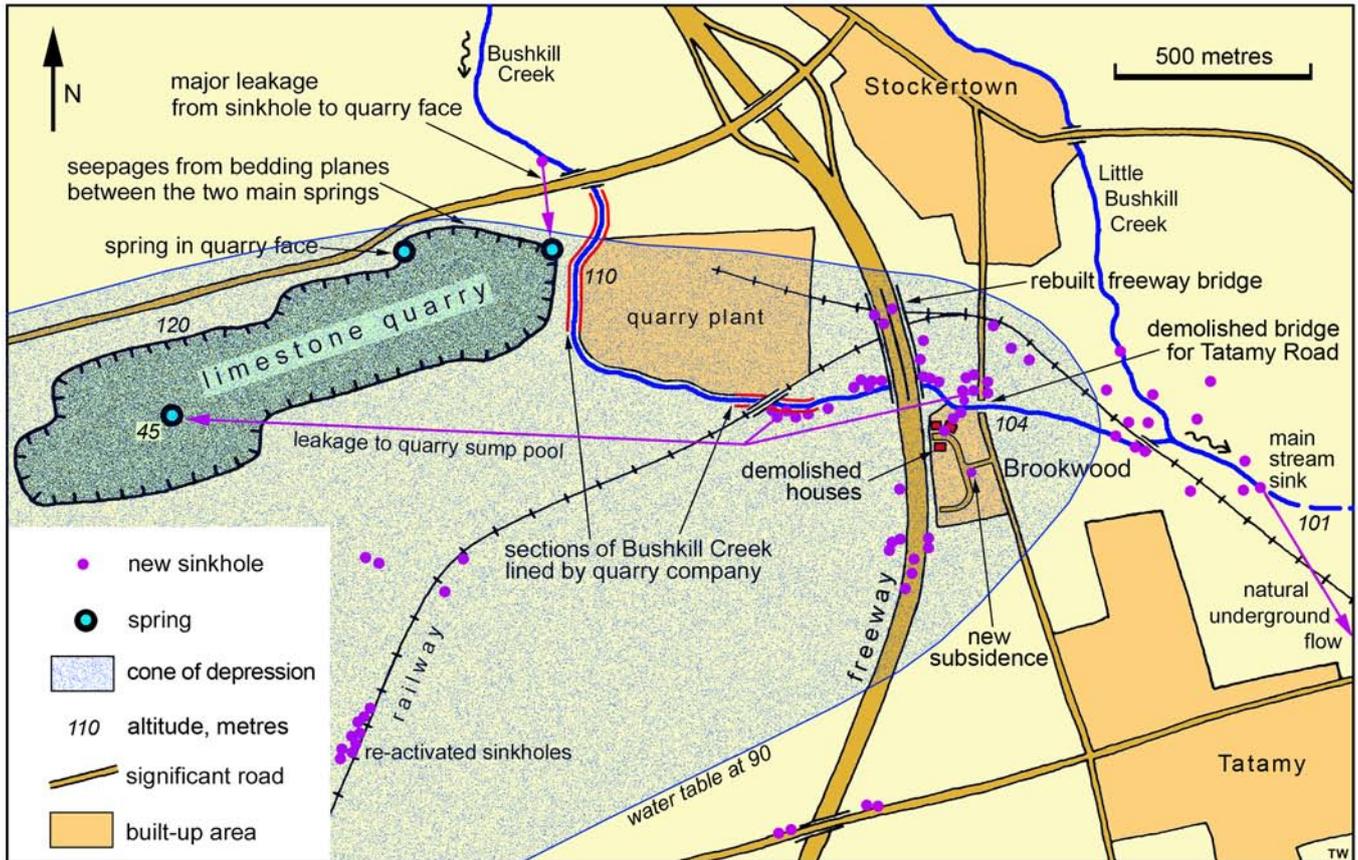
The quarry's pumping has created a cone of depression that has been mapped over 36 km^2 (Risser 2006). It extends largely east–west along the limestone outcrop, and is distorted to the south by the regional ground-water gradient (Fig. 4, where only its deepest part, within the 90 m water table contour, is indicated). This

Fig. 4. New sinkholes related to de-watering the Stockertown Quarry in eastern Pennsylvania. The 90 m water table contour surrounds only the deeper part of the cone of depression. The long leakage trace in the centre of the map is shown bent for clarity, but is probably along a single straight line from both sets of sinkholes to the quarry.

area, with more than about 10 m of drawdown, encompasses about 100 new sinkholes, all subsidence sinkholes formed within the soil profile. Quarrying towards the 45 m level started in 1993. After a few abnormally dry years, pumping was increased to the current rate early in 2000, and, later the same year, it was observed that water flowing into the quarry was carrying sediment. The first new sinkhole had appeared in 1999, beside the Tatamy bridge, and the autumn of 2000 saw many more new sinkholes in and around Brookwood.

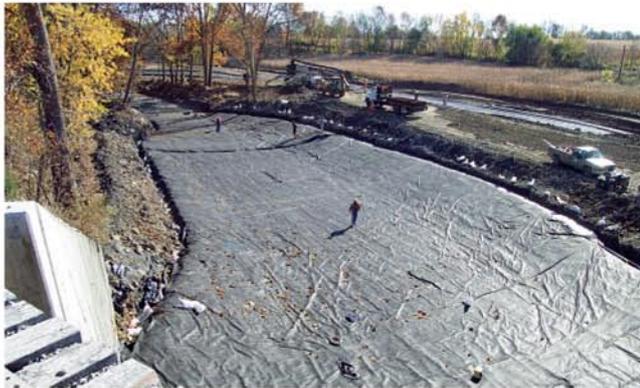
Fig. 5. Installing the liner along the creek bed downstream of Stockertown Quarry (photo: Brookwood Group).

One sinkhole in the creek bed below the railway bridge swallowed a large part of the creek flow, which then emerged in the far quarry floor. This input was greatly reduced when the creek bed was sealed by the quarry company. Subsequently, the creek began to lose about half of its flow into sinkholes between the freeway bridge and the Tatamy bridge, downstream of the lined section. An injection of brine confirmed that this also emerged near the far end of the quarry floor. Both these underground flows may pass largely along a zone 100 m wide of heavily fissured limestone (described as deeply weathered), which is aligned on an east–west fault and lies beneath a buried valley filled with 30 m of alluvial sediment and soil. This zone was recognized in boreholes drilled to rebuild the bridges that carried the carriage-ways of the north–south freeway, after footings under both had subsided in 2004 (Waltham *et al.* 2005). By then, the northern approach to the Tatamy bridge had already been destroyed by very active sinkholes (Fig. 6) that swallowed up to $1 \text{ m}^3 \text{ s}^{-1}$ of the creek's flow; the last span of the bridge was demolished early in 2007 to create space for sinkhole remediation. All the bridges over Bushkill Creek originally stood on pads founded in the alluvial soils that have since been washed into the limestone.

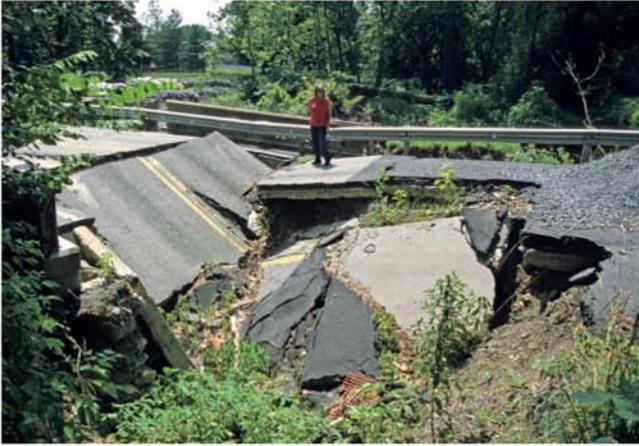
Fig. 6. The approach to the Tatamy bridge, destroyed by active sinkholes.

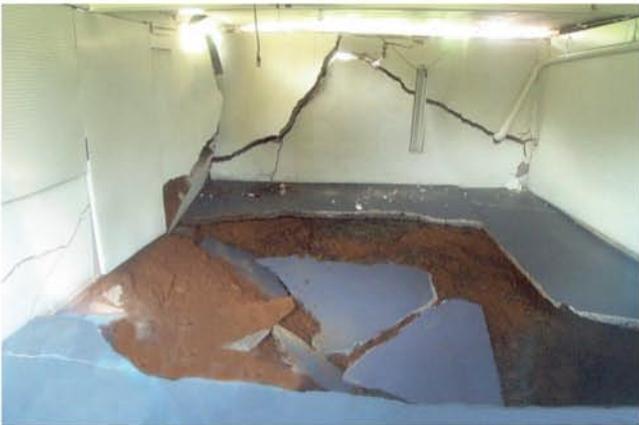
Fig. 7. The basement floor of 29 Babbling Brook Road, which collapsed into an expanding group of subsidence sinkholes (photo: Brookwood Group).

Away from the creek bed, sinkholes developed at many points over the cone of depression, but the most destructive are the active cluster within the north end of the Brookwood residential area. Worst hit was 29 Babbling Brook Road (the Sarkady house), with its first sinkholes developing in 2000. Late that year, these were filled with 1000 tonnes of soil and rock and 100 m³ of concrete, but they kept reopening and expanding (Perlow 2003). A resistivity survey indicated the presence of a buried sinkhole, with a soil-filled throat 5 m across, in the rockhead beneath about 10 m of soil. More subsidence sinkholes opened in the front lawn in 2003 (Fig. 2), and again in 2006, when the basement floor collapsed into yet another sinkhole (Fig. 7); this rendered the house uninhabitable, although the owners had long since moved out. Four more adjacent houses were also damaged by sinkholes within the same period, and three of their owners subsequently moved out. Residents in 16 neighbouring houses were justifiably concerned.

Continuing repair and filling of sinkholes has been carried out by Hercules personnel, but such work is only ever a stop-gap and can cause lateral expansion of an active sinkhole. One sinkhole in the southern bank of the creek has been filled and repaired eight times in 7 years. Permanent remediation is extremely difficult, and nearly impossible in practice, because the deep profile of soil and weathered rock hides the throats of sinkholes, where the bedrock fissures must be sealed to be effective. Major grouting would be excessively costly and could still not guarantee success in ground that is a mix of limestone blocks, residual soil, in-washed sediment and open voids.

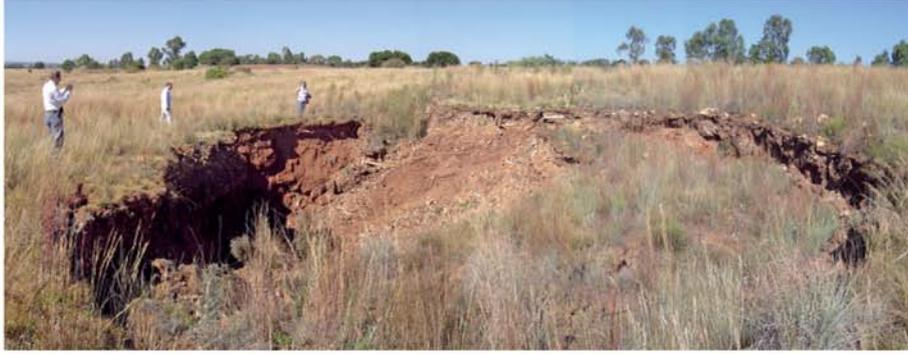
Fig. 8. A new sinkhole that is continuing to enlarge some months after its first failure over the buried dolomite south of Pretoria.

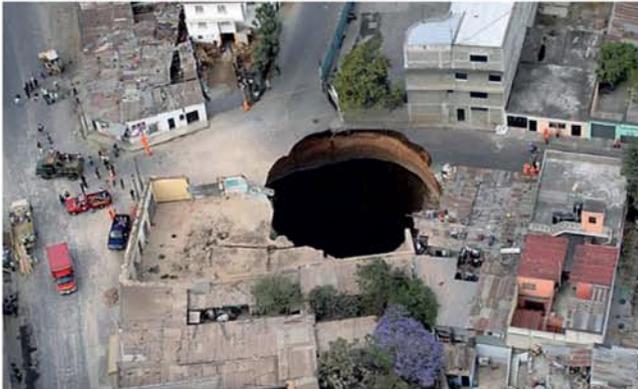
Early in 2007, a sinkhole collapse in the San Antonio suburb of Guatemala City provided the ultimate nightmare of a large unpredictable hole that instantly swallowed houses and people in the middle of the night. The new sinkhole was a little over 20 m in diameter at the surface with overhanging walls to a depth of 60 m (Fig. 10); the collapse killed three people, and destroyed one street and five buildings.

Fig. 10. The large dropout sinkhole in the suburbs of Guatemala City.

Collapse of the sinkhole was triggered by a major sewer failure after a period of heavy rains. Residents of the area reported that they had heard noises underground for a month prior to the final breakthrough to the surface; piping wash-out is noisier than rock dissolution when large chunks of wall material fall away in the later stages of a large pipe's expansion. Storm-water continued to flow through the base of the open sinkhole. Although piping failures do occur naturally in these sediments, the scale of this event was largely induced by failure of a storm drain that had been installed 50 years ago. The outlet of the soil pipe was not observed, but appears to have been into one of the nearby, steep-walled, fluvial canyons, where heavy flows of muddy water were seen; at least part of the pipe was created in the backfill that was poorly compacted after the drain's construction.

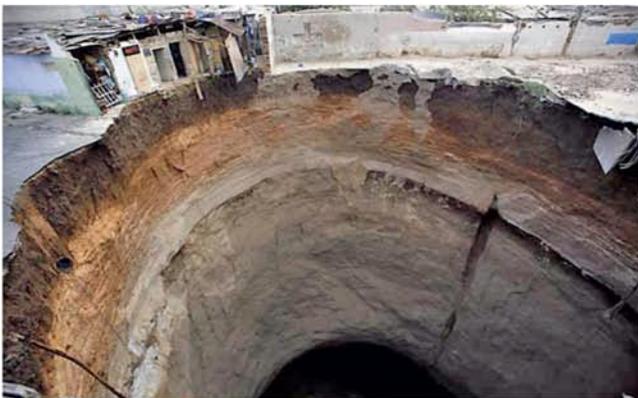
The sinkhole was caused by rock collapsing into a large void, but the rock is so weak that the site is better described as a large dropout sinkhole (Fig. 11). It developed in weak Quaternary volcanic deposits, mainly pumice and ash, which are very weak, crumbly and easily eroded. However, they have a degree of cohesion that allows them to stand in vertical faces, and also

Fig. 11. Weak pyroclastic sediments that are prone to piping failure, exposed in the new sinkhole in Guatemala City.

allows subterranean caverns to be opened up in them. The void that this sinkhole collapsed into was created by soil piping, whereby seepage water had washed the fines out of the poorly consolidated sediment, progressively taking coarser material and eventually creating an open pipe that developed headwards towards its water input. Eventual failure of the undermined roof was an inevitable continuation of the piping process. No rock dissolution was involved, and it is therefore a pseudokarst feature. Comparable large piping failures and sinkhole collapses are well known in the loess lands of China (Waltham *et al.* 2005).

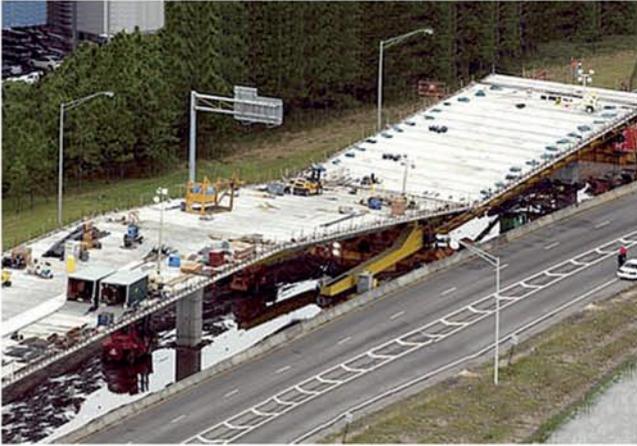
Across the south side of Tampa, in Florida, USA, an extra three lanes for tidal-flow traffic along the Lee Roy Selmon Expressway has been added as a viaduct 9 km long, elevated over the original central reservation. Deck sections, each 18 m wide and 43 m long, reach between single central piers (Wilson 2004). The piers extend as caissons 1.8 m diameter in bored holes that reached to rock 20 m or more below ground surface. However, the elevated expressway stands on limestone, and, during construction, one of the piers failed. Preceded by a sound like a thunderclap, it dropped 5 m straight down, aligned in its bored shaft. The road deck on either side tilted down to the failed pier (Fig. 12).

The failed pier had reached to a depth of 19.2 m, through 11.3 m of sand and clay soils, then through 0.9 m of what was described as weathered limestone, and

Fig. 12. The failed expressway viaduct after its pier had dropped into a void in the limestone beneath Tampa (photo: S. O'Rourke).

then 7 m into sound limestone. The entire pier appeared to have dropped into a void that lay at some depth below the pier toe. Later boreholes indicated that the pier had been bearing on a ledge of limestone, a situation not unusual in mature karst. The sudden drop suggested that this had failed under the pier's end-load, and skin friction down the soil profile had been instantly overcome; the accompanying sound effect was probably created by fracture of the bedrock. There were claims that this was not a sinkhole; and there was certainly no surface feature before or after the failure. However, it was a rock collapse into an underlying solution cavity that was either open or filled with soft clay. As such, it was a buried version of a collapse sinkhole that had been induced by imposed load.

The pier had a design load in normal use of about 5.6 MN, but was carrying 7.35 MN at the time of failure, when it was supporting the massive steel truss that was used to assemble the deck segments. The use of the truss had been perceived as a style of load test for each pier, and it certainly revealed bad ground under this pier. In limestone terrains, such an end-bearing column gains its integrity from an adequate thickness of sound rock over any potential unseen cave. There is rarely any alternative to proving this by an appropriately deep borehole. The Tertiary limestones beneath Tampa are not as strong as most, older, cavernous

Aftermath expressions of surprise that such a failure could occur, and claims that such an isolated cavity could not be identified, simply lacked justification. Void locations within the limestone could not be predicted, but sound rock could have been proven. Following the pier collapse, all other pier sites were re-investigated. A second pier was found to have subsided by 33 mm, probably over a clay fill within the complexly weathered limestone just below a highly irregular rockhead. Of the 206 viaduct piers, 155 were then retrofitted with additional micro-piles, or parallel bored piles, tied to a pile cap around the original pier. The expressway's extra lanes were opened to traffic in 2006, but the retrofit had added about a third to the total cost of the project. This could have been largely avoided if the prior "soil tests" had properly investigated the rock integrity.

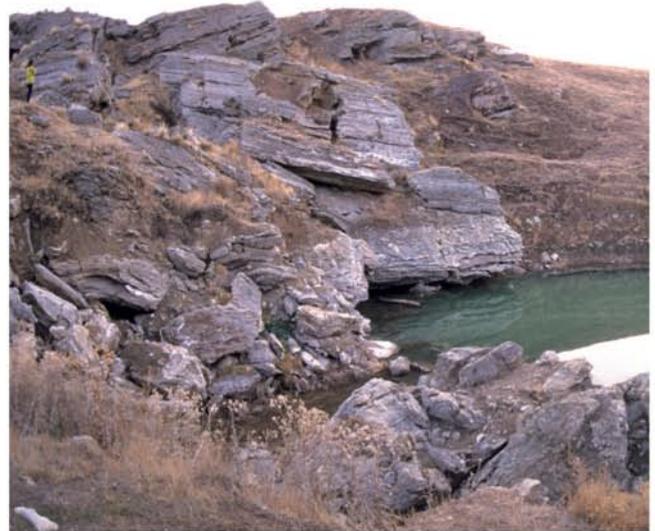
Fig. 14. Progressive small-scale rock failure within an active collapse sinkhole in the gypsum karst of Turkey.
