Civil engineering meets geology: at the Panama Canal

The Panama Canal ranks high among the world's greatest feats of civil engineering. The sheer scales of its ground excavations, its concrete structures and its economic significance are truly spectacular. It is also remarkable for the geology of the massive landslides that developed within its Culebra Cut.

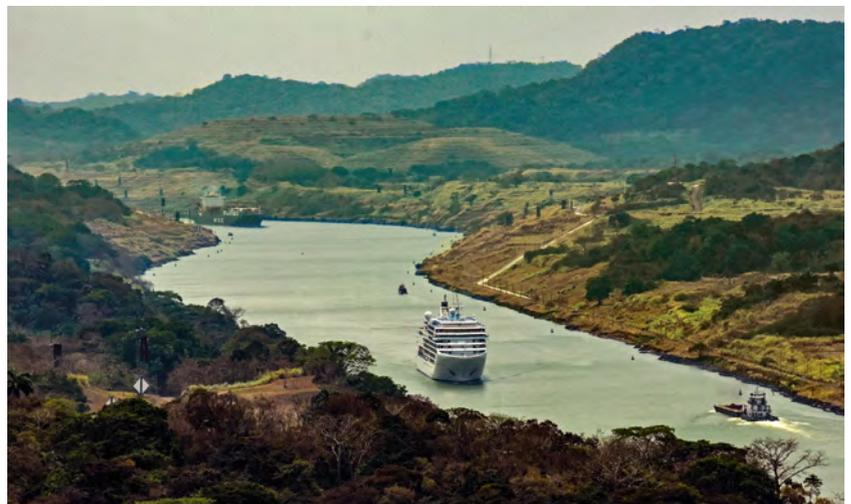
Fig. 1. Ships on the middle section of the Panama Canal, between the Culebra Cut and Gatun Lake.

hands of the US Army Corps of Engineers, and they actually had a navigable canal open within ten years (Fig. 1). They achieved this remarkable feat and timing by a combination of commendable planning, a limitless budget, massive effort and sheer brute force. Within all this, there were two key factors that ensured the canal's success.

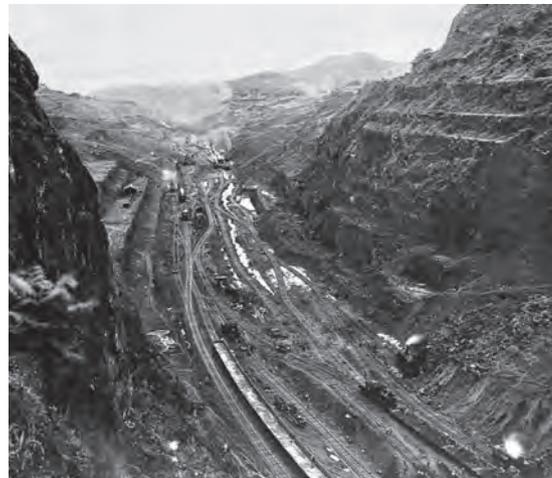
Fig. 2. The Culebra Cut during the American excavations, looking towards the northwest. The steep rock face cut into Gold Hill is on the right, and the lower slopes beyond would subsequently further degrade into the West and East Culebra Slides. (Historical photographs of the American excavations are from the archives of the National Academy of Sciences in Washington.)

Second was invention of the steam shovel and their manufacture on a grand scale. This opened the way for truly massive earthworks and became critical in overcoming the horrendous geological conditions that were subsequently encountered in the great Culebra Cut where the canal traversed the highest ground between the oceans (Fig. 2).

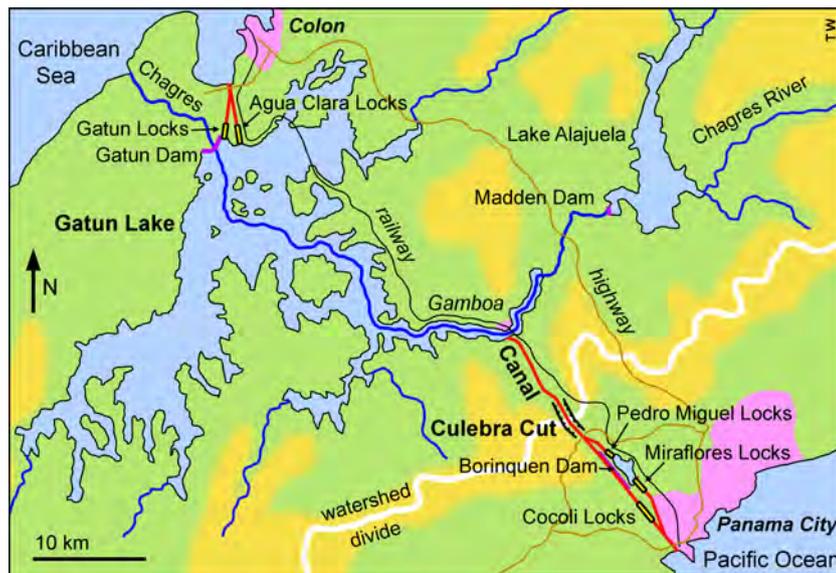
Fig. 3. Main features of the Panama Canal. The shipping route across Gatun Lake follows a slightly straightened course that lies almost above the drowned channel of the Chagres River. The railway is in its present alignment, after part of its original route was lost beneath Lake Gatun.

Due to the twisted geography of the Central American Isthmus, the Panama Canal has ships sailing westwards on their way from the Pacific to the Atlantic (Fig. 3). Some 82 km in length, the canal has two distinct halves. Its southeastern half, on the Pacific side, between Panama City and Gamboa is cut through Panama's highland chain, whereas the northwestern half out to Colon on the Caribbean coast is across the lowlands of the lower Chagres River.

But such was not to be, as both the canalization and the maintenance could be largely eliminated by the creation of a lake. Construction of a dam on the Chagres, to impound Lake Gatun, was the key to successful completion of the lowland section of the canal (Fig. 3). The locks at Gamboa would no longer be needed as the lake waters would back up into the Culebra Cut. Instead there would be a flight of three locks at Gatun. There were also enormous savings in avoiding the difficult dredging and canalizing of the flood-prone Chagres River. In addition, the huge impounded lake could absorb the peaks of the floods coming down from the upper Chagres and would maintain a reliable supply of water to feed through the locks when traversed by ships.

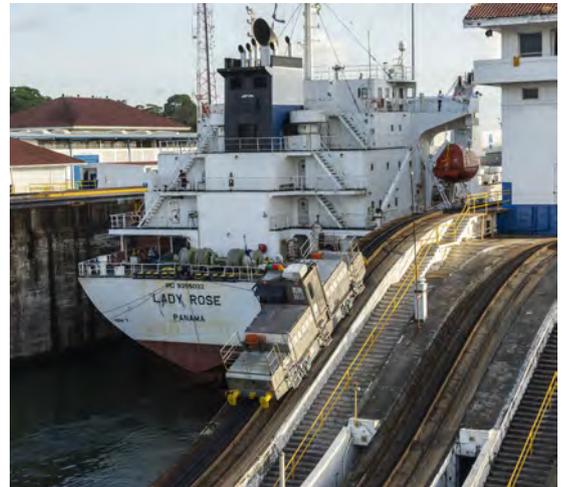
Fig. 4. One of the team of electric 'mules' guiding a ship through the Gatun Locks.

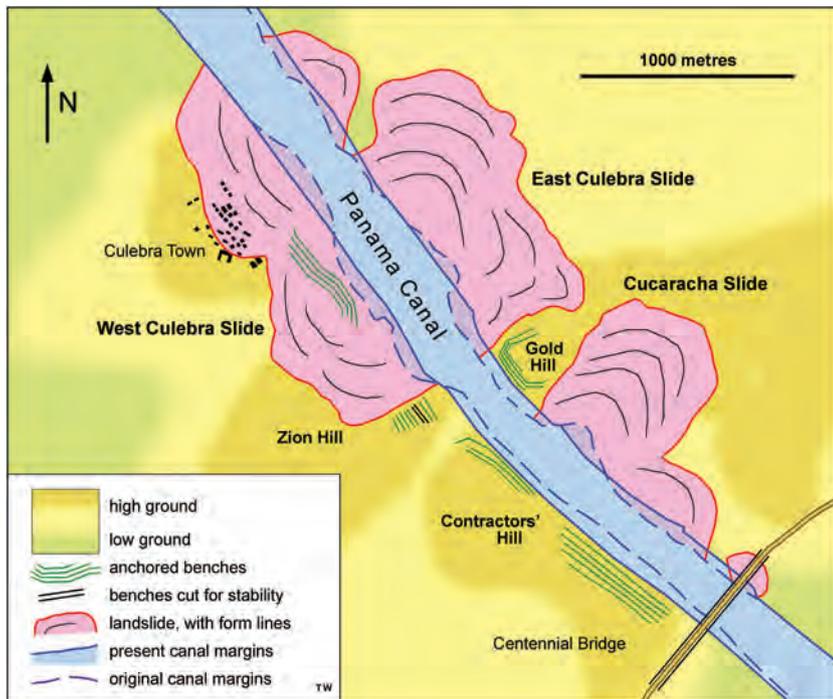
Fig. 5. The main landslides and hills along the Panama Canal's Culebra Cut.

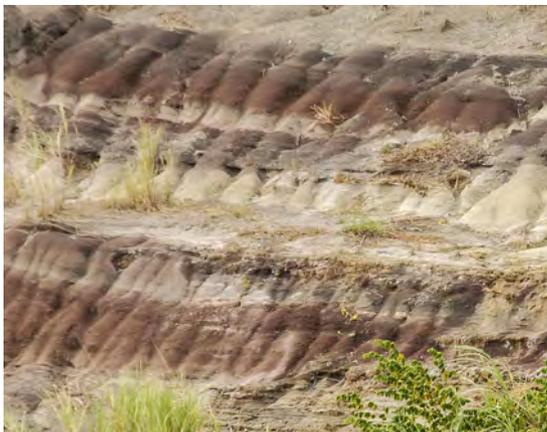
Fig. 6. An innocuous canal-side exposure of clays in the Cucaracha Formation.

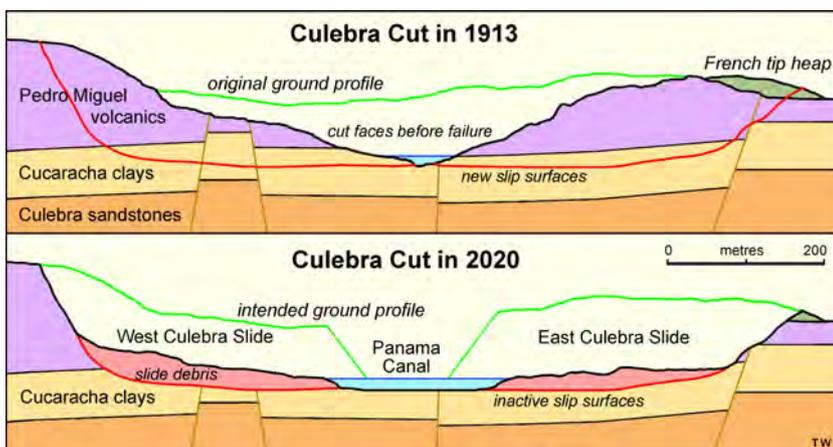
Fig. 7. Simplified cross-sections of the Culebra Cut looking towards the northwest, in 1913 and therefore late in the construction phase, and also as now after development of the two large landslides and the removal of most of their slipped debris.

Critical stages were reached within the Culebra Cut whenever and wherever excavations through the volcanic rocks reached down into the underlying Cucaracha clays (Fig. 7). This allowed extensive shear surfaces to develop within the clay, and the three large and famous landslides crept into activity while engineering works were still in progress (Fig. 8). The faulted and variable sequence of volcanic rocks already had a history of small slope failures, but their generally high strength became irrelevant when they were undermined by failure of the clays beneath. The two Culebra Slides were certainly deep-seated. It appears that the main shear planes at depth developed at least partly along gently dipping bedding planes or within the weakest clays of the Cucaracha Formation. However, uplift at the slide toes was observed when ground rose by as much as 10 m above slip surfaces that curved upwards to the surface. The landslides could therefore be described as rotational, but did not have the circular profiles that can develop in homogeneous material.

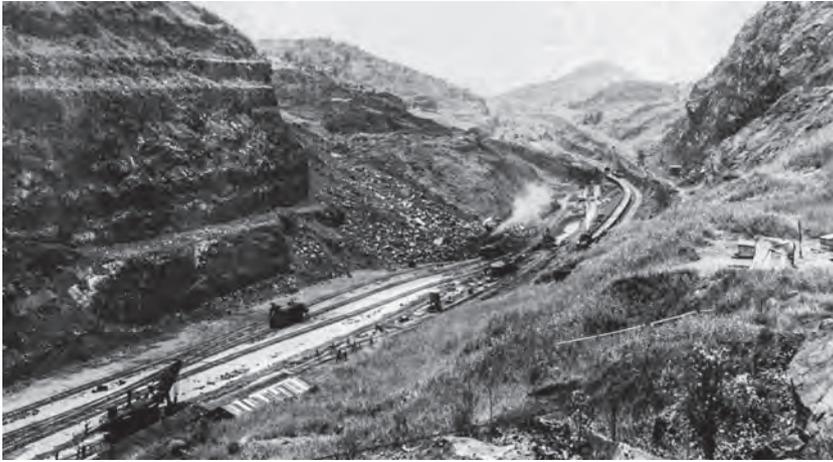
Fig. 8. An early stage of development of the large Cucaracha Slide. Most of the slide debris consists of Cucaracha clay, but the broken rock in the centre of the view is largely volcanic material from the adjacent face of Gold Hill.

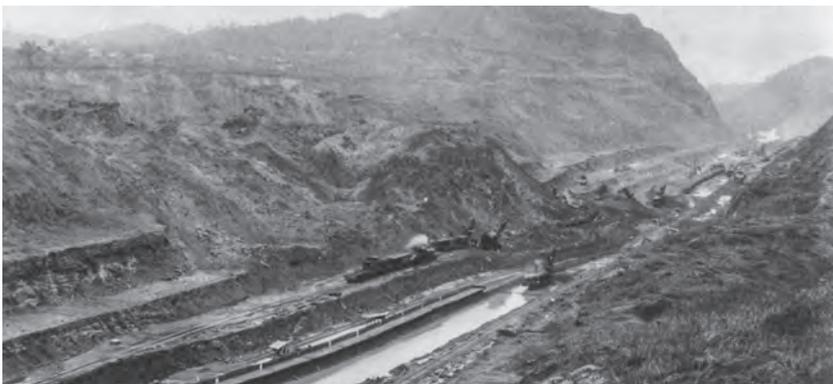
Fig. 9. An early stage of the East Culebra Slide, in 1913, before continued slumping and toe removal left a much lower profile on this bank of the canal.

structurally complex to be stabilized, so the engineers took the only available option of letting the slides run and removing the debris as it arrived (Fig. 9). This was where the massive machine capability of the Americans proved to be invaluable, and brute force really did win the day.

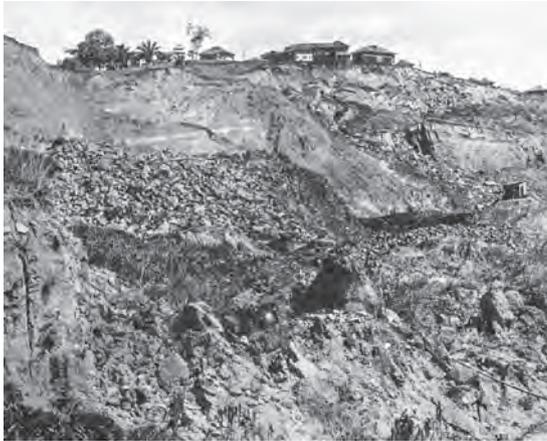
Fig. 10. The West Culebra Slide when successive slices were falling away from the head scarp, thereby undermining and destroying the small hill-top town of Culebra.

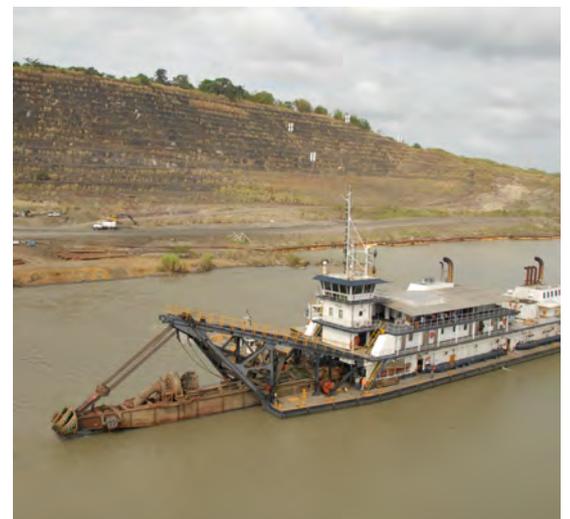
Fig. 11. A floating suction dredger in front of the West Culebra Slide in 2012, with its suction pipe and rotating head raised out of the water while not in action.

canal during the 1950s also included some re-profiling of the lower slopes. Ground movements have continued, but at reducing rates. Floating suction dredgers have proven to be the best way of removing slide debris that has slumped into the canal; they can also excavate any parts of the canal floor that have lifted at the toes of rotational slip surfaces. Dredgers were seen in action in 2012 and 2016, but not in 2020 (Fig. 11); it appears that the ground is slowly approaching a stable state.

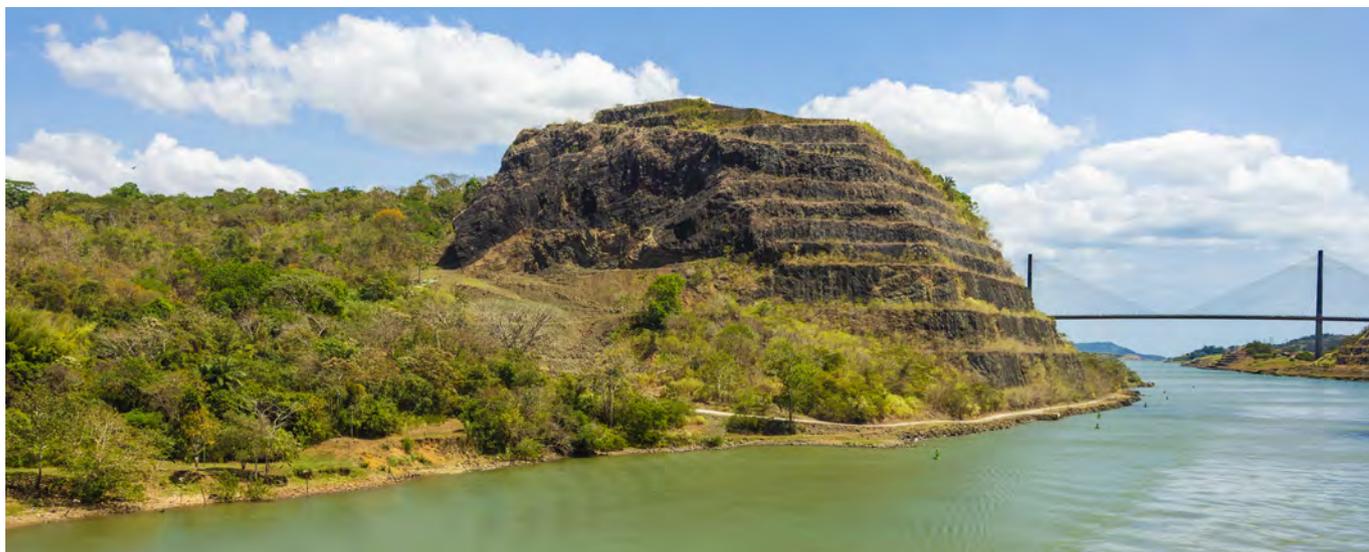
Fig. 12. The Canal's classic view of Gold Hill with the Centennial Bridge beyond. Though the terraced rock face of Gold Hill is the conspicuous feature, the low slopes on the left are actually more remarkable as they are all that is left after removal of most of the very large East Culebra Slide.

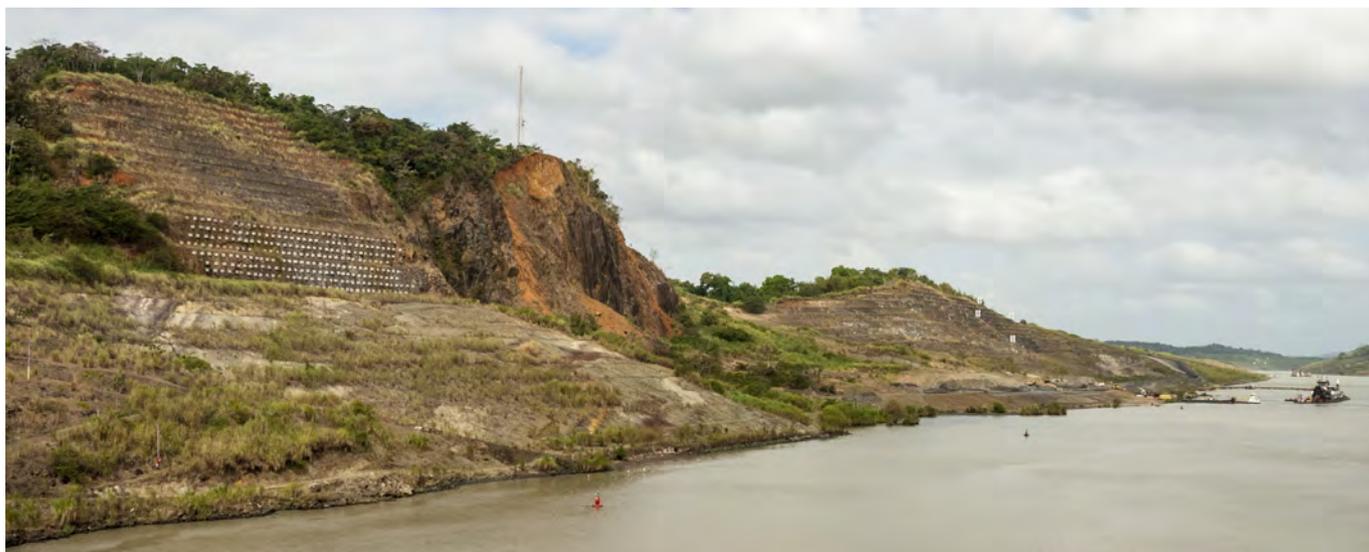
Fig. 13. On the left the anchored wall that has stabilized its rock buttress of Zion Hill after it was seen to be creeping over underlying clay. To its right, the West Culebra Slide has been cut to a much lower profile and is now largely stable, though a floating dredger was working at its toe when this image was taken in 2012.

In 1954, a widening head crack was found on Contractors' Hill. Stability was recovered by excavating a long, man-sized, drainage tunnel behind the face and also terracing the setback on the lower part of the slide. More recently, the rock spur of Zion Hill that forms the southern flank of the West Culebra Slide started to slide over the underlying clay. Its face was therefore benched, and the whole buttress of volcanic rock is now held intact by an array of long rock-anchors (Fig. 13).

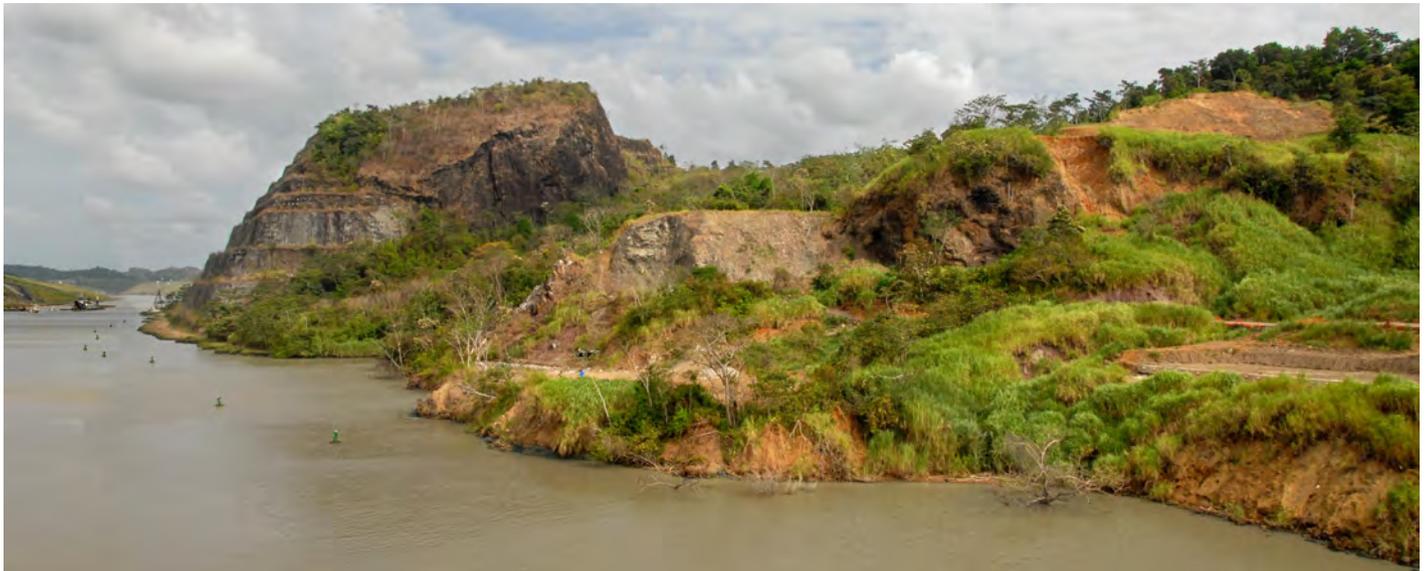
Fig. 14. Gold Hill in profile, with the broken ground of the Cucaracha Slide occupying the entire foreground.

Cut (Fig. 14), where large ships are still restricted to alternating periods of one-way traffic (though ships can pass each other on Gatun Lake and in the lock approaches). One other new feature was the Madden Dam, completed on the upper Chagres River in 1935. The impounded Lake Alajuela allows improved control of flood peaks, but is more important in holding water to replenish Gatun Lake during the four months of annual dry season when more water is released through the locks than is provided by rainfall.

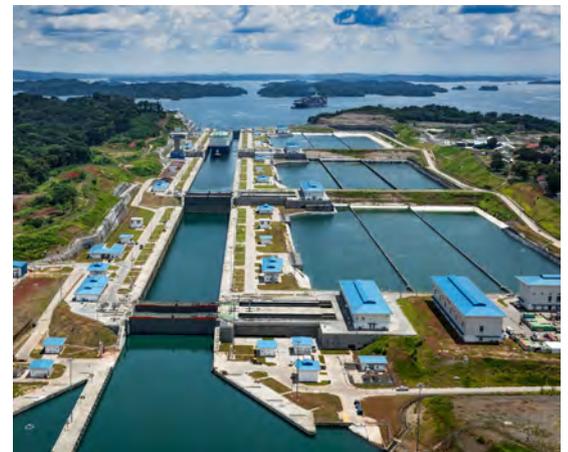
Fig. 16. The new Agua Clara Locks each with their three water-conservation basins. (Photo by Panama Canal Authority.)

were copied from designs on Belgian locks. Each lock is also accompanied by a multi-level set of water-conservation basins, which allow 60 percent of the water to be retained and re-used instead of all being lost whenever a ship goes either up or down through the locks (Fig. 16). These basins are a critical innovation, as the amount of water in the Chagres catchment imposes a limit on total lock use, which is now far from being reached due to the new measures of water conservation. The new locks also lack the guiding electric mules, because modern ships are so much more manoeuvrable under their own power; however, some ships have hit the lock walls, and the mules could be sorely missed.

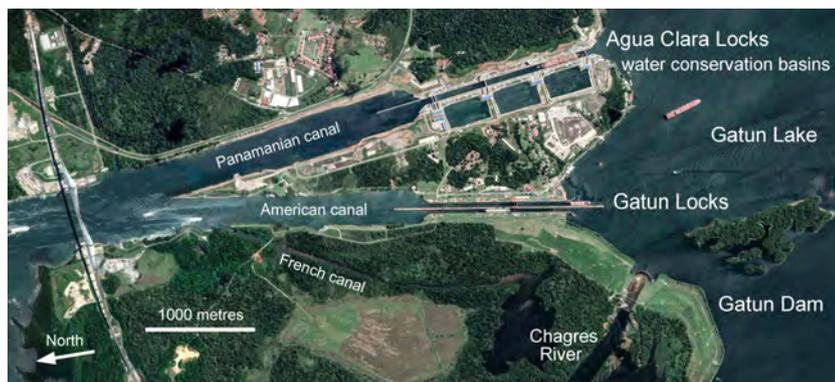
Fig. 15. Old and new locks out of Gatun Lake at the Atlantic end of the Panama Canal. The Earth components of the Gatun Dam are the entire areas covered in paler green grass, with the curved crest of its concrete spillway at the centre above the Chagres River. (Base images from GoogleEarth.)

Yet again, construction at Panama became another giant piece of civil engineering. It used more than seven million tonnes of concrete, but all was completed for the first transits of the larger ships in June 2016. 'Neopanamax' dimensions, as determined by the new locks, allow ships to carry 6500 standard 12-m-long containers, as opposed to 2500 on the older Panamax ships. There are just six new locks, in two triple flights without parallel duplication. They lie beside the original locks, which are still used for most smaller ships (Fig. 15).

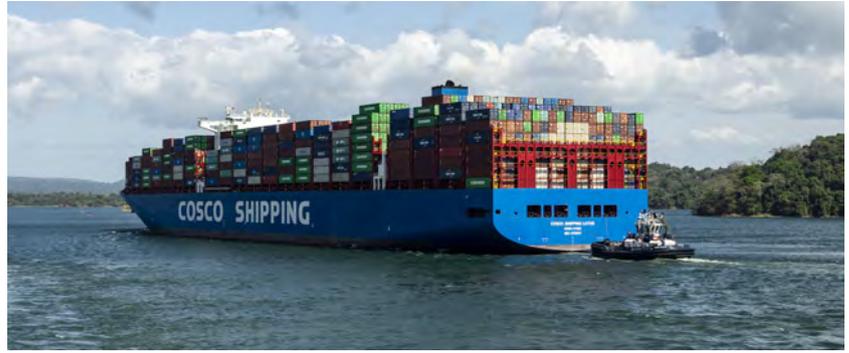
Fig. 18. Weighing in at more than 150 000 tonnes, a fully loaded Neopanamax container ship sailing at some 26 m above sea level on Gatun Lake.

The expanded canal has already proved to be a great success for the Panama nation, and the new lock dimensions assure its future (Fig. 18). There are already container ships that are too large to transit the new locks (whereas they can pass through the Suez Canal), but large numbers of new ships are being built to Neopanamax dimensions. Perhaps the greatest threat to the future canal traffic is climate change, which could open the Northwest Passage between Canada's Arctic islands and provide a shorter route from China to Europe, but this would only be for a part of each year.

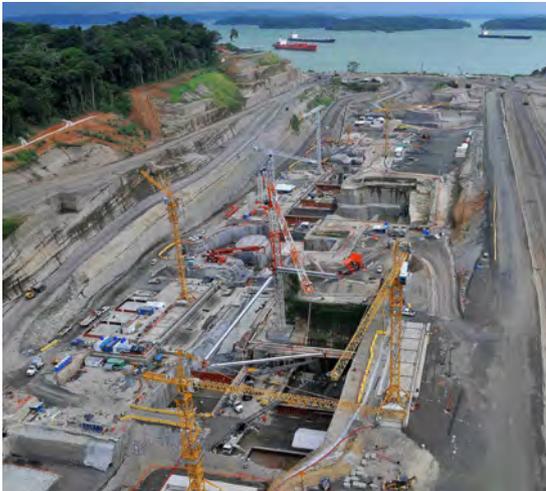
Fig. 17. An early stage of construction of the Agua Clara Locks, with the excavations bounded by steep faces cut into stable Palaeogene sedimentary rocks. (Photo by Panama Canal Authority.)

The new Agua Clara Locks are at the Atlantic end of the canal, adjacent to the old Gatun Locks. Away from the mountain axis, their ground conditions were relatively simple. Palaeogene sandstones and mudstones that are strong and massively bedded allowed steep faces to be cut for the lock excavations, and these remained stable prior to backfilling around the concrete structures (Fig. 17).
