# Landslide protection in Kazakhstan

Tony Waltham

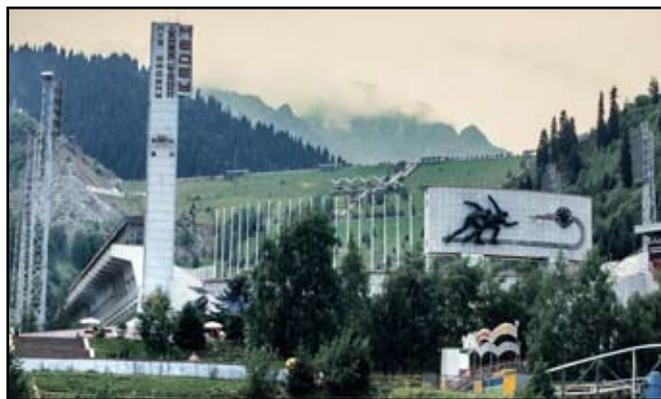
*The Medeu ice stadium protected below the downstream face of the rockfill dam which acts simply as a catch for debris flows.*

The big feature at Medeu is the huge ice-rink stadium, which was the top Soviet venue for speed skating before Kazakhstan broke away from Russia in 1991. And rising high above the stadium is a massive rockfill dam – which holds no water. It is a giant debris catch.

With the giant debris catch now only half empty, Medeu and Almaty were again at risk. So the dam was enlarged. It is now a seriously huge structure, 150 m high with a crest length of 530 m, built of  $8.5M m^3$  of rockfill. Its catch basin can

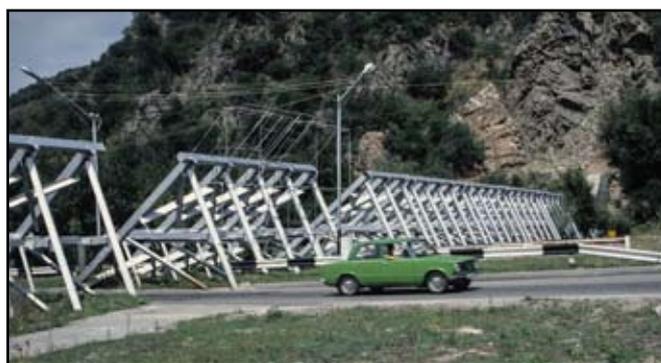
*Upstream face of one of the more modest debris-catch-barriers downstream of the Medeu dam.*

Debris flow protection works continue below Medeu, where smaller flows could be generated on slopes downstream of the big dam. Open steel-frame barriers reach across the valley floor, broken only by gaps for the river in normal flow, and for the road. These are similar to lahar barriers on some of Japan's volcanoes. They are designed to trap the large debris and take some of the destructive power out of any flow events – a welcome defence for the upper suburbs of Almaty. Today they stand unused, but could be more than appropriate if debris flows increase in frequency in a new climatic regime caused by global warming.

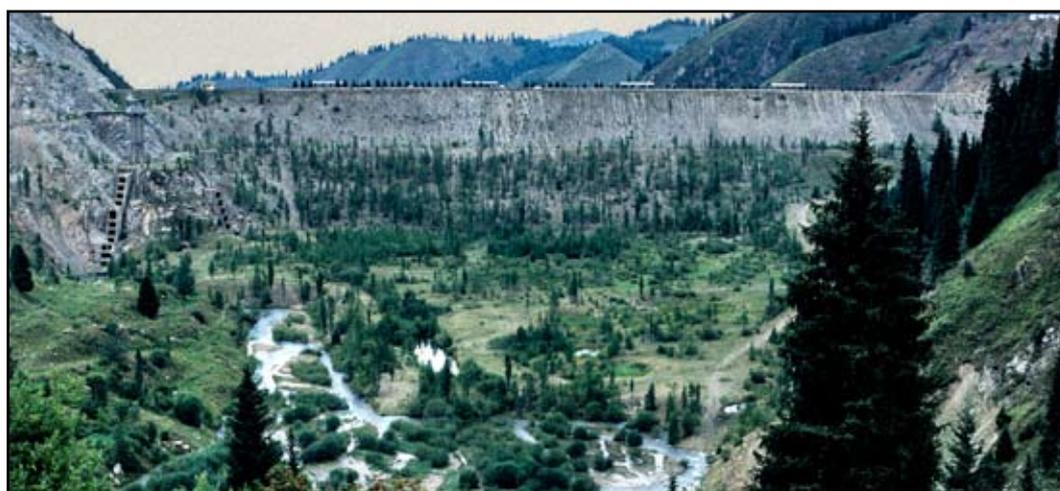
*Looking downstream across the Medeu catch basin, with the rockfill dam across the far side. The flat floor is the debris of the 1973 flow, which the dam successfully stopped. On the left, the ladder of dark holes forms the outlets for water above any level of new debris fill.*

Then in 1973 the precautionary engineering paid off. A debris flow arrived, and was totally restrained by the dam. Nearly  $4M m^3$  of debris half-filled the basin behind the dam, along with  $1.5M m^3$  of floodwater, which then drained off slowly and harmlessly.

hold  $12.6M m^3$  of inflowing debris, and a multilevel ladder of overflow tunnels is designed to drain off  $30 m^3/s$  of water from whatever level the debris reaches (Fig. 2). Today, the basin is still waiting, because there have been no debris flows since 1973. In part this is due to engineering works that have controlled the outflows from lakes ponded behind retreat moraines in the upper valleys; failure of their marginally stable till dams was a potential source of debris flows, posing one type of hazard now largely eliminated.
