Movement of the Mam Tor landslide, Derbyshire, UK

A. C. Waltham¹ & N. Dixon²

Abstract

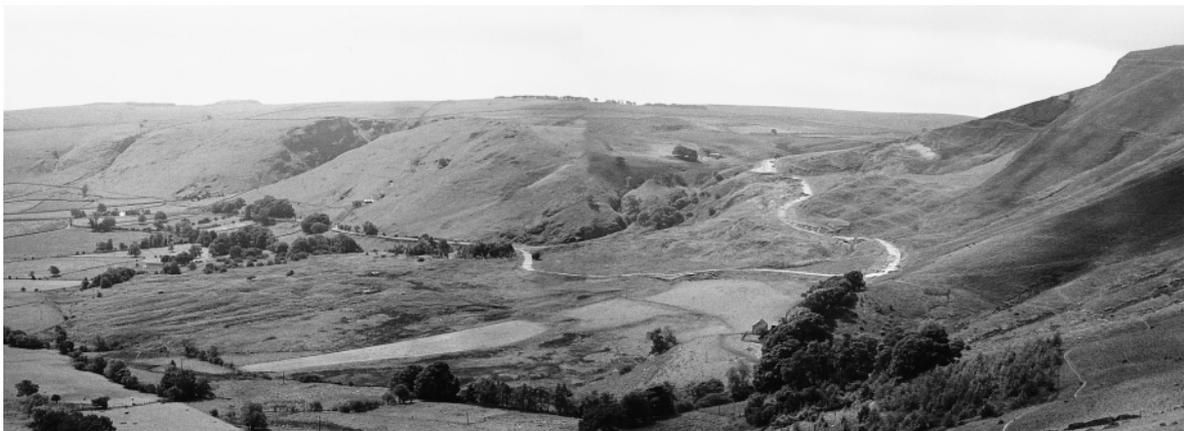
Fig. 2. The Mam Tor landslide viewed from the sandstone ridge to its north in 1998. The head scar is only seen in profile on the right, with the Iron Age fort ramparts visible just below the skyline. The road descends over the slipped blocks of the landslide mass, before turning back across the lower debris flow. Treak Cliff is the steep slope in reef limestone extending from the far side of the landslide to the shadowed breach of the Winnats Pass.

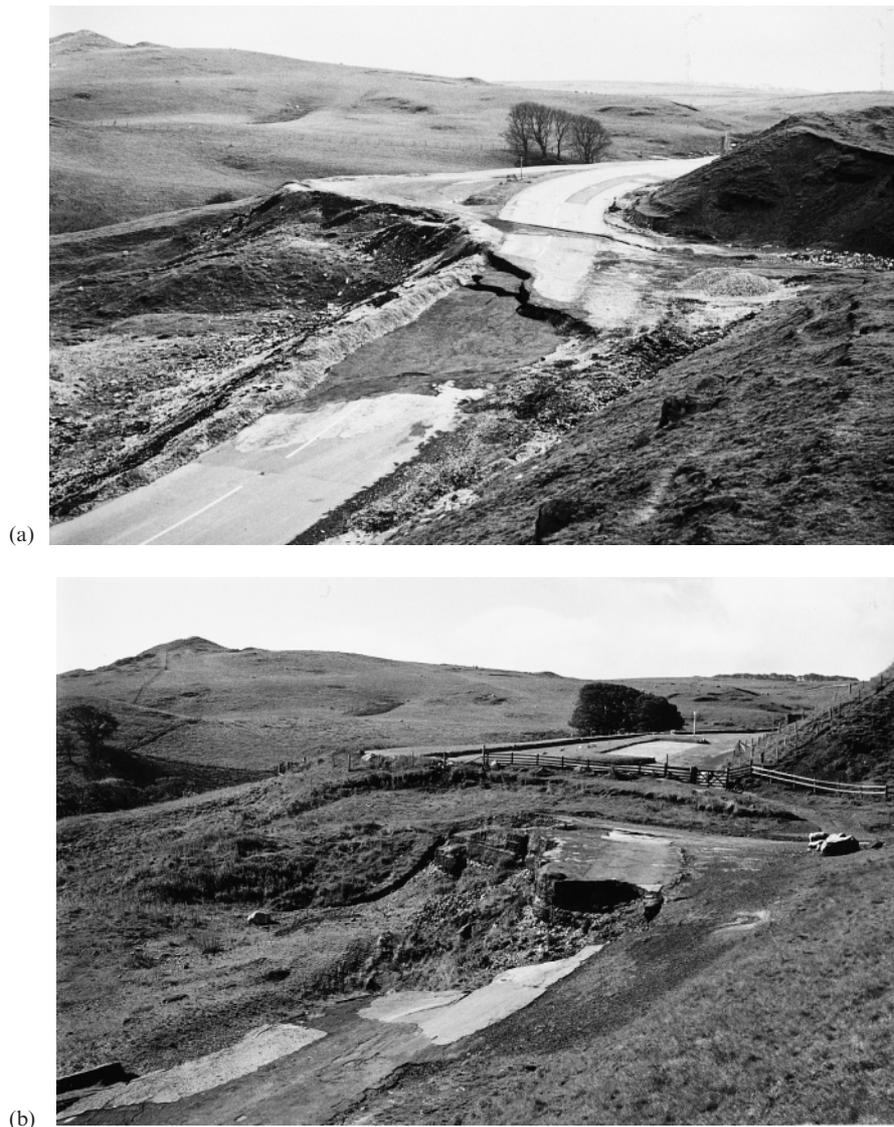
Fig. 5. The breaks in the upper road surface where it crosses onto the active landslide from the southwest. Photographs were taken in (a) 1977, soon after the road was closed to traffic, and (b) 1998. The earth bank across the road below the fence was placed over the landslide's marginal scar in 1990, and has subsequently broken.

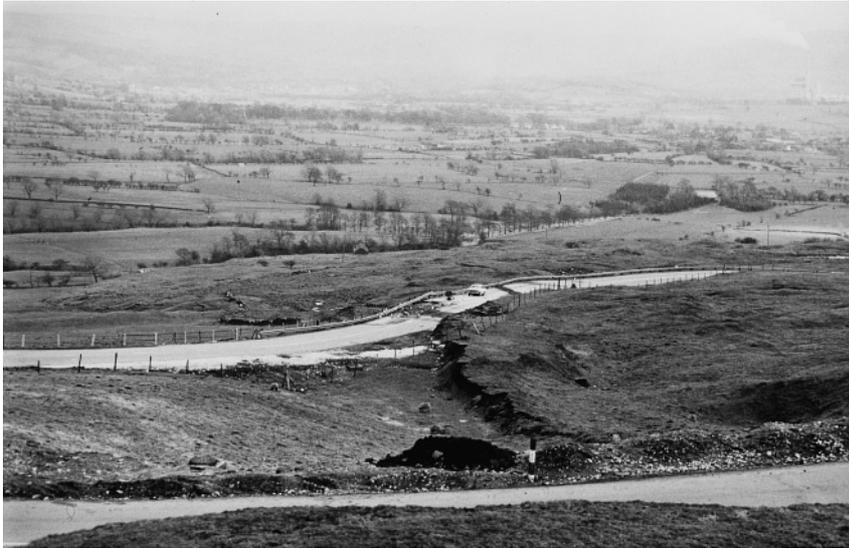
Fig. 6. The northern margin of the landslide where the slide debris is heaved obliquely up the rising slip surface to create a fresh and rising step in the ground surface. The photograph was taken looking down the slide in early 1977, when the movement rate was at a maximum; the scar is now less active and is largely grassed over.

supports; immediately west of the road, a bank of ground rose over a fresh earth scar where the rim of the slide debris was heaved obliquely up a slip plane which rises to intersect the ground surface (Fig. 6).

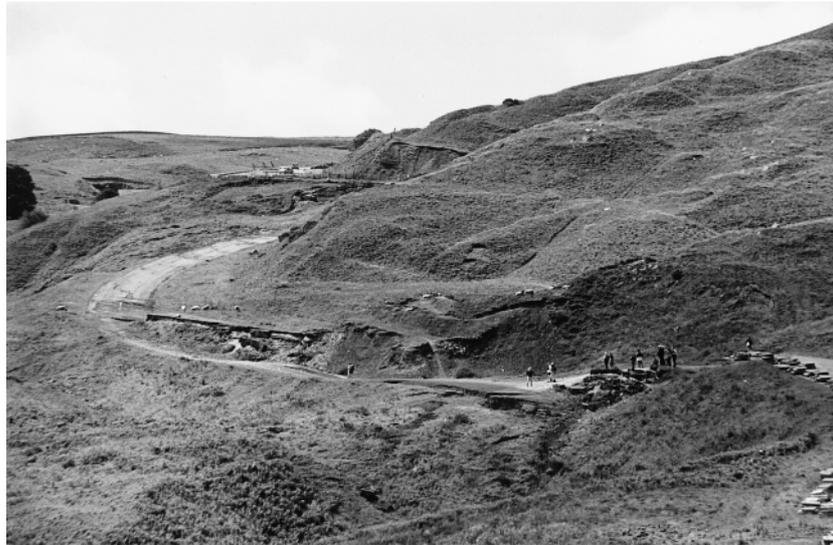
Fig. 9. The upper road across the landslide is broken by the head scars of element M as this cuts into the stepped and hummocked ground created by the multiple slide blocks which form element H, as seen in 1998.

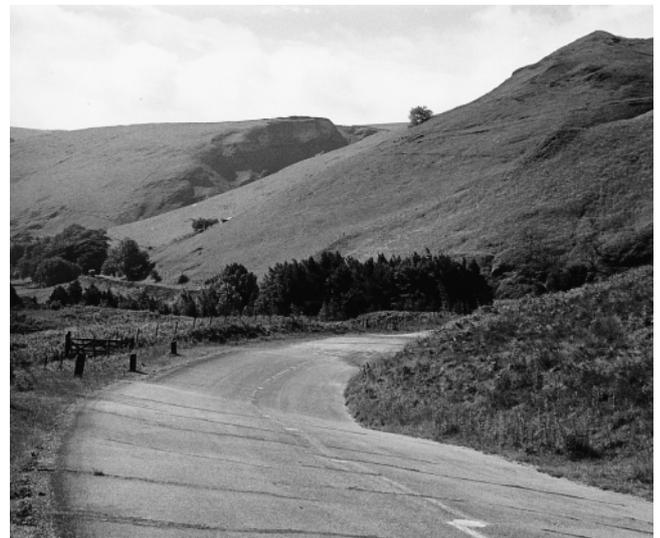
Fig. 10. Severe distortion without major fracturing of the lower road across the debris flow elements of the landslide in 1998.

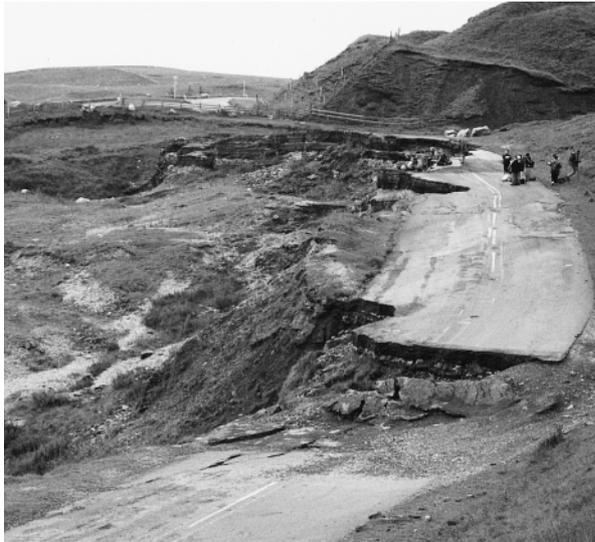
Fig. 16. Severe damage to the upper road on the southern part of the landslide, as it was in 1998. The road has slide element L falling away to its left, and steps down onto element J in the foreground. Intermittent remedial works have set the road further into the slope, creating the steep bank with trench drains on the right; the same works have placed fill to support the left of the road, but have therefore head loaded the active landslide element L.

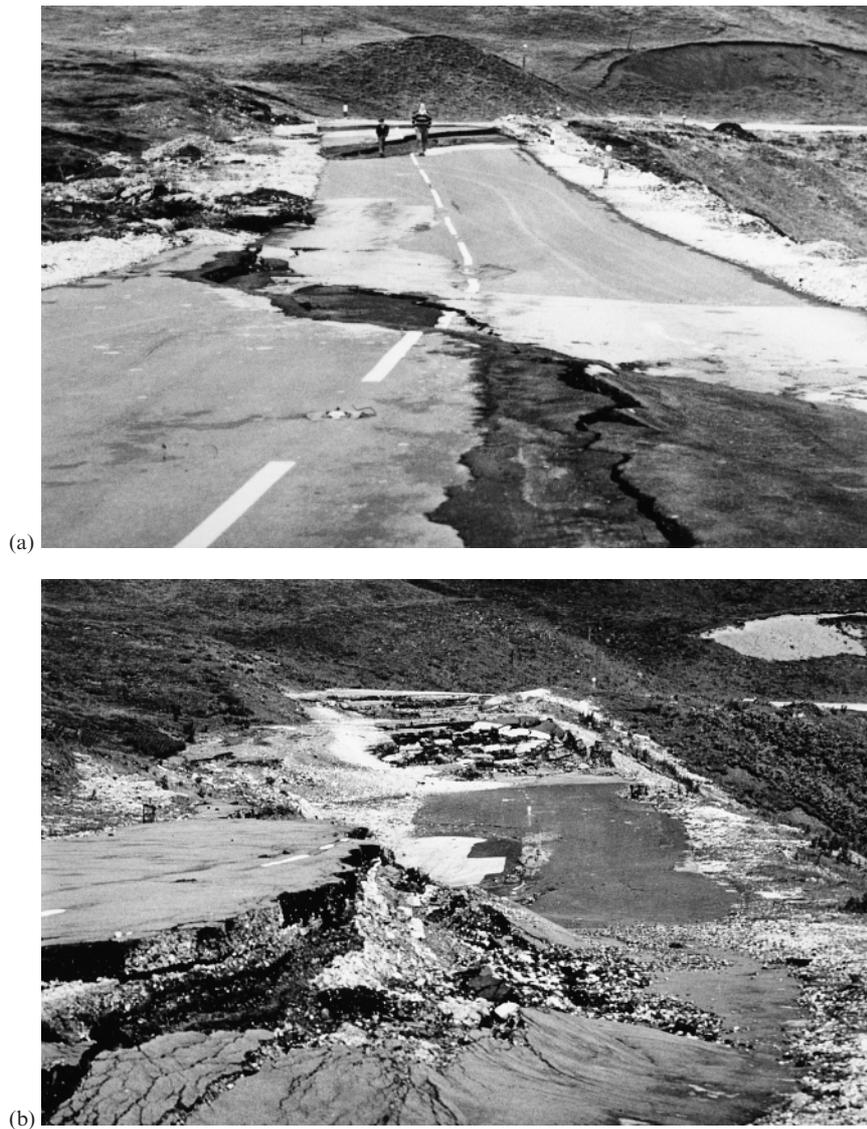
Fig. 17. Displacement of the upper road where it crosses landslide element M. Photographs were taken in (a) 1977 and (b) 1998. Movement is downwards and to the right at a mean rate of 0.25 m per year.
