Engineering Geology

Collapses of old mines in Korea

Ground collapses over abandoned mines constitute a significant geohazard in Korea. Recent collapses at the Mookeuk, Chungyang and Toehyun mines provide examples of the failures of rock over old stopes, and of old backfill that had been placed in abandoned stopes. Micro-seismic monitoring by borehole geophones is used to locate rockfalls within the Keumgok mine in order to design appropriate remedial filling. The government's Mine Reclamation Corporation has an ongoing programme of documentation and remediation of the old mines.

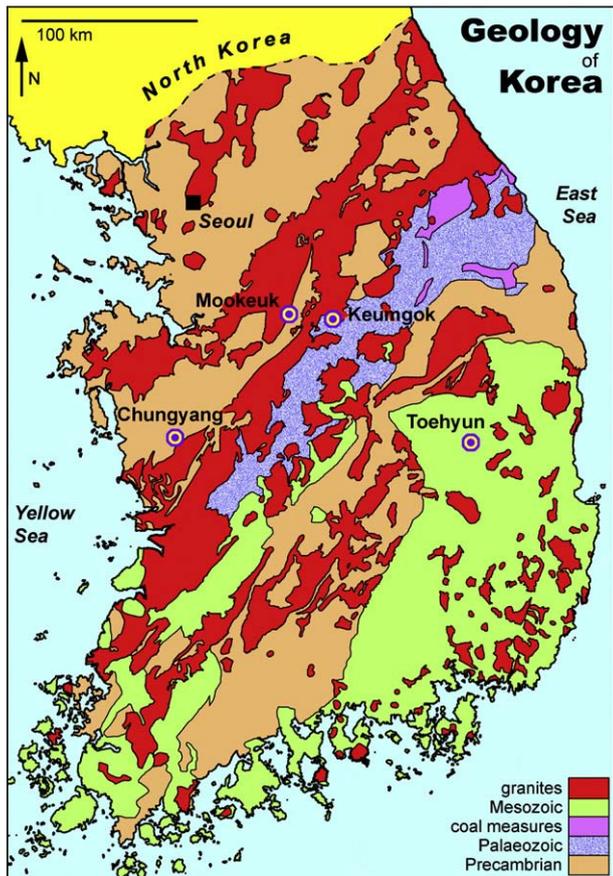
Fig. 1. Outline geological map of Korea (excluding Cheju Island) with locations of the four mine collapses referred to in the text.

The geology of the Korean peninsula (Fig. 1) is dominated by metamorphosed and strongly folded Precambrian and Lower Palaeozoic rocks with numerous large and small, late Palaeozoic, granitic intrusions. In the southeast, a younger cover of Mesozoic sedimentary and volcanic rocks is less deformed, and is intruded by late Cretaceous granites. Mines old and new are scattered throughout the country, though there are fewer within the Mesozoic cover away from their mineralising granites, and there is none in the shield volcano basalts that form the whole of Cheju Island (100 km south of the peninsula depicted in Fig. 1). The small area of Carboniferous coal measures in

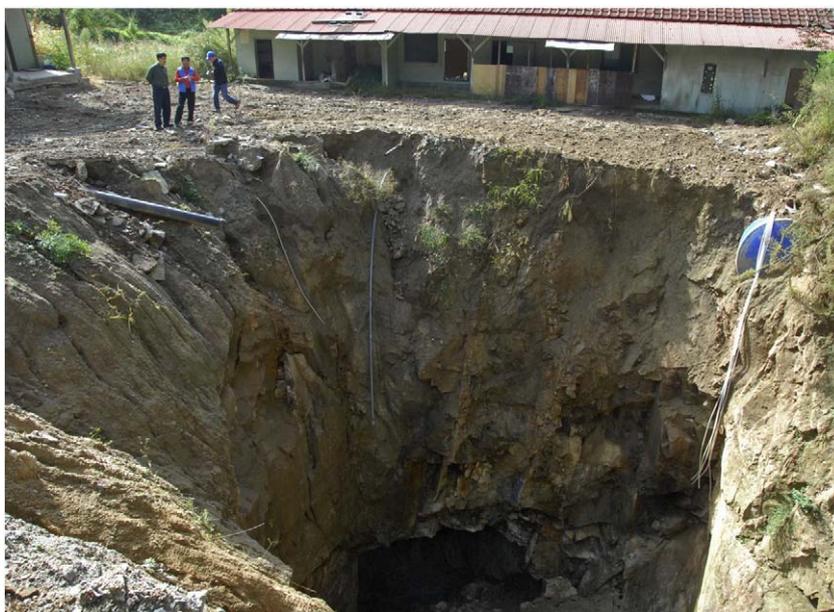
The initial collapse occurred on 27 May 2008, when a hole 8 m in diameter opened in the ground to a depth of 30 m (Fig. 2). This was a sudden ground failure, only preceded by a small-scale subsidence and soil cracking for about an hour. By sheer good fortune, the collapse hole developed in the garden that was surrounded on three sides by

This collapse of the ground surface occurred nine days after a short period of very heavy rainfall; 52.5 mm of rain fell on 18 May, in contrast to a mean daily precipitation of 4 mm. This was after a previous year's rainfall about 20% higher than the annual mean. The site lies in a slight natural valley that collects run-off and soil water from the adjacent slopes, though its floor has no permanent stream channel. Limited wall collapse caused the surface hole to enlarge to about 10 m across in mid-June. A larger collapse expanded the surface opening to about 15 m in diameter on 2 August 2008; this was again at an interval after another period of heavy rainfall on 19 July. Over the following 15 months, there have been no further significant changes to the collapse hole. A pile of fallen rock debris, has its top about 15 m below surface level; this slopes down for about 20 m to a remnant of rock floor visible within the mine stope that extends into darkness on the south side of the daylight hole. Collapse debris has now run into some of the deeper levels within the old mine.

Fig. 2. The open collapse hole over the old Mookkeuk gold mine, looking south along the line of the vein, in late 2009.

A survey of the visible and accessible features was completed in August 2008, and twelve boreholes, some vertical and some inclined, were drilled to depths of 60 m to investigate the adjacent sub-surface geology. These enabled down-hole camera recording of bedrock fractures, which indicated some increased fracture opening due to rock relaxation close to the mine workings. The hospice has moved elsewhere, and the site has been left to stabilise until the surface hole can be backfilled with a reasonable expectation of no subsequent subsidence.

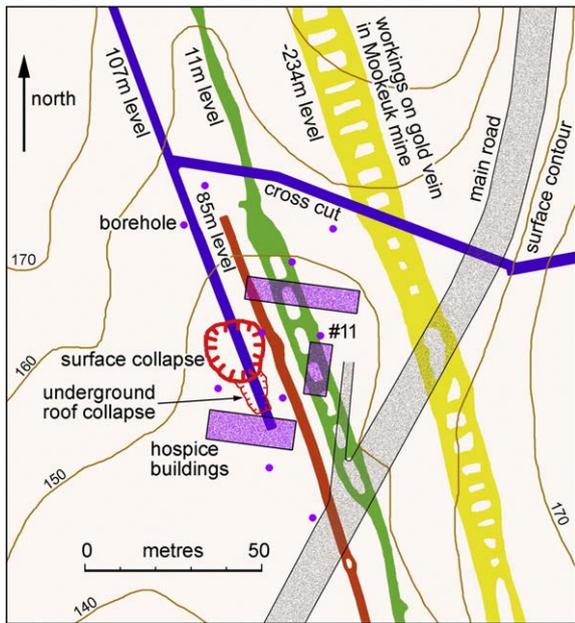
The ground failure at Mookkeuk was over the oldest part of the mine, worked in about 1910 (Fig. 3). A stope of the Hyungje vein was worked above a roadway floor 40 m below ground level (Fig. 4). There is no surviving record of exactly how high the stope reached, but it appears to have risen to within a few metres of rockhead. A roof of granite about 5 m thick survives over the stope's continuation to the south (Fig. 2). Above this, soil and weathered rock are a few metres thick, but thicken towards the northeast (Fig. 5). There is no evidence that the rock roof had been weakened by any small shafts reaching from this stope to the surface before being capped, buried, forgotten and subsequently destroyed by the collapse. From the borehole data, RQD varies from 50 to over 90 within the uppermost 30 m of the granite, with some recognisable decline in values closer to the vein, though this is not consistent.

Fig. 3. Surface and underground features at the Mookkeuk mine. Surface contours and mine levels are labelled in metres above sea level. Extents of the higher levels are only approximate.

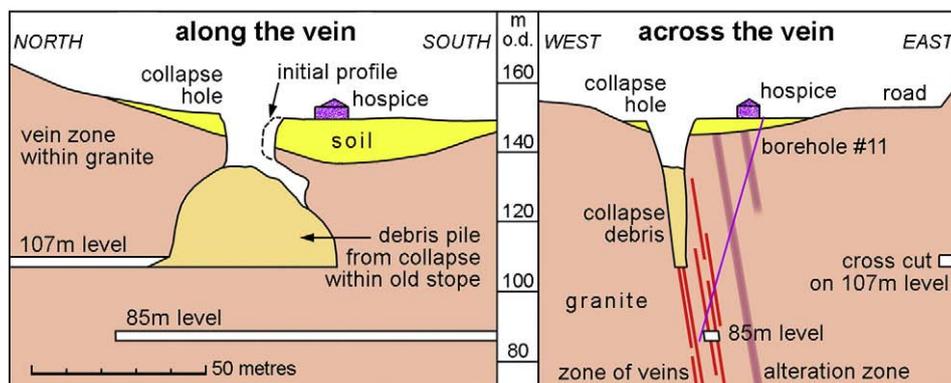
The widest exposed roof span in the mine is about 6 m, but the old stope may well have expanded to nearer 10 m on intersecting or parallel veins at the site of the collapse. High fracture density, and the weak, mineralised, altered rock along the zone of veins were significant factors in permitting collapse of the old stope roof. Without these, the cover of unweathered granite left over the stope would have to have been only about a metre thick to collapse without imposed load. Clearly, high groundwater pressures following the heavy rainfalls helped determine the timing of the event, but would have had limited impact on the granite where only widely spaced fractures are now exposed in the walls of the collapse. The water table is currently about 30 m below surface level at the collapse site, with most of the mine now flooded.

It appears that the Mookkeuk mine collapse was due to the final failure of undisturbed rock that spanned an excessively wide mined cavity. Without records of the stopes prior to the failure, the extent of preceding progressive roof and wall failure remains uncertain. There are small surface pits along the main and subsidiary veins, but there are no other surface collapses. In a well-populated area, and adjacent to a main road, remediation and redevelopment of the site is appropriate. It is fortunate that remedial works will not be excessively large due to the narrowness of the old workings along the vein.

Fig. 4. Cross sections through the collapse at the Mookkeuk mine, both along and across the vein.

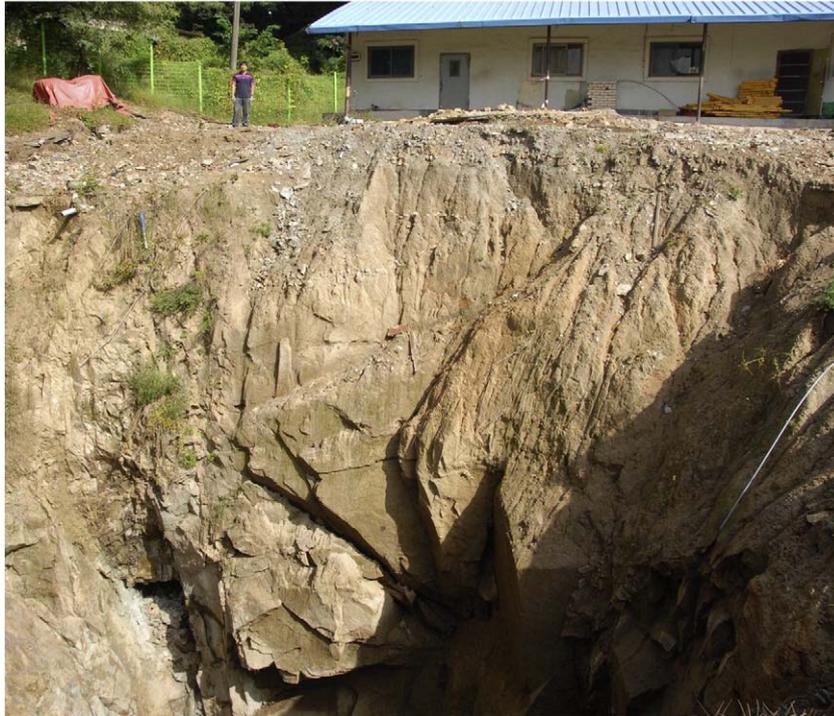
Fig. 5. Massive granite exposed in the north face of the Mookkeuk collapse.

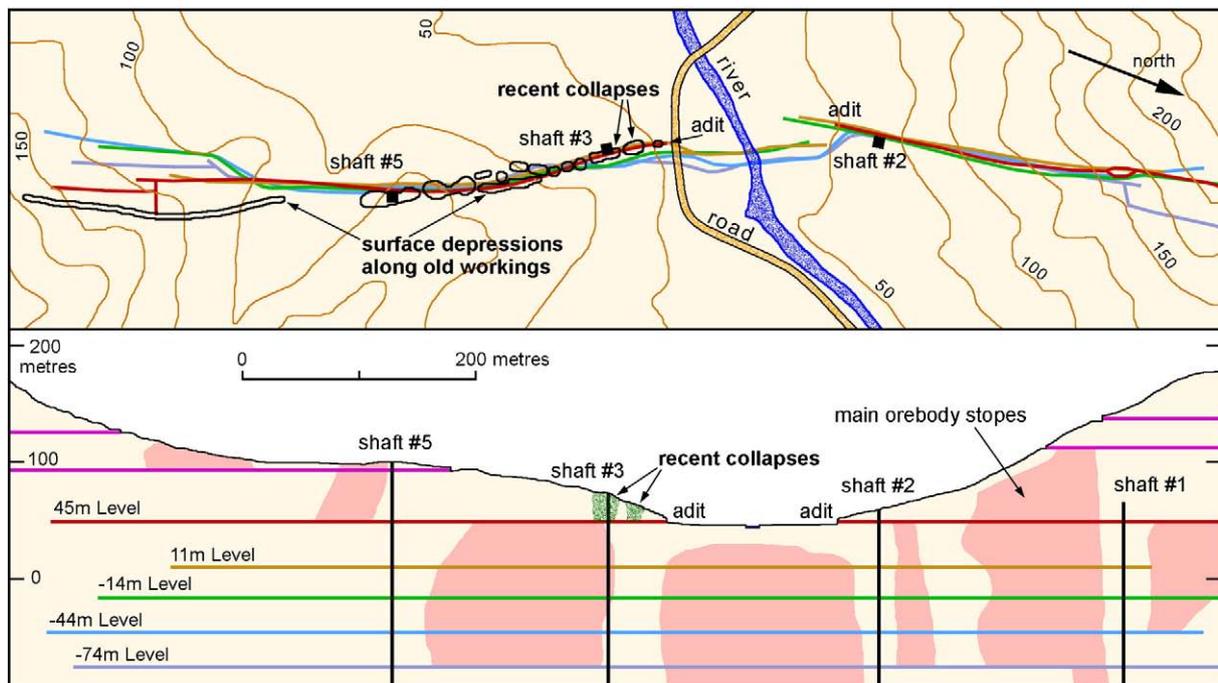
A mineralised vein system was identified in 1912, beneath the wooded sides of a small valley 25 km southwest of the city of Gongju, in Chungchongnam province (Fig. 1). The near-vertical veins lie within, and along the axes of, thin sheets of Cretaceous quartz-porphry that were intruded into Precambrian granite gneisses. A substantial mine operated from 1935 until 1982, producing over 16,000 tonnes of tungsten, together with bi-product gold, silver, copper and molybdenum. Stopes just a few metres wide were developed beneath the valley floor and under both hillsides, and reached a vertical range of 400 m (Fig. 6). At the north end of the mine, parallel workings were developed on a bifurcation of the main vein.

Fig. 6. Plan and profile of the central part of the Chungyang vein mine. Only the main areas of stopes within the richer orebodies are identified on the profile, and workings also reached into leaner parts of the vein; the mine extends beyond the map in both directions, and also to deeper levels.

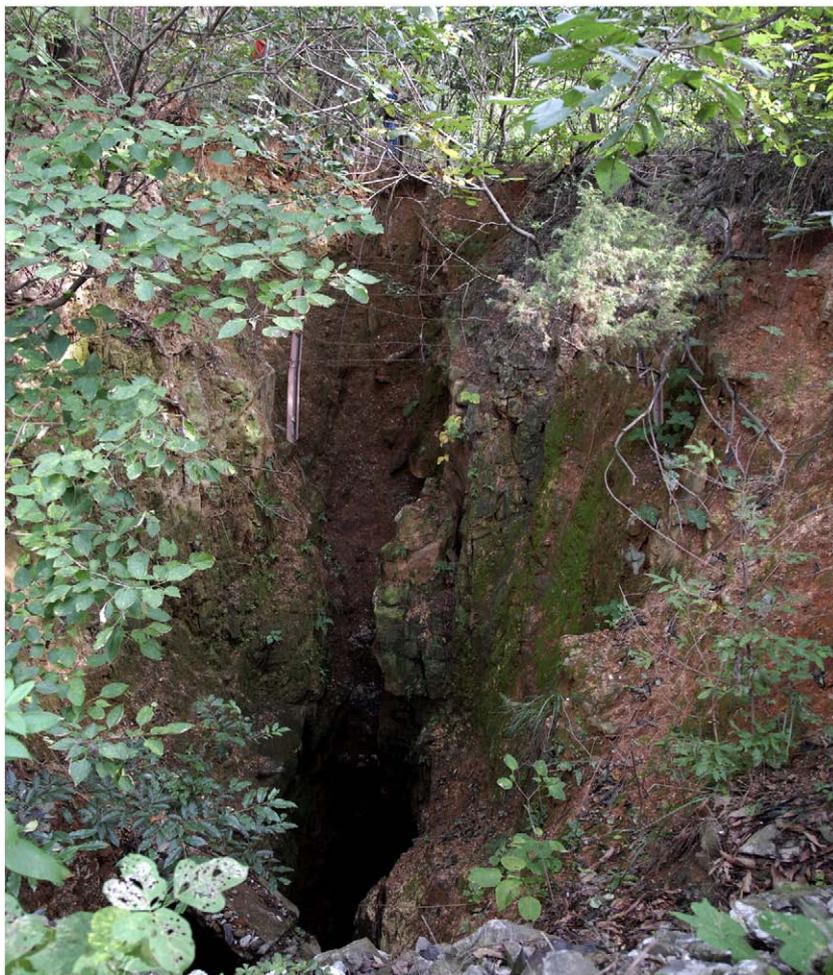
Significant collapses of the backfill have developed recently at two sites along the Chungyang vein (Fig. 7). Each has left an open hole less than 2 m wide and about 15 m long; they both descend into darkness and their unstable walls prevent further investigation. One has exposed the outside of the concrete lining of the shaft #3, which was backfilled at some time in the past; the square shaft was set into the western wallrock on the edge of the vein, so that one side is now exposed where the stope's backfill has fallen away.

Any geohazard from ground instability over the old Chungyang mine depends largely on the extent to which backfill is supported on timbers above open stopes and on the state of those timbers. From the appearance of the two collapses now visible, a potential threat must

Fig. 7. The northern of the two recent collapse of backfill over the old Chungyang mine, looking south along the main vein.

be recognised along the whole footprint of the mine. Areas with backfill that rests on bedrock pillars are likely to be stable, but the extent of these is not easily determined. The costs of remedial works may be so high that it is economical to regard the narrow strip of steeply sloping woodland directly over the mine as sterile and inappropriate for any development. The exception to avoidance of the undermined ground is the road crossing on the valley floor, but current data indicates that this is not at risk. In addition, the strong wallrocks mean that ground adjacent to the vein is not at risk.

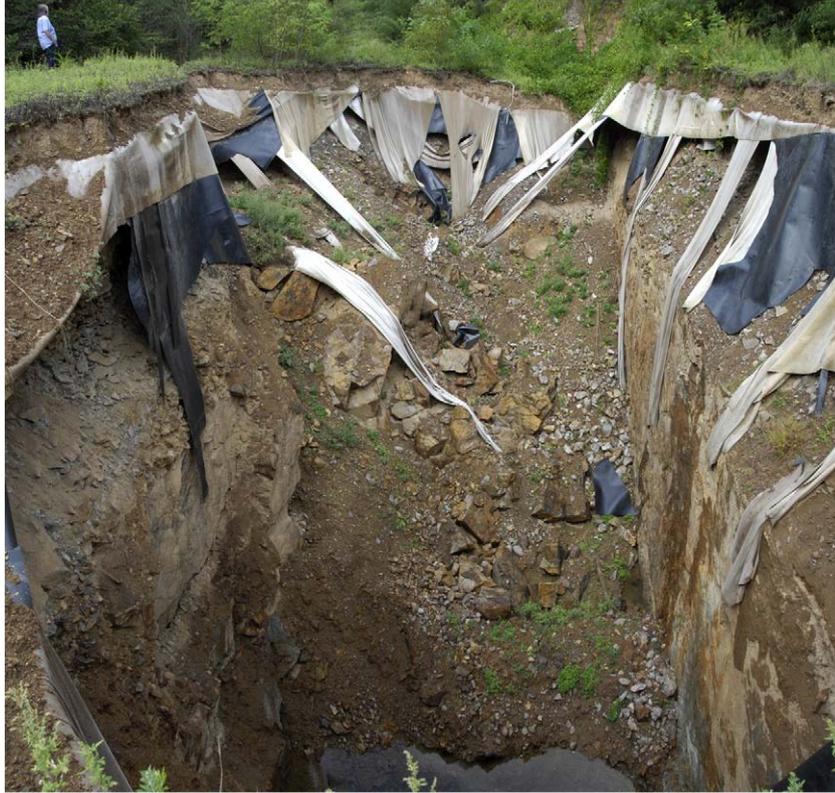
A small collapse sinkhole was first seen in the upper end of the restored ground in March 2009, during routine monitoring for soil contamination. The surface hole was only a few metres across and lay above a small inclined shaft into which the cover of restoration debris had slumped. By early April, a second sinkhole, over 10 m in diameter, had opened in the centre of the restored ground. Further wall collapse caused this hole to grow to about 20 m by 15 m in May 2009. This event appears to have been triggered by an earthquake of Magnitude 3.8, which had its epicentre near Andong, 35 km away; this would have generated ground shaking only to about Intensity IV at the mine site. Subsequent minor slumping of the restoration debris exposed in the upper walls has enlarged the sinkhole to about 18 m by 25 m, with a ramp of fallen debris down to standing water 12 m below ground level (Fig. 8).

It would therefore appear that the primary cause of the surface collapses was the movement of backfill that had not been properly

Fig. 8. The collapse sinkhole at the old Toehyun mine, looking north, after it was enlarged during the 2009 earthquake. Broken strips of geotextile, placed beneath the soil during site reclamation, hang down the walls.

contained or engineered and therefore ran into lower parts of the mine that were still open. The geotextiles above the restoration fill were never intended to span an open void 8 m across, and therefore failed under the weight of their soil cover.

A complete restoration of the site may require judicious grouting of fill within some parts of the mine to ensure the stability of any new backfill in the sinkhole. This may involve costs that are excessive for a site is on the edge of forest land with almost no need for visitor access. The site is scheduled for a thorough investigation in the near future.

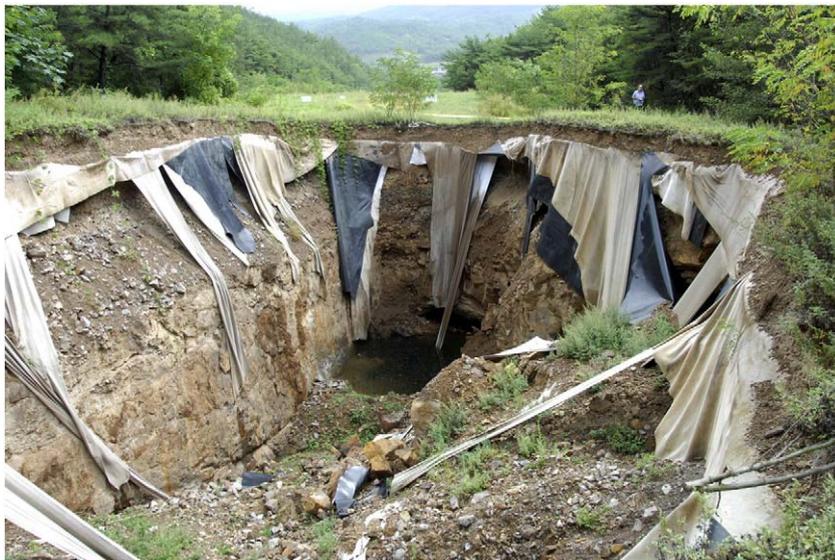
The collapse sinkhole has revealed an opening between rock walls about 8 m apart. This appears to be an old open cut on the line of the mineralised vein. There are no signs of freshly broken rock that might indicate the collapse of a rock roof above an underground stope. It appears that the open cut was backfilled before being covered with the restoration debris, but there are no known records of the mine's development. At the southern (down-valley) end of the sinkhole a sloping rock roof descends into and below the standing water. The slope of collapsed debris can be seen running down into an underground stope over which the sandstone bedrock is intact (Fig. 9).

Fig. 9. The large collapse sinkhole at the old Toehyun mine, looking south, down the valley, after the earthquake.

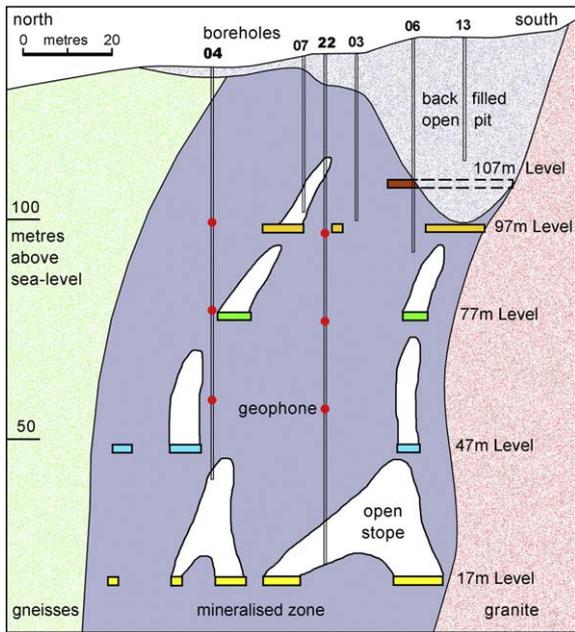
Fig. 10. Section through the old Keumgok mine, with the boreholes and geophones that are part of the current investigation. The lowest level (at –13 m) is not shown.

underground mining then continued to reach depths of 150 m along a strike length of more than 250 m (Fig. 10). The open-pit was backfilled around 1980, and the site was redeveloped in 2003 for housing. Three-storey blocks of apartments were built above some of the deeper old underground workings but avoided most of the backfilled open-pit and the mine levels with less rock cover (Fig. 11).

Subsequently, a programme of micro-seismic, real-time monitoring has been established to determine the locations and extent of the rockfalls, in order to design remediation appropriate for the site. A total of 30 geophones have been installed at depths of 40, 60 and 80 m in each of ten boreholes across the site (Fig. 11). These have the time resolution to be able to locate the source of any vibrations created by rockfalls within the mine. They have now been installed for nearly a year, and have not yet recorded an underground rockfall; the instruments are known to be working satisfactorily because they have recorded frequent events that originated from blasting in a quarry 900 m away.

It is apparent that the old Keumgok mine workings may eventually require filling with rock paste injected through boreholes to allow safe development of the immediate and adjacent ground. Whether the entire mine, or just the upper levels, will have to be filled can only be determined by a proper understanding of the pattern and extent of the rockfalls; the current programme of monitoring is intended to provide this.

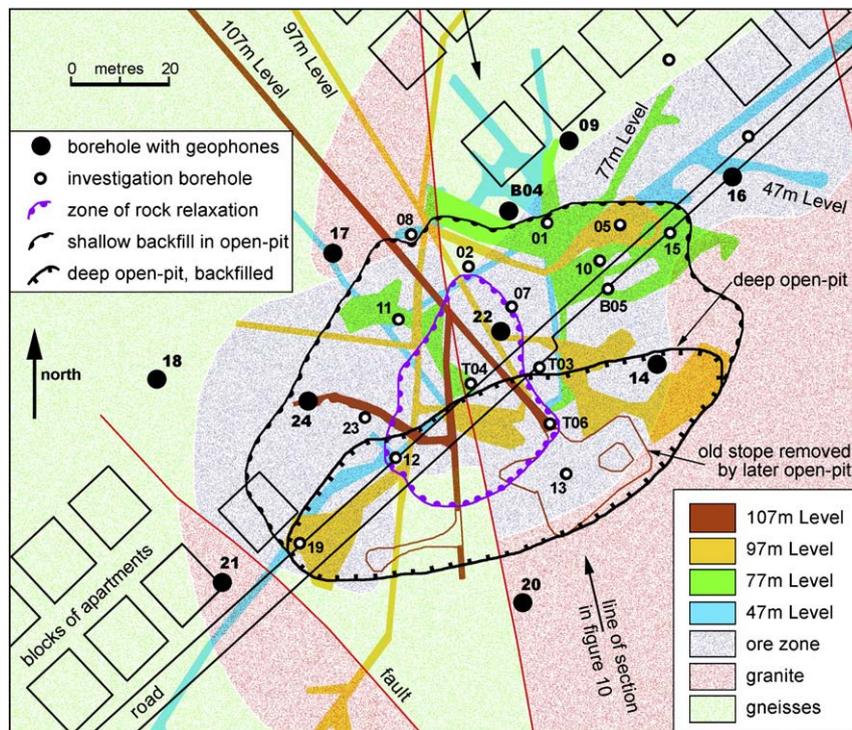
these lie at depths of only 20–30 m in orebodies adjacent to the deeper sections of the backfilled open-pit. This prompted an investigation programme. Boreholes intersected extensive cavities in the upper parts of the old mine. They also revealed a significant zone of ground relaxation beneath and adjacent to the deeper part of the backfilled open-pit (Fig. 11). The water table lies at about 100 m, very close to the floor level in the deepest part of the old open-pit. Rock Mass Ratings were interpreted from the borehole data to lie in the range of 30 to 95, with a mean of 67 and some recognisable decline around higher levels of the old mine.

Fig. 11. Surface and underground features of the Keumgok mine. Surface level is close to 135 m across the site. Deeper levels within the mine (at 17 m and –13 m) are omitted for clarity.
