LANDMARK OF GEOLOGY IN THE EAST MIDLANDS

Castle Rock, Nottingham

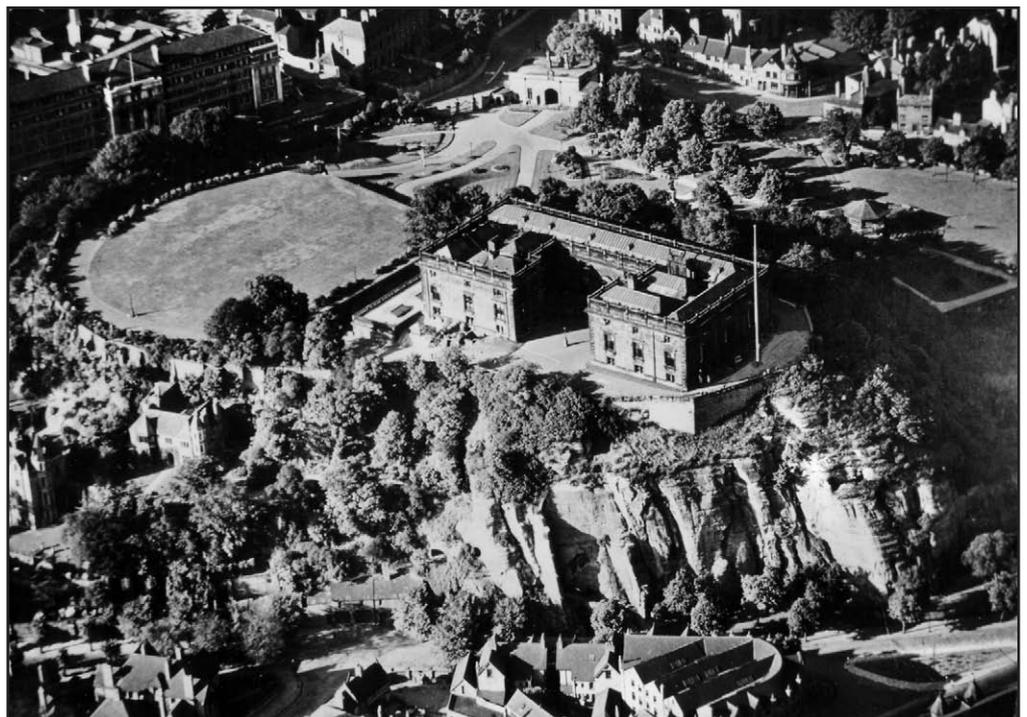
Figure 1. Castle Rock seen from the southwest, with vertical joints defining the castellated buttresses of the sandstone cliff.

The Nottingham Castle Sandstone inherited its gently dipping tectonic structure from its position on the eastern limb of the Pennine Anticline, which was uplifted by tectonic movements on the periphery of the Alpine orogenic belt. It now dips eastwards at about one degree, but otherwise exhibits remarkably little deformation. The sandstone is a weak rock; it has a sparse cement of clay particles that bridge between the quartz grains (Fig. 4), and the many open pores were formerly occupied by a primary calcite cement that was dissolved away by circulating groundwaters (the cement survives in the same sandstone formation at depths of hundreds of metres). The sandstone gains its mass strength from the scarcity of its fractures. Major bedding planes are widely spaced, and joints are mainly restricted to a single system aligned roughly NNW-SSE, and dipping steeply to the west; these have a mean spacing of about 15 m along the Lenton Road section. Joints in the same system are spaced more closely within a belt immediately west of the Castle, creating the unstable rock slabs on the southwestern side of Castle Rock (Fig. 1).

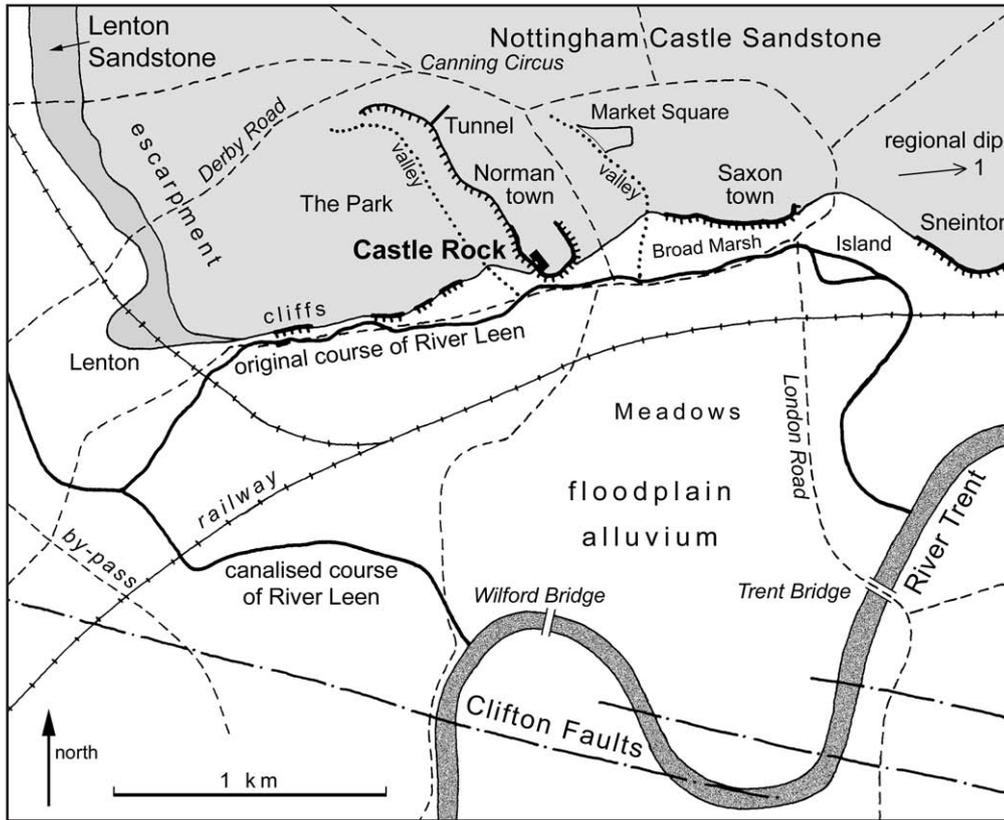
Figure 2. The geology and surrounds of Castle Rock, showing the River Leen in its original course along the foot of the river-cut cliffs that fringe the Trent floodplain where it breaches the sandstone escarpment.

of the Rock are from later times, they include the beer cellars behind the two inns, and a series of rather featureless rooms that must have formed the back rooms of houses and workshops fronting on Castle Road (*Mercian Geologist*, 1992, v13, p5-36). Behind the northernmost of these, the linear caves forming a grid are among the youngest in Nottingham, having been excavated as air-raid shelters around 1939 (Fig. 5). Worthy of note is the Park Tunnel, cut through the ridge that extends behind Castle Rock. Excavated in the 1850s to allow access for horse-drawn coaches into the Park Estate, it was soon demoted to a footpath when new roads were built round the south of Castle Rock. But its geological benefit remains with the excellent exposures of sedimentary structures in the clean vertical faces cut in the sandstone (Fig. 2).

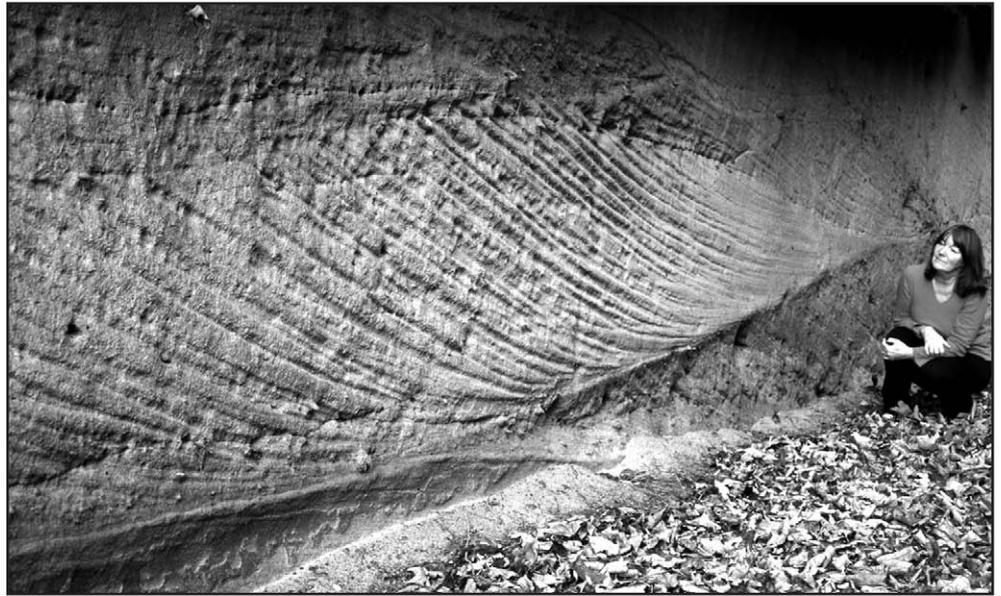
Figure 3. Current bedded sandstone exposed by the entrance to the Park Tunnel.

dips, but these are merely apparent dips in uniformly inclined foresets, viewed in rock faces at different orientations. The most splendid example of cross-bedding within a single sand bar is exposed farther north in the clean vertical wall on the north side of the lower exit of the Park Tunnel (Fig. 3), and there is a wealth of other sedimentary structures exposed in and around the tunnel.

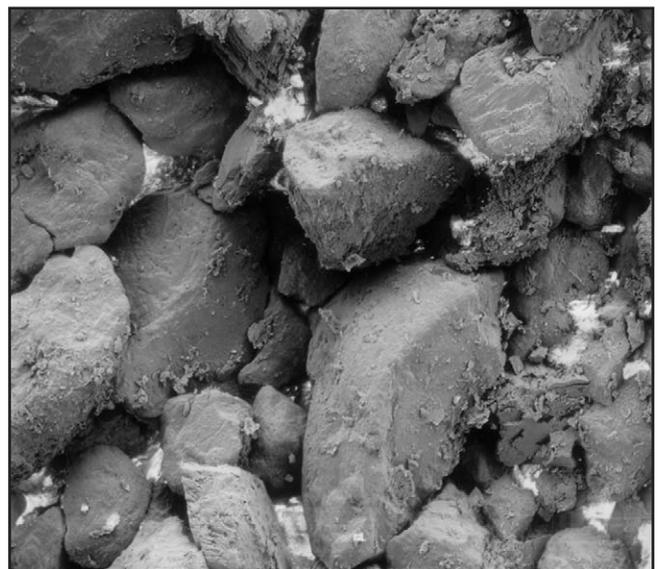
Figure 4. Nottingham Castle Sandstone, with quartz grains bonded by a minimal clay cement; an image from a scanning electron microscope; field of view is 4mm across

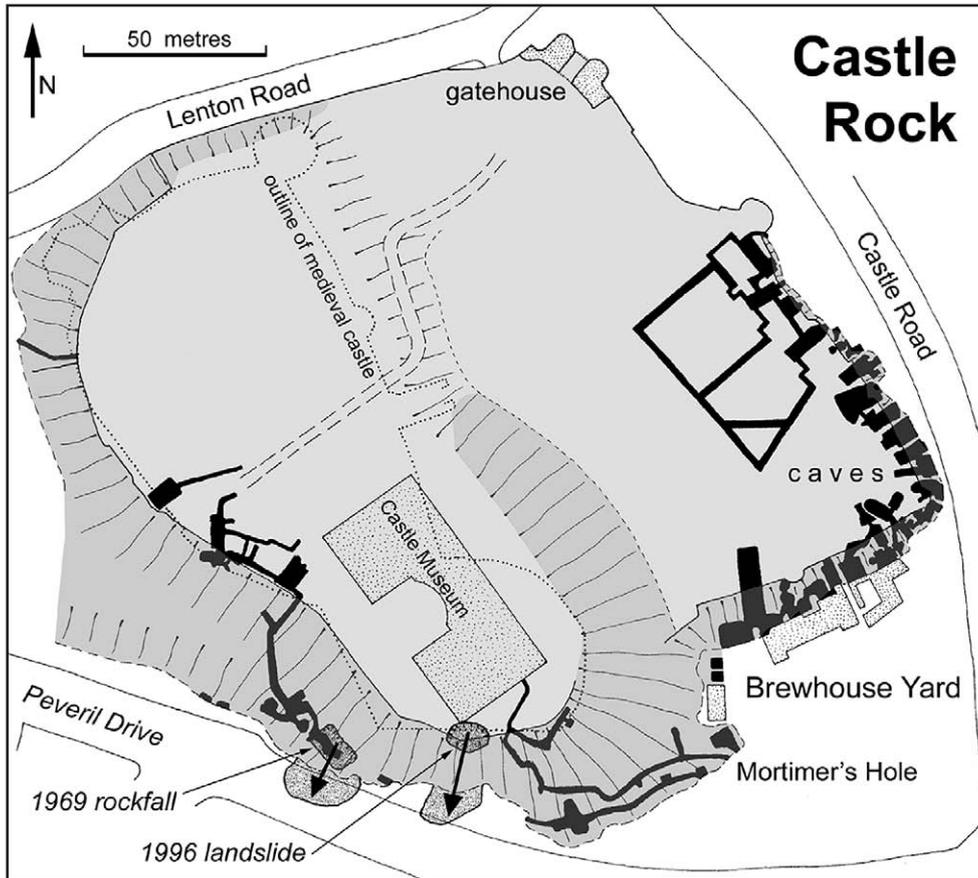
Figure 5. The caves and features of Castle Rock.

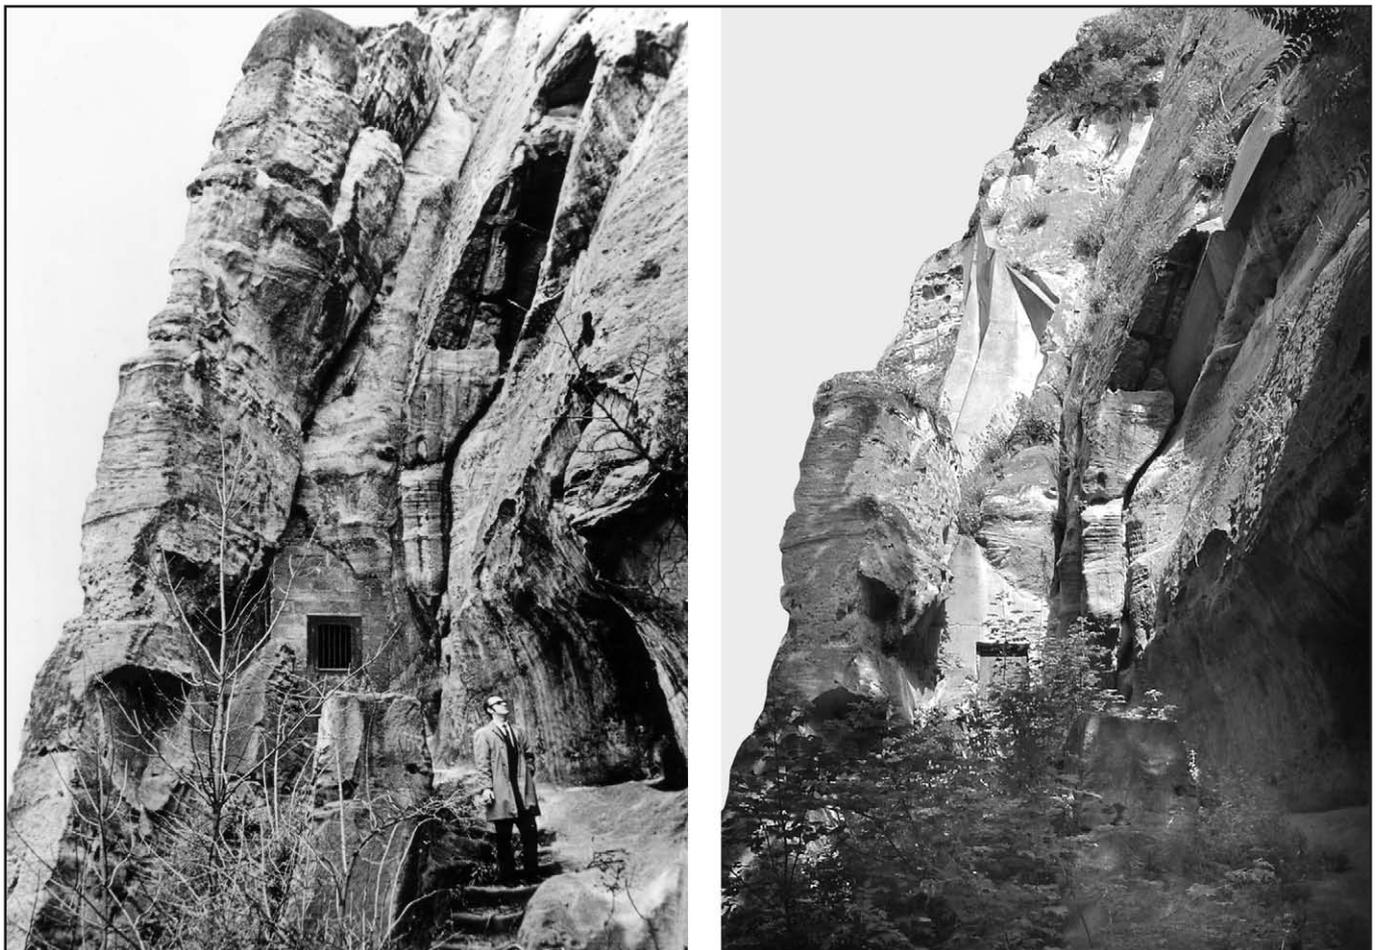
Figure 6. The heavily jointed western face of Castle Rock, over the lower entrance to the Western Passages caves. The photo on the left, probably taken in 1937, shows the intact outer buttress, before its demise in the 1969 rockfall. The photo on the right shows the massive concrete ribs installed after the rockfall to support the remaining rock.

event, when only the soil and wall collapsed over the stable sandstone (*Mercian Geologist*, 1997, v14, p53-57). Rockfalls in 1939 and 1969 did, however, incorporate the sandstone bedrock, when large joint-bounded slabs fell away from the cliffs on the south-western corner of the site. In the later event, an almost vertical rib of sandstone, about 8 m high and long but only a metre wide, collapsed over the entrance to the Western Passages (Fig. 6). Precautionary engineering works after the 1969 event left the concrete buttresses and plugged fissures that are still visible above Peveril Drive, along with concealed rock anchors that stabilise the rock within this zone of joints (Fig. 6).

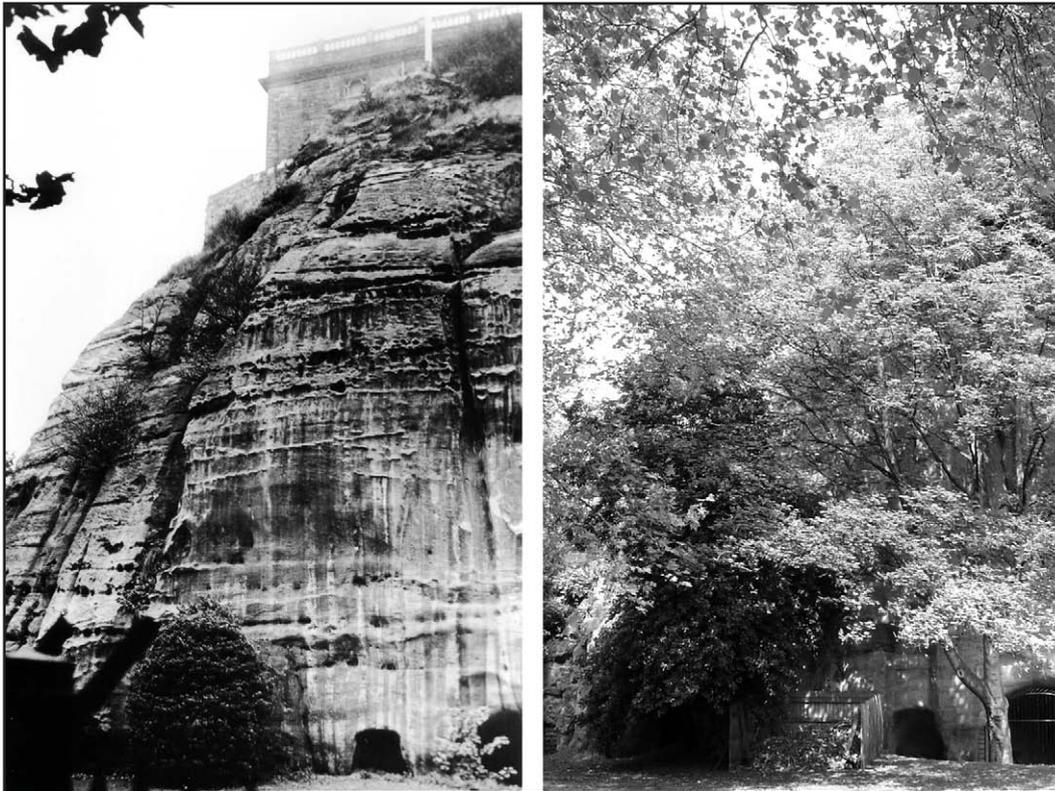
Figure 7. The steep southwestern face of Castle Rock, devoid of trees in 1958, and almost lost to sight behind the greenery in 2004.

protective coating of glass-reinforced polyester that is almost invisible due to the sand incorporated in it. But these faces are steadily being lost behind trees that grow ever taller in front of them (Fig. 7). The future may be brighter, as growing tourist interest in the caves and Castle Rock is leading to wider appreciation of Nottingham's geological heritage. Consequently, it is to be hoped that a new management plan of the Castle and its Rock, due to be completed by Nottingham City Council within the next 18 months, may lean towards the geological conservation aspects (a rebuild of the castle terrace, lost in 1996, is due within the same time frame). The city lost its castle landmark during the Civil War, and it would be a tragedy if the Castle Rock landmark was lost 400 years later behind a screen of trees.
