# Thistle Landslide

## Utah reroutes round mud mound

Very rapid large-scale engineering operations were called for in the United States when a Utah valley was drowned in April by ponding behind a massive landslide. Geologist Dr Tony Waltham of Trent Polytechnic civil engineering department reports what he found recently when he visited main contractor W W Clyde at the site.

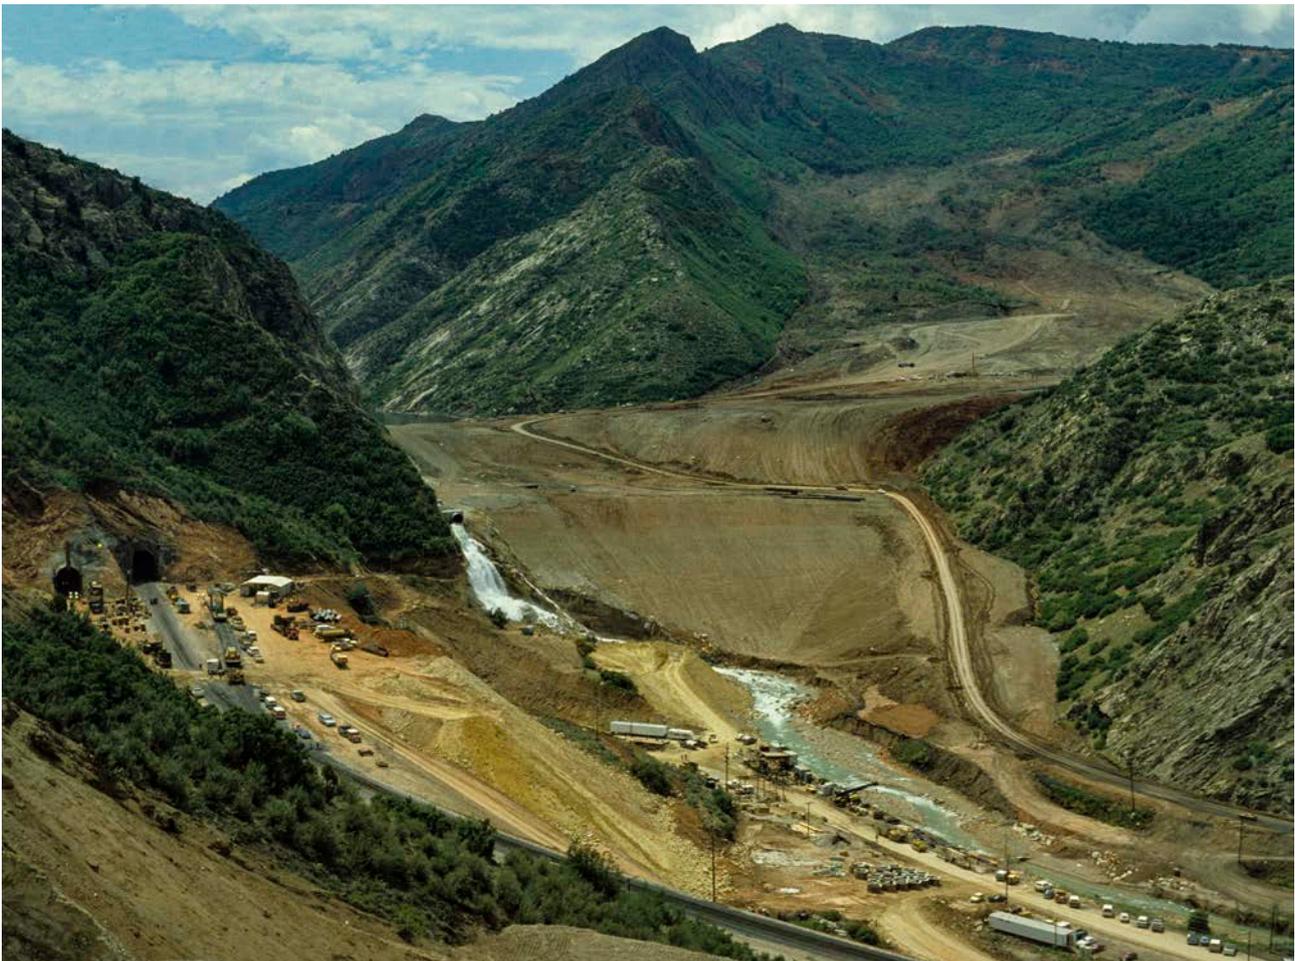
*The landslide and dam seen from the new road on Billies Mountain, with the lake extending away to the left.*

The natural dam created by the slide is almost perfectly located in the narrowest section of the valley. Both walls are bedrock, though this is fractured and may be excessively permeable. The slide material is almost ideal watertight clay. It is still under compression from the main mass of the slide but may be heavily fissured towards the water face.

Material was moved from the heart of the slide and placed on the downstream face of the dam to give a 9° slope that is expected to be stable. The 300m-long crest of the dam was leveled, and raised at the eastern end.

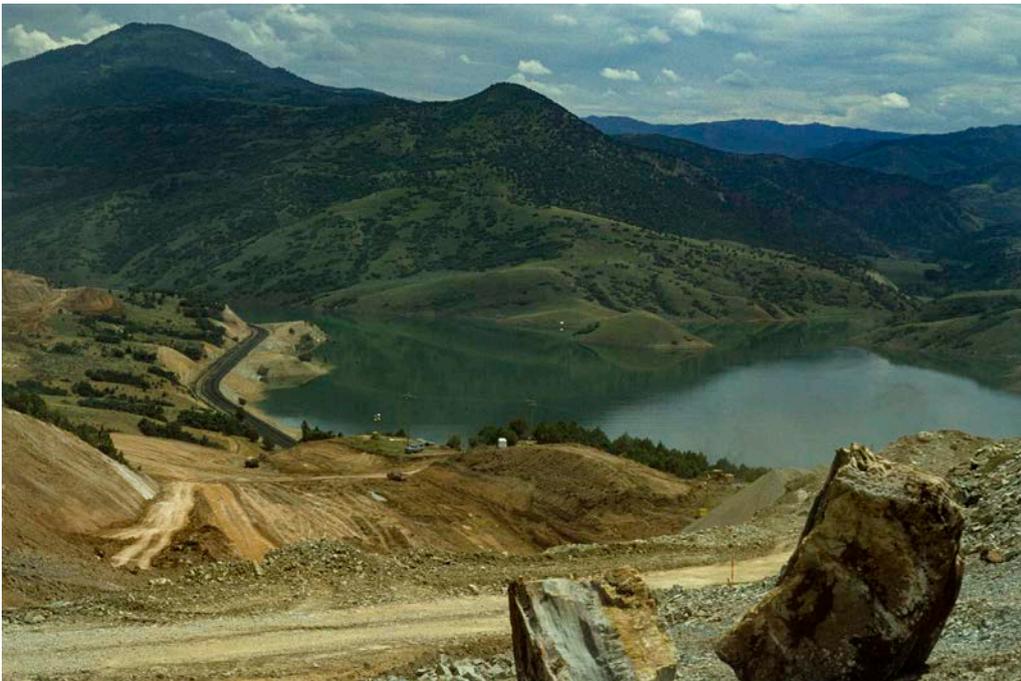
*Road excavations east of the Billies Mountain cutting, with the new lake in the background and the new rail tracks along its shore.*

Most of the earthworks have involved cutting benches into the valley sides in a variety of sedimentary rocks, mainly clays, siltstones and fairly friable sandstone. Cross-valleys have necessitated an impressive amount of cut and fill, though haul distances are mostly short. Difficulties have been caused by the steep slopes

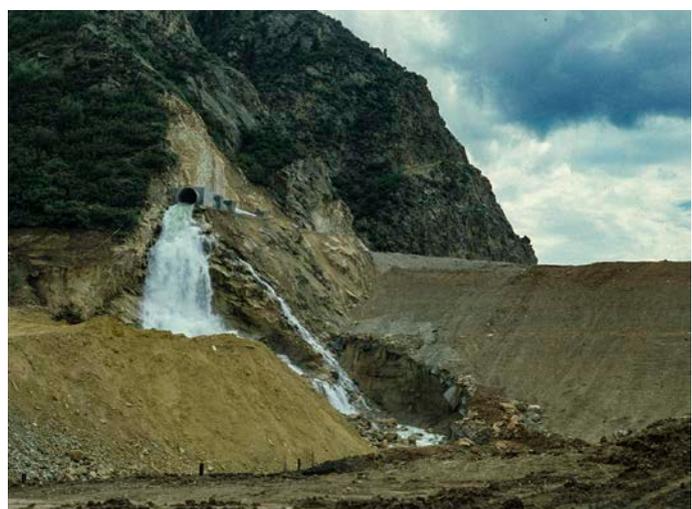
*Water from the new overflow pipe cascades down a bedrock spur, safely away from the front of the landslide dam.*

Meanwhile an overflow tunnel 3.5m in diameter was cut in bedrock and extended with pipe so that the flow ran clear of the dam face. Lake level is now stabilized at tunnel level, 55m above the original valley floor. Concern for the dam stability continues and a low level tunnel is now being cut to allow complete drainage of the lake and inspection of the dam.

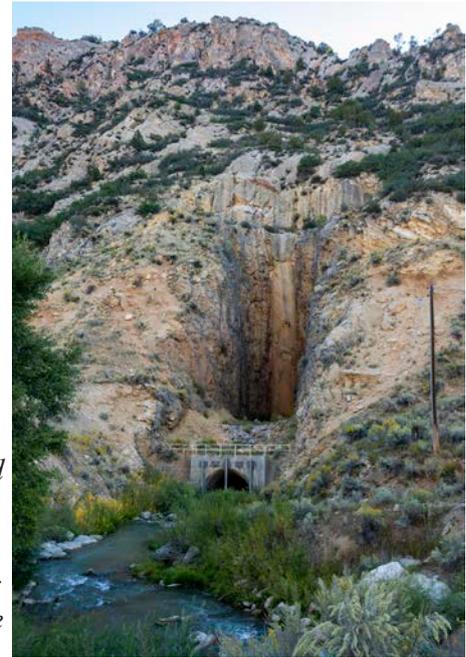
*The notch in the hillside that was progressively blasted downwards to drain the lake into the shaft at the back.*

The landslide dam retaining the new Thistle Lake was deemed unsafe in the long-term. It was therefore drained in 1984, before even the new road and the second railway tunnel had been opened. A low-level drainage tunnel was excavated through bedrock beside the landslide debris, through to the foot of a shaft sunk on the lakeshore. A short channel to the shaft was then deepened in stages so that the lake level progressively dropped, and the river now drains directly into the tunnel. Though damaged houses emerged from the retreating waters, the townsite of Thistle has not been re-established.

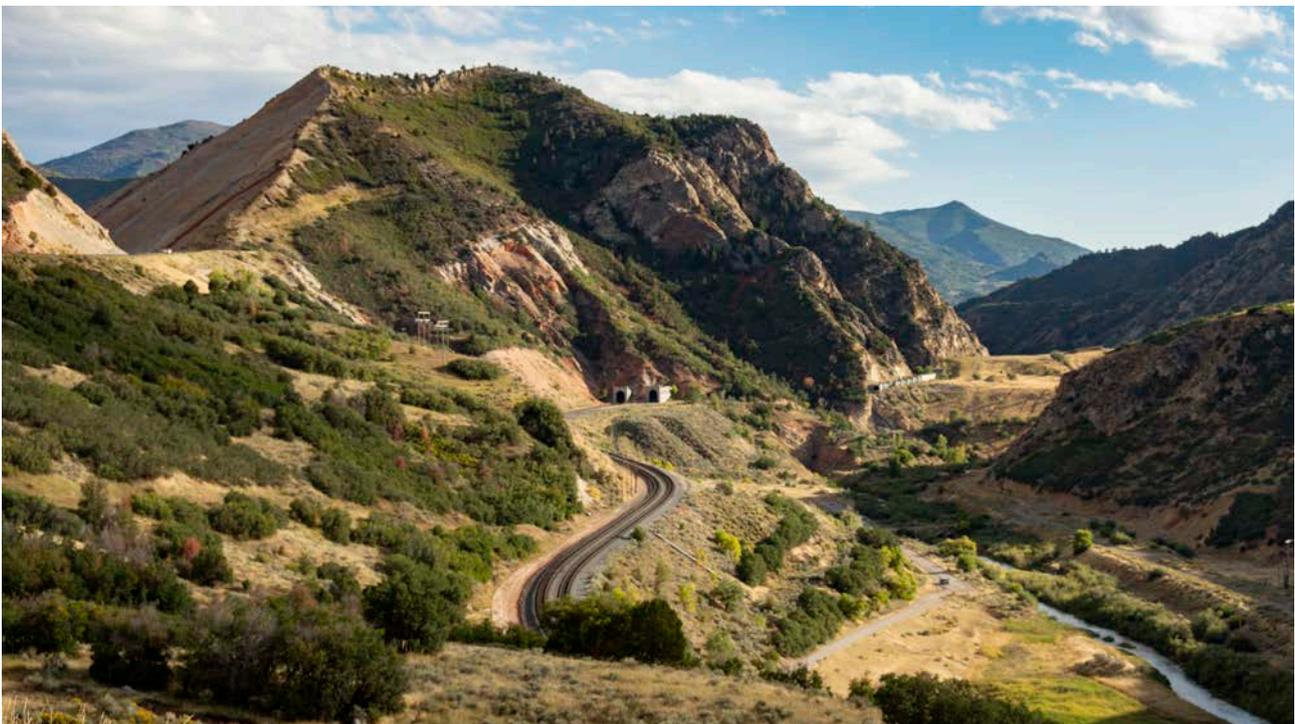
*The site as it appeared in 2017; the new road cutting is high on the left; the railway runs into its twin tunnel portals in the centre; the landslide debris lies in sunlight where it blocks the main valley on the right.*
