Rock failure in collapse and caprock sinkholes
Rock failure under imposed load over caves

Sinkholes and Subsidence:

Karst and Cavernous Rocks in Engineering and Construction

by Tony Waltham, Fred Bell and Martin Culshaw

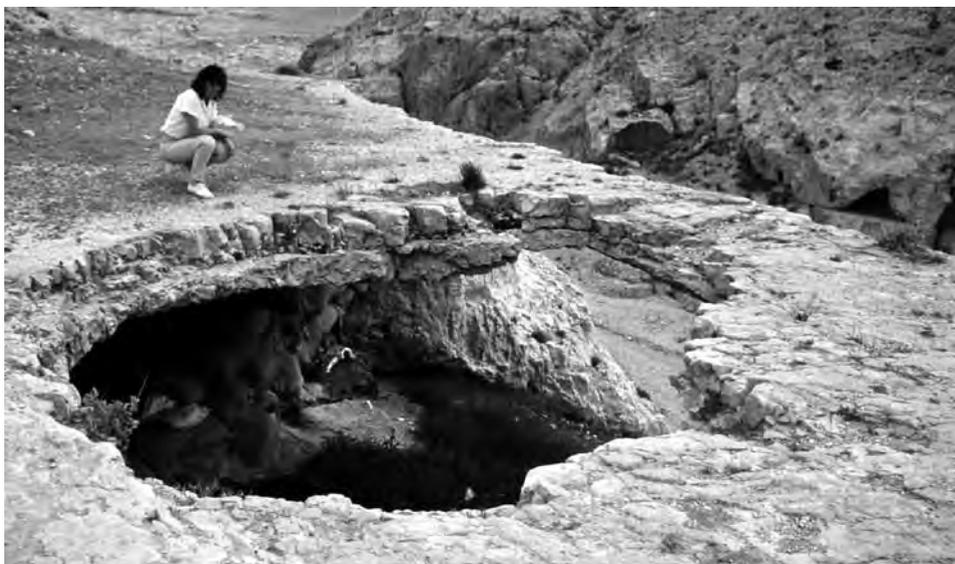
Figure 3.1. Collapse of the thin limestone roof over a small cave in the side of a wadi in Jordan; the two beds that roofed the cave, and partially survive in the entrance arch, are probably an indurated duricrust over a more easily eroded blocky limestone.

The stability of a limestone cave is a function of its unsupported span and the structural integrity of its roof rock. Most caves are structurally sound; relationships between cave widths and the rock mass quality of cavernous limestones suggests that the majority of caves would require little or no support if they were regarded as engineered structures (Waltham and Fookes, 2003). A tubular tunnel dissolved out of massive limestone far beneath the surface is extremely stable. In contrast, even the smallest caves can collapse in zones of heavily fractured rock or beneath very thin roof slabs (Figure 3.1).

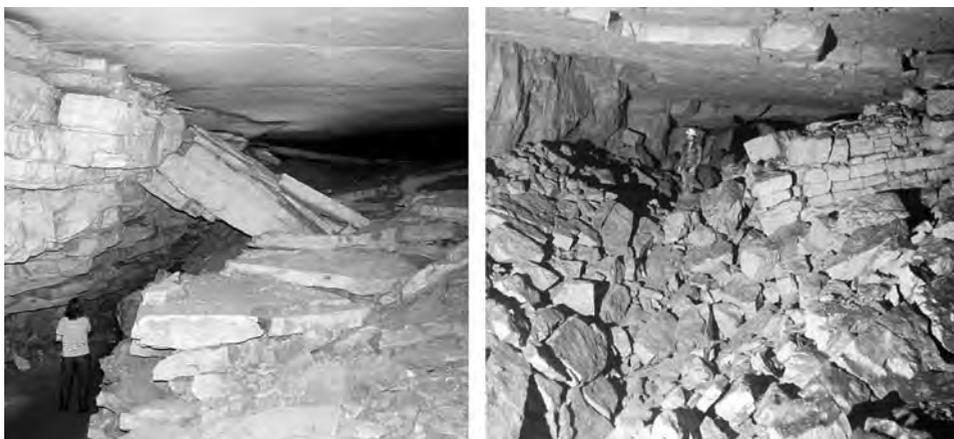
Figure 3.3. Cave passages with flat limestone roofs developed by progressive failures along bedding planes; on the left in Mammoth Cave, Kentucky, and on the right in Ogof Agen Allwedd, U.K.; in both caves the roof is some metres above the original dissolutional passage. TW.

Roof collapse by progressive roof failure is widespread in limestone caves, and can be very conspicuous in any zones of more thinly bedded limestones (Figure 3.3). These contrast with roof profiles that retain their original dissolutional features in massive limestones or within single very thick beds, and can span large voids with no sign of breakdown (Figure 3.4). The simplest analysis of a cave roof in bedded limestone is to treat the beds as beams failing under their own weight between the cave walls.

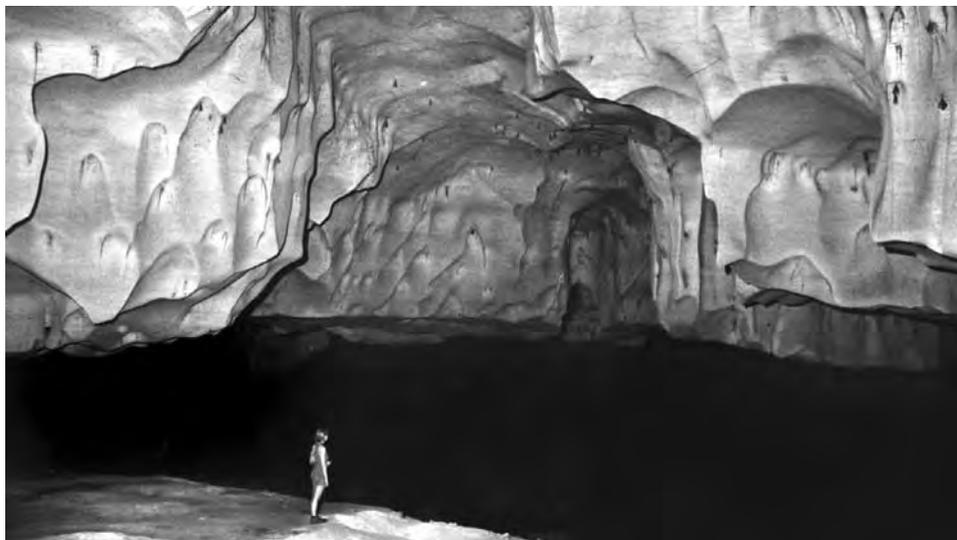
Figure 3.4. Massive limestone forming the roof of the Niah Great Cave, Sarawak, with no signs of breakdown to destroy its dissolutational sculpture.
TW.

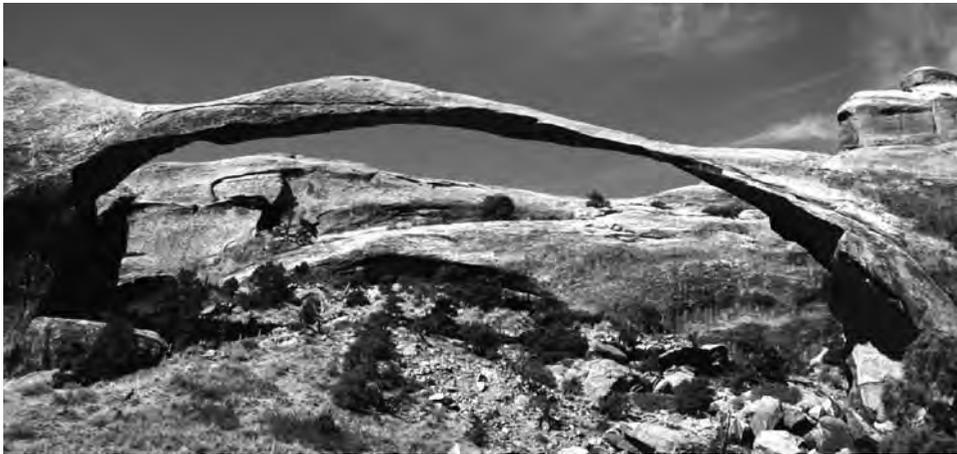
Figure 3.7. The stable, low-profile, compression arch that forms Landscape Arch in the sandstone of Arches National Park, Utah, spanning 93 m and only 5 m thick.
TW.

A compression arch is much stronger than a beam in the same material, and natural arches can be very thin. The spectacularly thin Landscape Arch (Figure 3.7), in Utah, demonstrates how strong rock is under compression. It is weathered out of sandstone that is weaker than most cavernous limestones, and is not devoid of fractures. Regarded as one bed, it plots on Figure 3.5 very close to the stability limit of $L = 17d$. An arched cave roof developed by phreatic dissolution (below the water table) creates a naturally stable profile, but is rarely wider than 20 m; most large cavern roofs have arch profiles that have evolved by roof stopping within the tensile zone. A roof arch in a limestone anticline could gain strength where its blocks of rock between radiating joints perpendicular to the bedding mimic a stable voussoir arch; this is very rare in nature, but may contribute to the stability of the enormous Sarawak Chamber in the Mulu karst (Gilli, 1993).

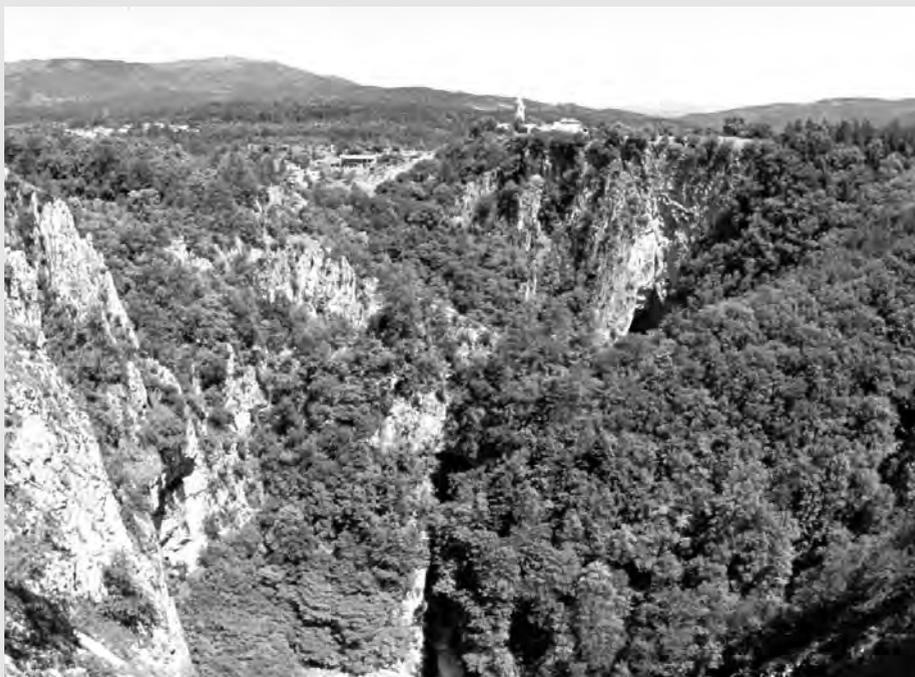
Figure 3.1.2. The view eastwards across the Velika and Mala collapse sinkholes. The village houses and church stand above the cliff that drops into the Mala sinkhole breached by the upstream segment of the Skocjan cave, and the wooded ridge in the foreground separates the two sinkholes.

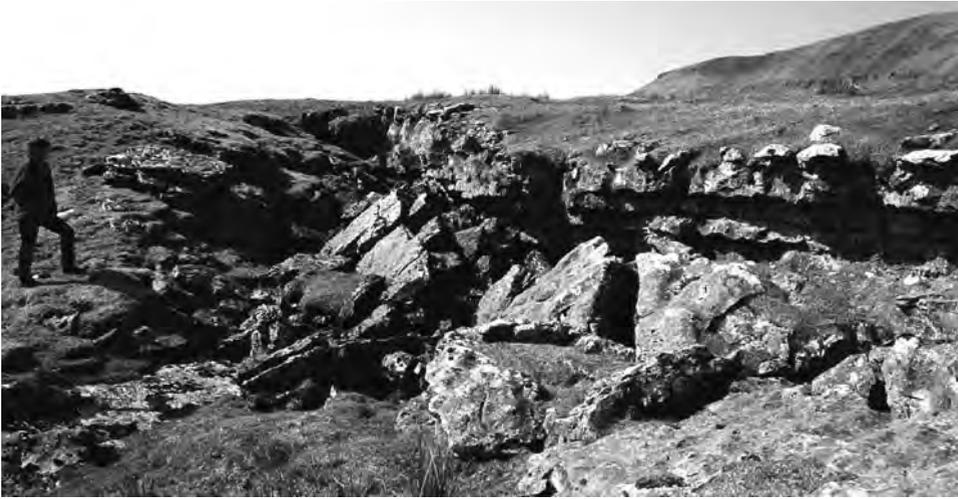
Figure 3.10. A small collapsed cave in Penyghent Gill, in the English Pennines, where a roof about 1 m thick has collapsed along the length of a low cave that was 5–10 m wide.
TW.

Total roof collapse over a length of shallow cave passage can create a very elongate collapse sinkhole lined by large slabs of undermined rock (Figure 3.10); failure of these wide caves in Penyghent Gill has created the largest area of undisturbed cave collapse in Britain (Waltham *et al.*, 1997). On a much larger scale this process can create a gorge or ravine (Figure 3.11); the Patale Chhango gorge in

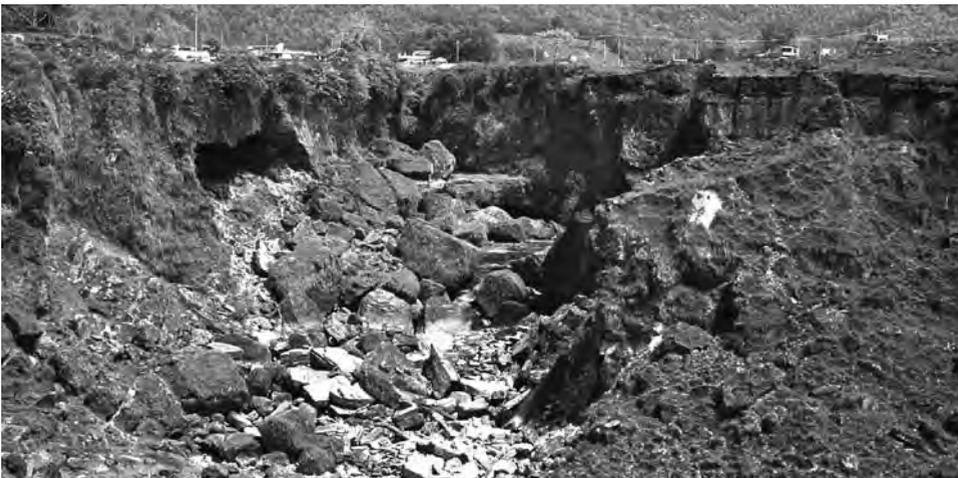
Figure 3.11. The chaos of large fallen blocks that defines the collapsed cavern at the mouth of the Patale Chhango cave in lowland Nepal; the short gorge is 55 m deep, and most of the collapse blocks are of the conglomerate that roofs the visible cave openings.
TW.

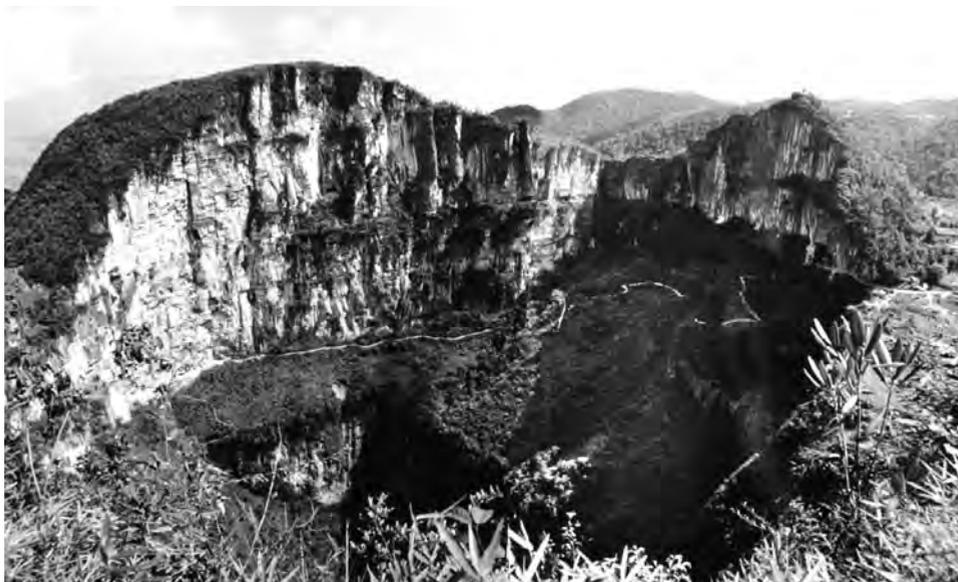
Figure 3.13. The giant collapse sinkhole of Xiaozhai Tiankeng, near Chongqing, China; the footpath winds across the wooded ledge before descending 300 m down a talus slope in the inner shaft.

The very largest collapse sinkholes are also known by the Chinese term, tiankengs (meaning *sky holes*). They are typically more than 250 m deep and wide, with vertical walls forming a large part of their perimeters, and the finest examples lie in the very mature karsts of China and New Britain. China's Xiaozhai Tiankeng is 660 m deep and 600 m across, with vertical walls above and below a sloping terrace at mid-depth (Figure 3.13); below the terrace a debris cone on one side of the hole descends to the river that crosses the floor of the tiankeng between cave passages only about 20 m wide (Senior, 1995; Zhu and Zhang, 1995; Zhu *et al.*, 2003).

The most likely origin of a tiankeng appears to be the deepening of a solution sinkhole directly above the stoping of a cave roof. Both features are likely to develop on a zone of locally increased rock fracturing. Deepening of the sinkhole concentrates infiltration, and thereby accelerates roof stoping below, where the cave river efficiently removes the breakdown debris. This model (Figure 3.14) was first based on the giant sinkholes of the Nakanai karst in New Britain (Maire, 1981), and may be applied on a smaller scale to many collapse sinkholes. Once its vertical walls are exposed, a tiankeng would evolve towards a rounded plan-form by face retreat due to weathering and small-scale breakdown. Distinct from this collapse origin, a second type of erosional tiankeng has been proposed (Zhu, 2001) where a large sinking river initiates the shaft development. However, waterfall retreat in a river sink tends to create an elongate slot that lacks the rounded form of the larger tiankengs, and waterfall erosion would appear to be only contributory to the collapse process. Tiankeng evolution is demonstrated by three sites within China's Xingwen karst (Waltham *et al.*, 1993). Xiaoyanwan is a massive collapse sinkhole ringed by vertical walls that truncate giant cave passages, while Dayanwan is an older degraded tiankeng, and the large chambers of Zhucaoijing will eventually coalesce and collapse into a third tiankeng (Figure 3.15).

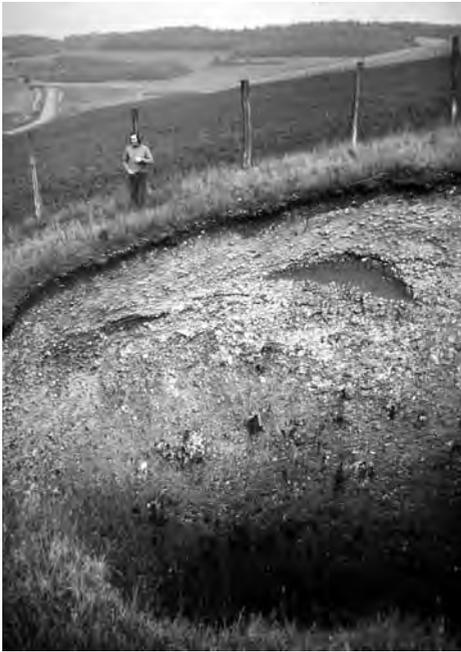
Figure 3.16. The collapse sinkhole of the Bime des Enfants in the chalk karst of northern France, 26 years after its sudden appearance.
TW.

observed collapse event created the Bime des Enfants in France's Aube department in January 1948. It left a sinkhole 16 m deep and 10 m across, with walls in typically well-fractured chalk, in a gently sloping hillside (Figure 3.16). There was no cave accessible around the edge of the mound of fallen debris, but the immediate area is distinguished by having some long stream caves with passages generally 2 m high and 1 m wide, which are large by the standards of the European chalk. The limestones of Australia's Nullarbor karst are described as chalky, and have porosities normally >25%, but they do have large cave passages slowly developed in the desert climate, and consequently have large collapse sinkholes totally unlike anything in the European chalk.

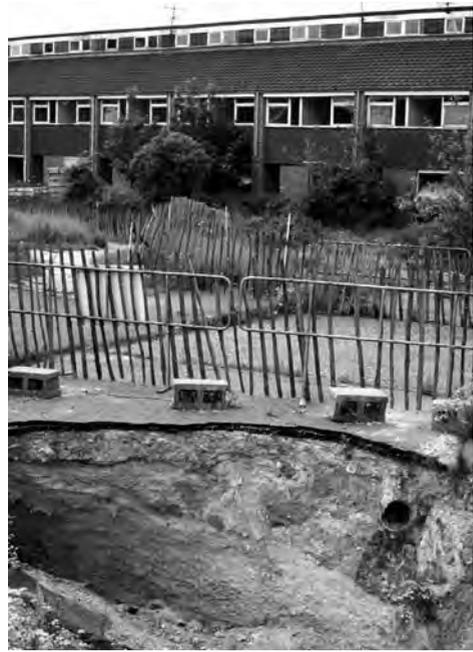
Figure 3.17. One of the collapse sinkholes formed by liquefaction failure of the chalk over old mines in Bury St. Edmunds, U.K., seven years after their failure destroyed the road.
TW.

A special feature of chalk is its susceptibility to liquefaction when it is both disturbed and saturated (Burland *et al.*, 1983). Disturbance may be due to engineering handling, when wet chalk is well known to liquefy into a slurry, but may also be due to stress within a cavity roof, or due to frost shattering. The latter is ubiquitous across the outcrops of southern England and reached depths of up to 10 m during the Pleistocene cold stages. Saturation is easily achieved at point inputs of drainage off a soil cover or by concentrated engineered drainage, and increased dissolution is then an inevitable side effect. A site with drainage from soakaway drains directed into chalk that has inherited frost shattering and stands over ground cavities is optimal for liquefaction and consequent ground failure. The well-known collapses (Figure 3.17) in a new housing estate at Bury St. Edmunds, U.K., remain one of the most spectacular consequences of chalk liquefaction (Waltham, 1989; Bell *et al.*, 1992). However, these developed around drains over old flint mines close to the depth limit of Pleistocene frost action, and strictly they are therefore crown holes. Comparable liquefaction over natural cavities is limited by the scarcity of adequately large caves, though sinkholes of this type have been known to develop over gull cavities along cambered escarpments. It is debatable as to how much liquefaction contributed to the roof stoping that formed the Bime des Enfants (Figure 3.16). There were no indications of point drainage input that could have locally saturated the chalk, but the failure was during a cold and wet winter, and its exposed walls are in putty chalk and rubble chalk very similar to that in the collapses at Bury St. Edmunds.

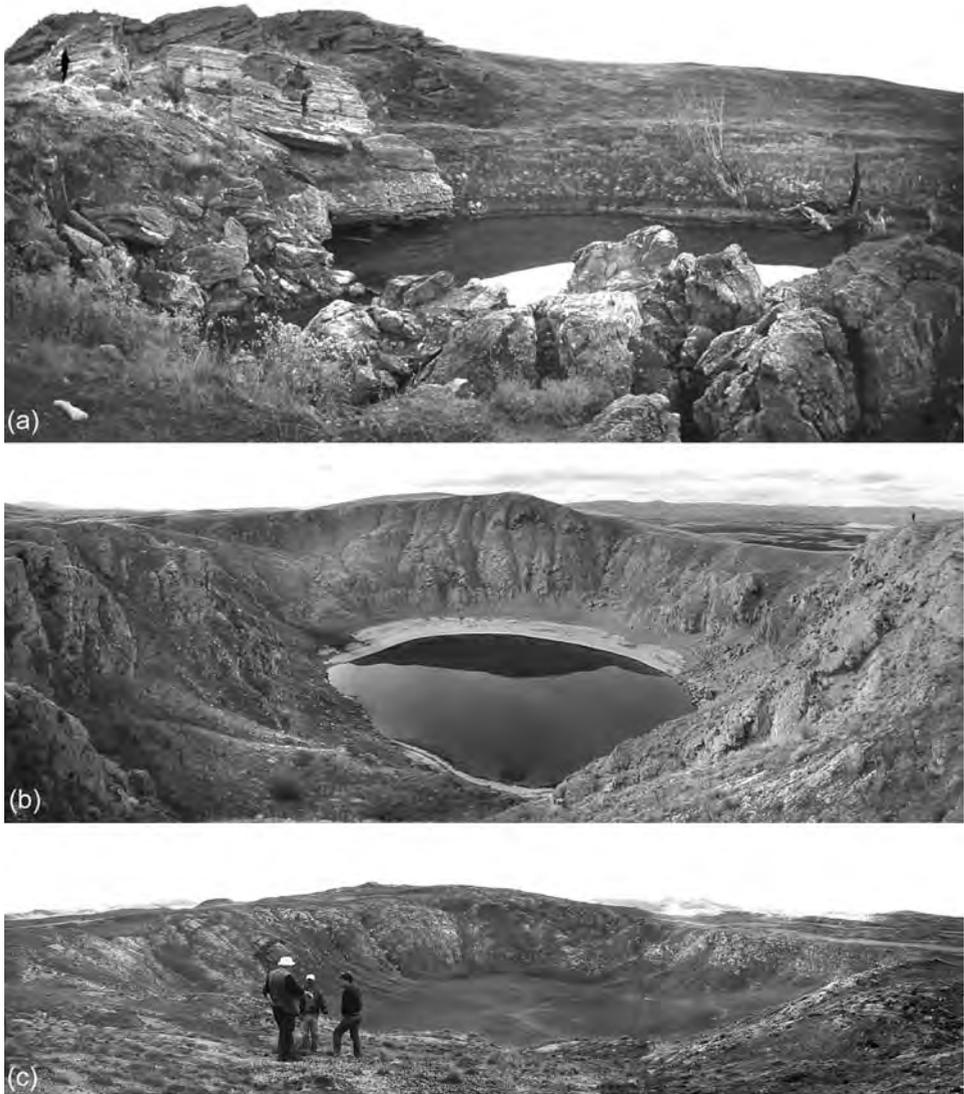
Figure 3.18. An evolutionary sequence of collapse sinkholes in the gypsum karst near Sivas, Turkey. (a) Active dissolutional undermining and rock collapse in a small corner of the riverside Bielekbasi sinkhole. (b) An almost static lake in the mature Kizilcam sinkhole. (c) A large degraded sinkhole on the hills above Mahmutaga.
TW.

that circulates rapidly to and from the adjacent Kizilirmak River. Its margin is an almost complete line of dissolutional undermining with small collapses producing talus slopes of gypsum blocks into the lake on its floor. In one corner, the collapse is into larger blocks (Figure 3.18(a)), and indicates a maximum failed span that could

have reached about 25 m – compatible with the maximum sizes of gypsum caves recorded in many karsts. It appears that numerous small collapses accumulated to form the large Sivas sinkholes. An evolutionary sequence can be recognised (Figure 3.18) from the active riverside collapses, to the mature collapse sinkhole of Kizilcam far from the river's circulation and therefore less active, to the unnamed degraded sinkholes high on the plateau and fossilised by fluvial rejuvenation and water table decline. The same sequence may also apply to collapse sinkholes in limestone, but over much longer timescales.

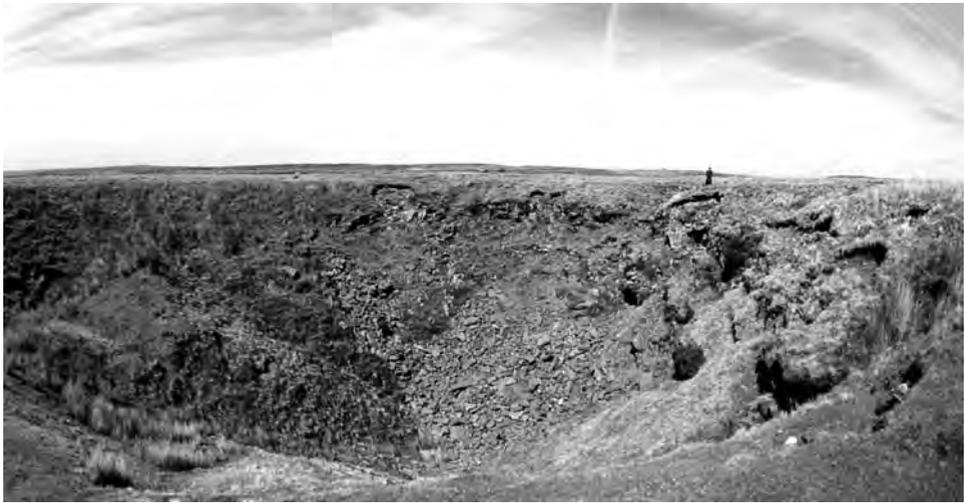
Figure 3.19. A large caprock sinkhole over the interstratal karst of Mynydd Llangattwg in Wales, U.K.; all the exposed and collapsed rock is strong gritstone, and the top of the limestone is about 10 m below the floor of the sinkhole.
TW.

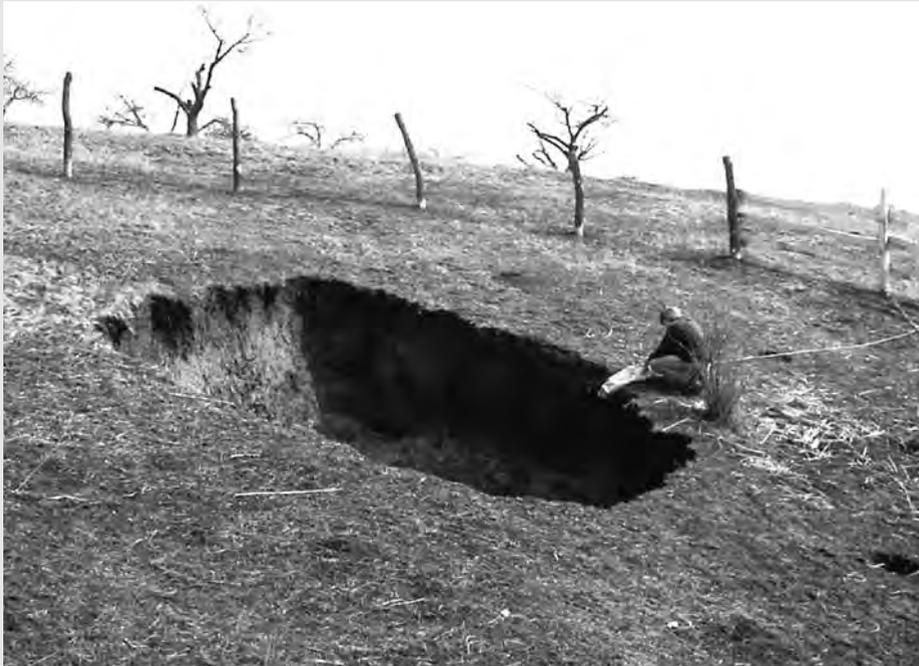
Figure 3.2.1. The freshly collapsed clay walls of the Dankivsky caprock sinkhole, Ukraine, with the way into the underlying cave lost in the darkness.

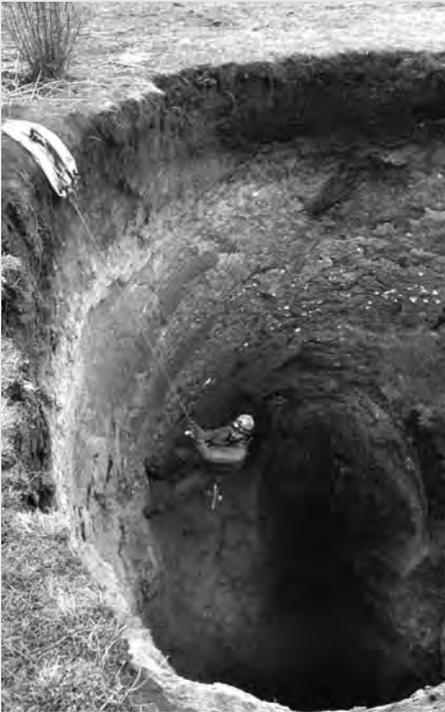
Figure 3.2.2. The grass-covered clay slope at Dankivsky broken by the new caprock sinkhole.

The world's most cavernous interstratal gypsum karst underlies the Dniester Valley of the western Ukraine and northern Moldova. On 11 January, 1998, a caprock sinkhole developed in a clay hillside at Dankivsky when a small instantaneous surface collapse broke through from an underlying gypsum cave. The new sinkhole was 5 m across, with vertical sides that descended 22 m to a sloping floor of fallen debris. It was in the previously unbroken grass cover of a field (Figure 3.2.1), and the collapse was heard at a farm one kilometre away. At the foot of the newly opened shaft (Figure 3.2.2), there was an opening over the debris cone and into the domed roof of a cave 9 m wide (Fig. 3.2.3). This dome had formed by wider collapse of the gypsum roof beds of a cave passage that continued about 5 m high but totally underwater where its roof was intact. The cave passage is very similar to those, just 12 km to the south, that extend for 92 km in the maze cave of Zolushka, which has been drained by pumping activity in an adjacent quarry (Klimchouk and Andrejchuk, 2003). Both the gypsum and the caprock clays are of Miocene age.

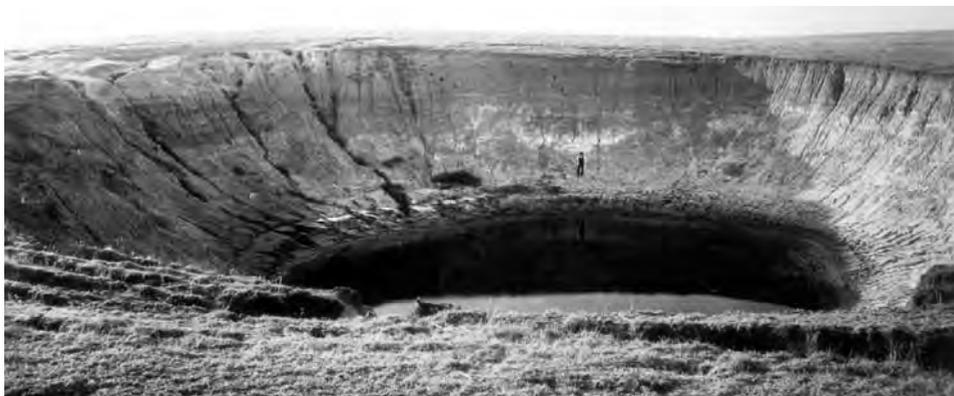
Figure 3.25. The caprock sinkhole that developed in 1879 over deeply buried salt at Meade, in Kansas.

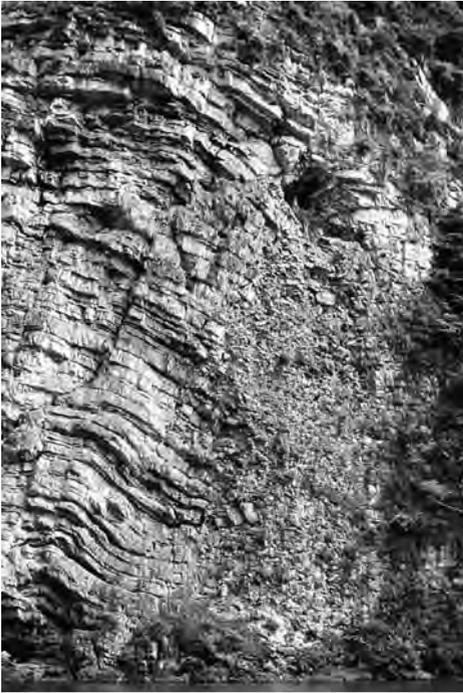
Figure 3.26. Limestone breccia pipe with an open cave at its top, exposed in the cliff of an island in Halong Bay, Vietnam. TW.

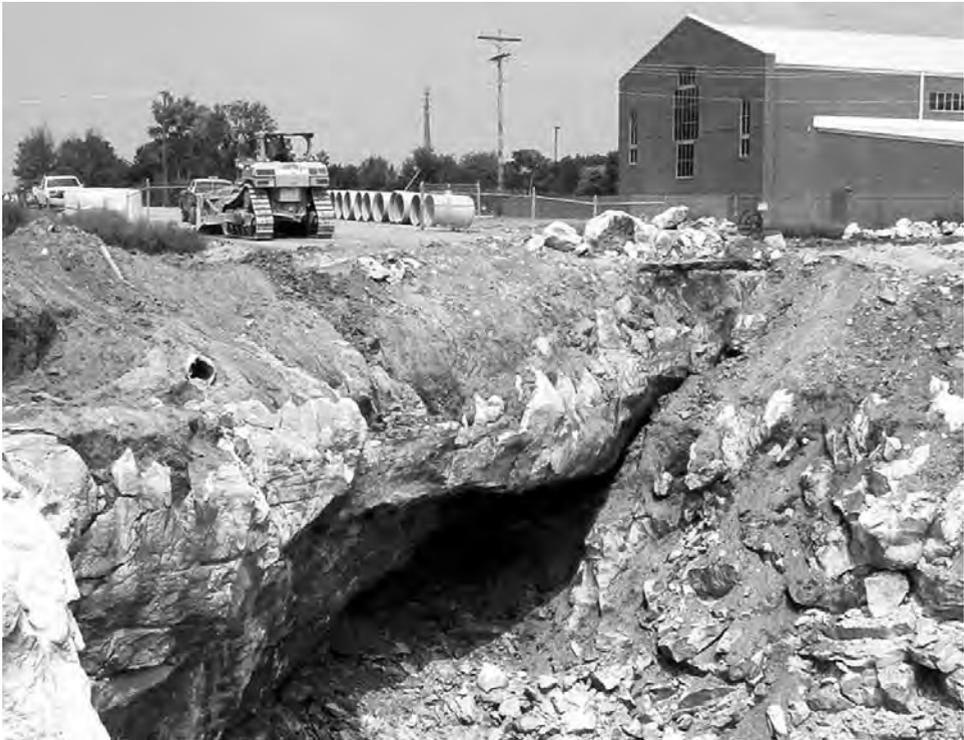
Figure 7.1. Fractured rock around the margin of the new collapse sinkhole that destroyed Dishman Lane in Bowling Green, Kentucky, in 2002.

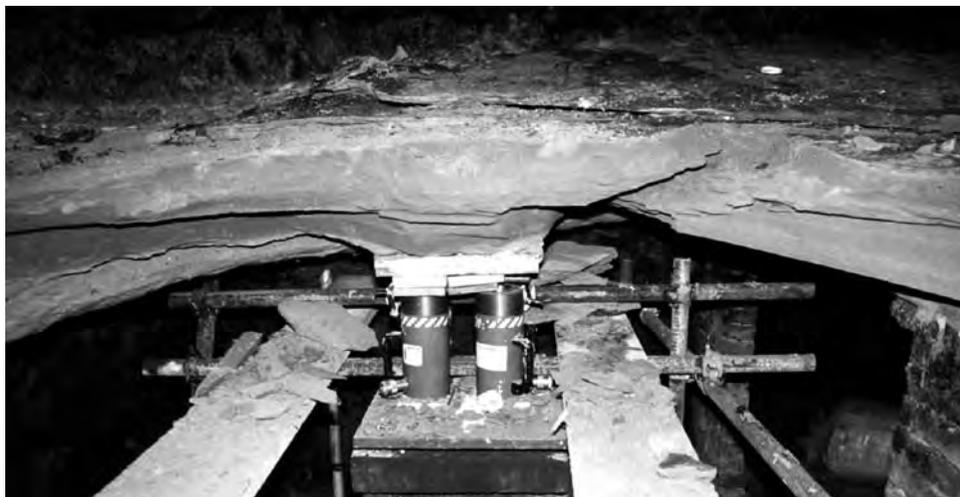
Figure 7.6. Broken rock in a cave roof loaded to failure; a full-scale test (by loading upwards on hydraulic jacks) on homogeneous sandstone in Nottingham, U.K.
TW.

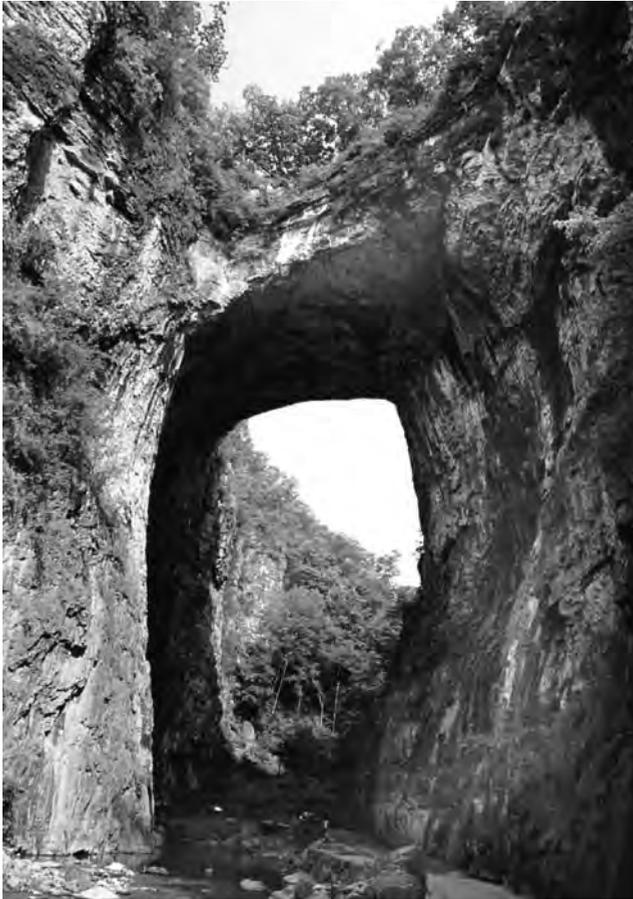
Figure 7.8. Natural Bridge, Virginia, with a road over its thin but stable arch.
TW.
