Soil failure in subsidence sinkholes
Sinkholes induced by engineering works

Tony Waltham

Sinkholes and Subsidence:
Karst and Cavernous Rocks in Engineering and Construction
by Tony Waltham, Fred Bell and Martin Culshaw
2005

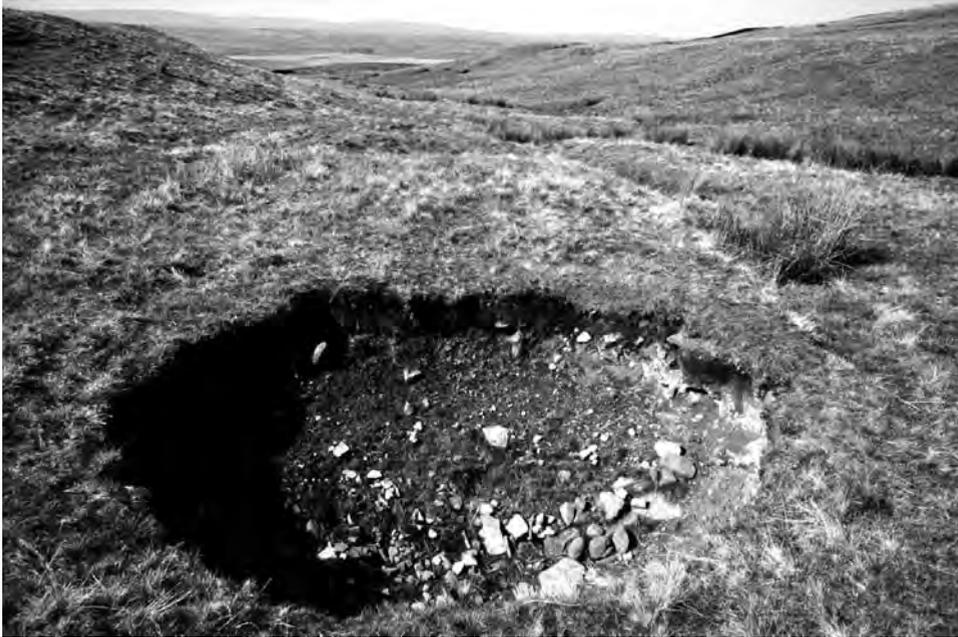
Figure 4.1. A typical small, fresh subsidence sinkhole formed in till overlying cavernous limestone in the Yorkshire Dales, U.K.; the new sinkhole is only about 3 m wide and 1 m deep, and it does not expose the limestone as rockhead is at a depth of about 3 m. TW.

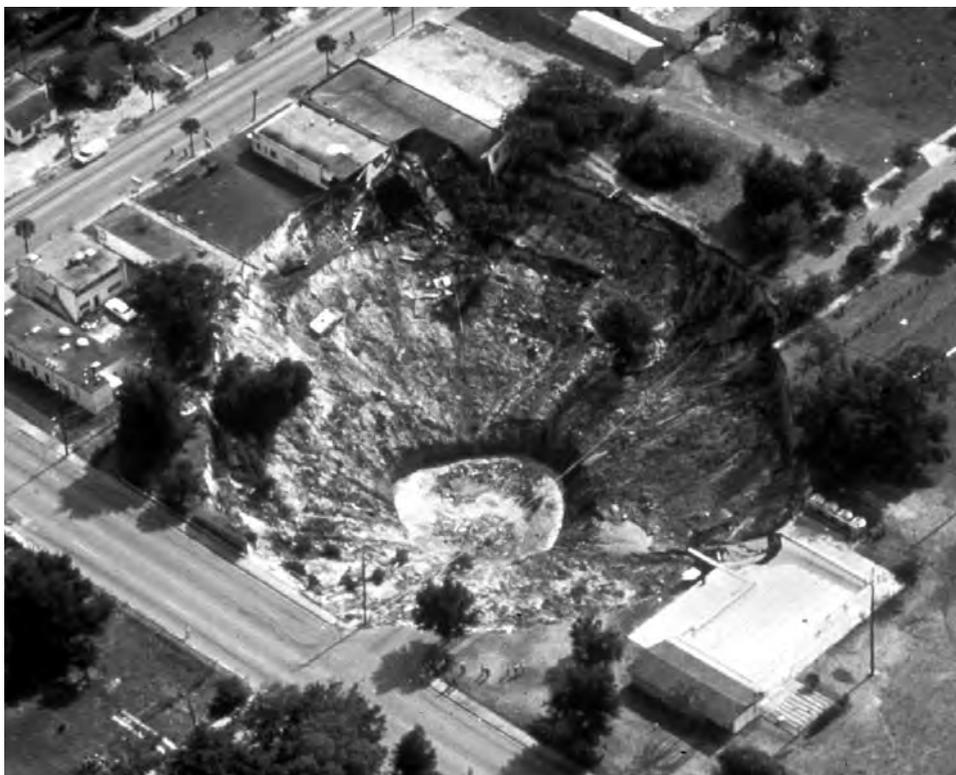
Figure 4.2. The large subsidence sinkhole in Winter Park, Florida, just after its initial dropout in May 1981; water is ponded within the steep-sided throat down through the clay soils, while the upper slopes were at the time still actively slumping back to form the wide bowl in the sand cover.

Development of the Winter Park sinkhole in Florida was observed and documented (Jammal, 1984), because it was in a suburban district of Orlando. The ground was first broken when a large tree disappeared with a swishing noise into a new hole, and soil was then lost into it progressively over the next two days, when the sinkhole grew to a depth of 30 m and then had its sides flare out to a diameter of 106 m (Figure 4.10). Subsequently it achieved some sort of stability, before partially filling with water, and was later artificially modified to remain as a permanent lake. It appears that a large cavity had migrated up through the cohesive sandy clays of the Hawthorn Formation over an unknown length of time; its clay roof finally failed to breach the overlying loose sands, which slumped into the underlying pipe within the two days of observed sinkhole enlargement. Initially, the sinkhole was almost dry, but it soon filled to the piezometric level of the Ocala Limestone aquifer, indicating a restricted water flow through the debris-filled pipe beneath the sinkhole. The

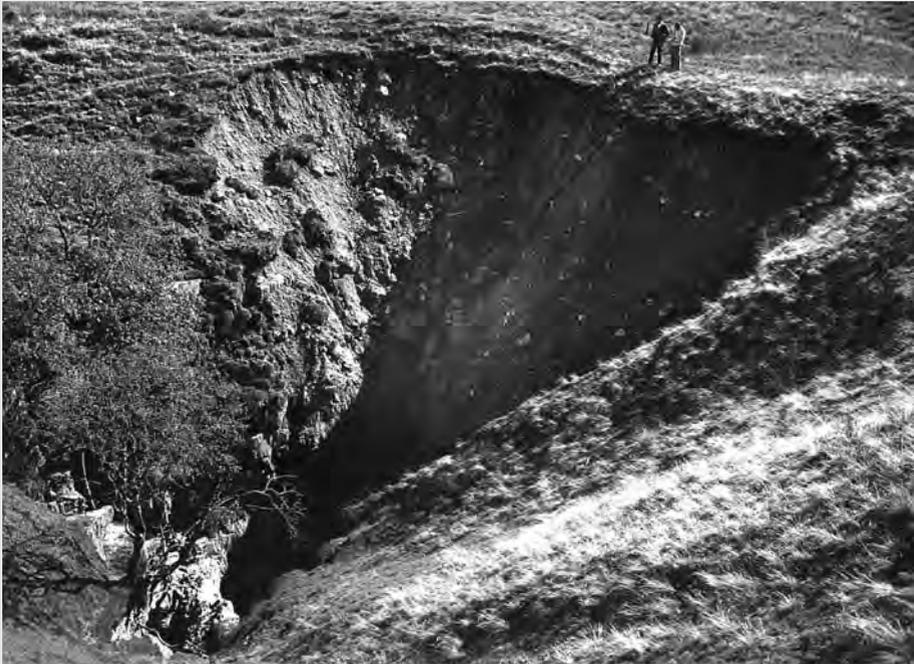
Figure 4.1.2. The subsidence sinkhole of Marble Pot, soon after its far side slumped into a newly open fissure in 1980.

Within the Yorkshire Dales glaciokarst, many of the broad limestone benches are mantled by till sediments that are pocked by thousands of subsidence sinkholes. Marble Pot is one of the larger sinkholes in the area, 40 m across and 15 m deep, and circular except for a stream trench entering on one side. A small stream drains into it, so that the underlying fissure system has evolved to be large enough to be accessible, at least in parts. This has allowed the underground features of Marble Pot and two more adjacent sinkholes to be mapped by cavers (Figure 4.1.1). If this profile had its scale adjusted so that most of the fissures were only 100–200 mm wide, it would suffice as a model for the karst morphology beneath subsidence sinkholes worldwide, where significant surface depressions appear unrelated to any visible or accessible voids in the bedrock.

Marble Pot has been developing ever since the mantle of till was left over the limestone outcrop on the retreat of the late Pleistocene glaciers about 12,000 years ago. The fissures and cave passages that constitute the constricted cave system beneath it have some earlier origins, as some of the lower passages contain stalagmite deposits that appear to be interglacial. Once the till had been deposited, seepage water (derived both from direct rainfall and small flows of allogenic surface drainage off the adjacent shale slopes) fed through to the rockhead fissures, and suffosion by this water carried sediment down into the limestone voids. The cohesive nature of the Yorkshire Dales till meant that the sinkhole then developed in a series of dropout events, each one followed by slumping of the sinkhole sides so that they flared out into the characteristic, steep, inverted cone. The most recent event was in 1980, when the whole of one side of the sinkhole failed (Figure 4.1.2). The soil all slumped into a newly opened fissure, which had been previously seen from below when cavers had looked up at a hanging choke of boulders with water dripping from between them. This temporary plug had failed during a winter storm event, and many tonnes of debris had fallen into the underlying rift. This totally choked the route down, except for the stream that could filter through the rubble and sediment.

Many large subsidence sinkholes expand by repeated failures of parts of their soil cover. Marble Pot in the English Pennines (Box 4.1) was reactivated when the boulders, jammed across the top of the rockhead fissure in a previous dropout, were washed out to initiate a second phase of rapid soil loss. The sinkhole profile was then maintained as a new slice of soil slumped into the open fissure. Fresh clearance of the bedrock outlet rejuvenates the sinkhole and helps to maintain its steep profile. In

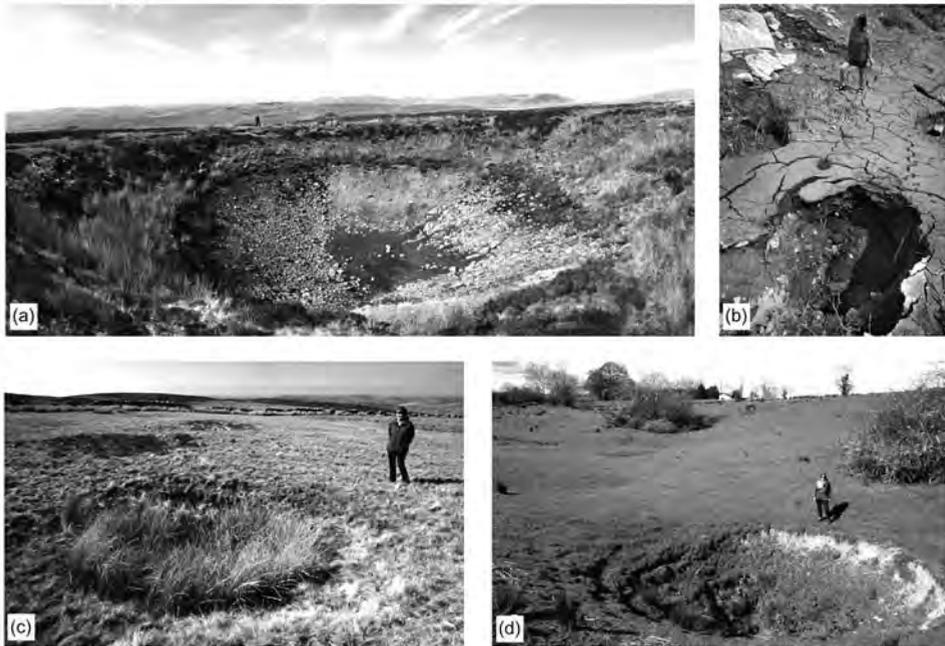
Figure 4.3. Variations in morphology of subsidence sinkholes; (a) – a large and old sinkhole in till, that holds a lake in wet weather but drains out in dry conditions, in the Yorkshire Dales karst, U.K.; (b) – a small new sinkhole in clays that floor a valley in Pennsylvania that loses all its water underground; (c) – an old, degraded sinkhole with its fissure drain sealed by inwashed clay so that it has reed grass growing in a small pond, in the Yorkshire Dales, U.K.; (d) – a newly reactivated sinkhole with fresh scars in its soil slopes, on the limestone of County Cavan, Eire.

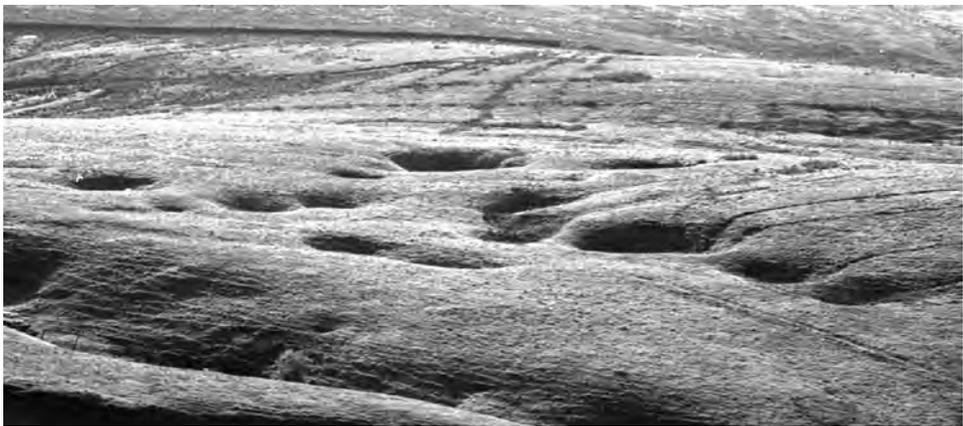
Figure 4.4. A cluster of subsidence sinkholes, locally known as shakeholes, in a patch of moraine till in the English Pennines.

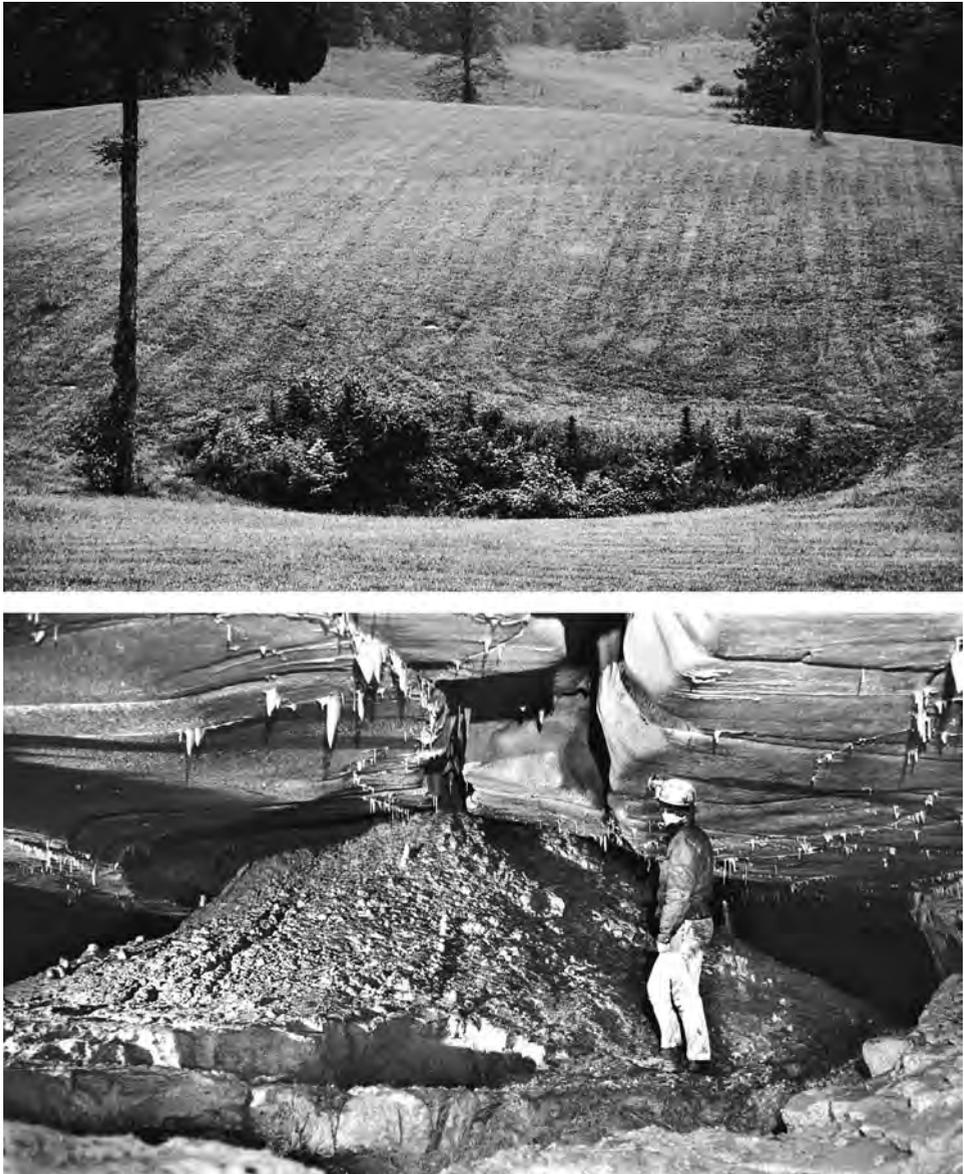
Figure 4.5. A small subsidence sinkhole in the karst of Indiana, and the cone of debris emerging from a fissure directly beneath it in Blue Spring Cave.

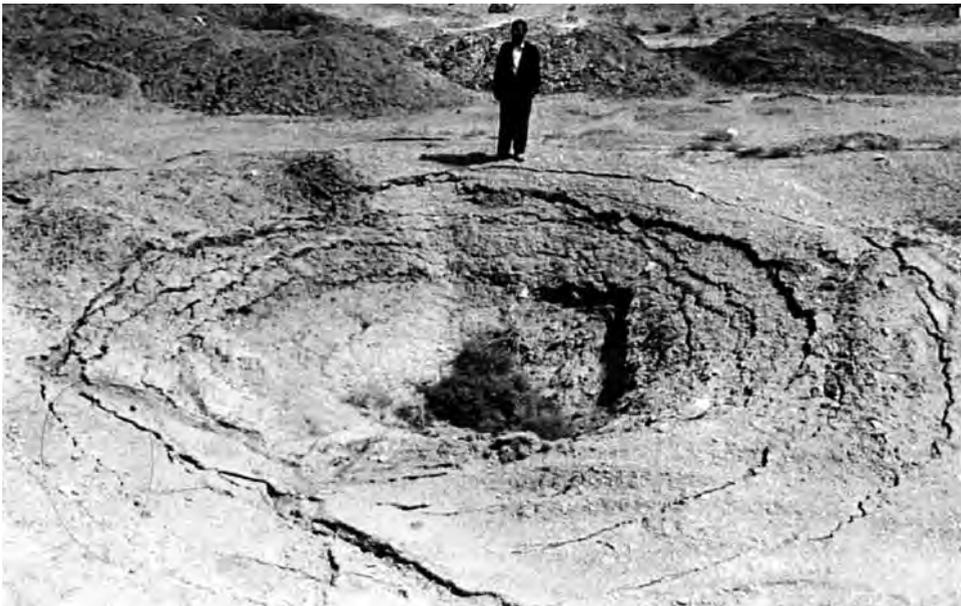
Figure 4.7. A small suffosion sinkhole newly developed in sandy soils near Kerman, Iran. Photo: Habibeh Atapour.

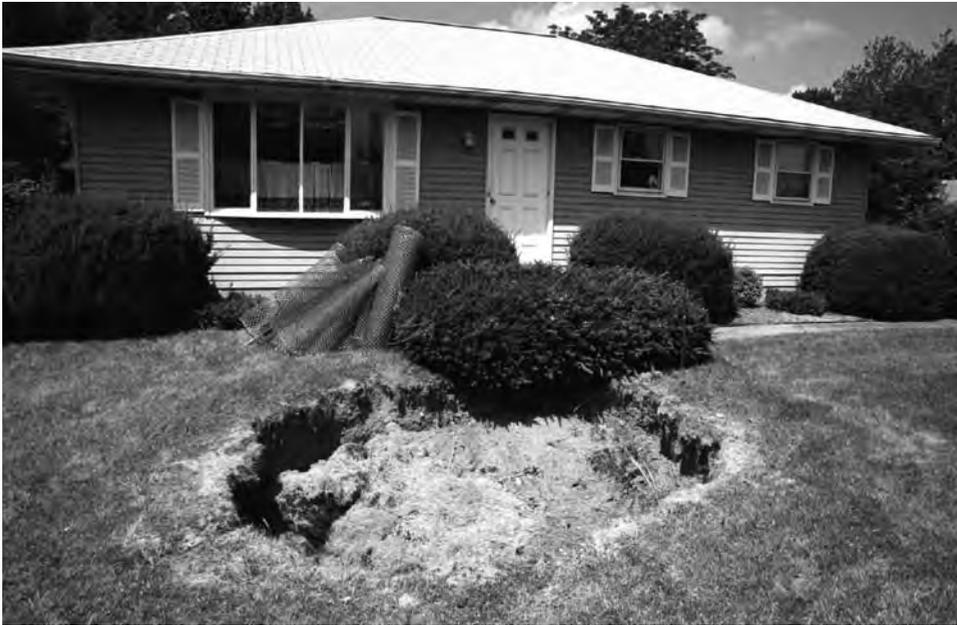
Figure 4.8. A dropout sinkhole in the front lawn of a house in Pennsylvania; the hole was originally 5 m deep but was filled with soil to prevent the sides flaring out, and the soil fill had compacted and settled by 0.7 m by the time this photo was taken. TW.

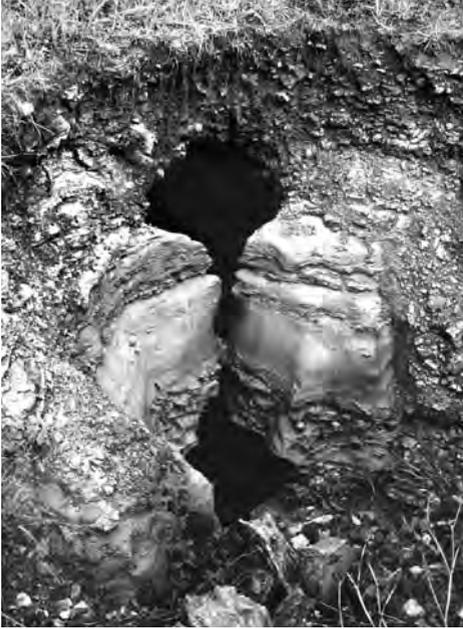
Figure 4.11. A soil arch beneath about 150 mm of cover over a cavity developed over a fissure in limestone rockhead, exposed in the side of a small collapse in Kentucky.

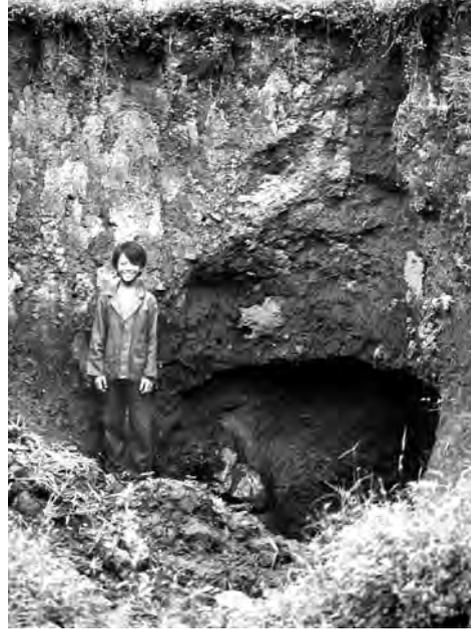
Figure 4.12. A thick soil arched over a piping cavity in the edge of a fresh dropout sinkhole in the Xingwen karst in Sichuan, China; rockhead is deeply pinnaced in this mature karst, and the edge of a limestone pinnacle is exposed just to the right of the boy's feet. TW.

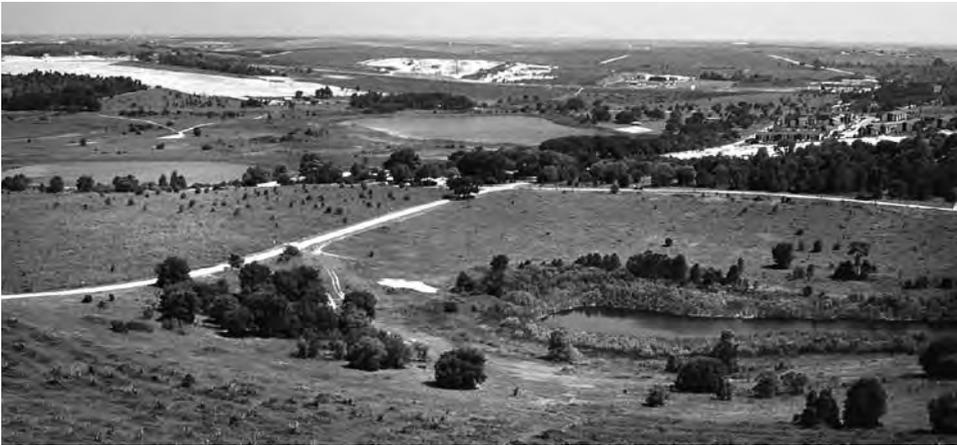
Figure 4.14. Lakes stand in many of the very old subsidence sinkholes that have degraded to wide bowls in the thick sediment cover over the limestone in the Florida lowland karst. TW.

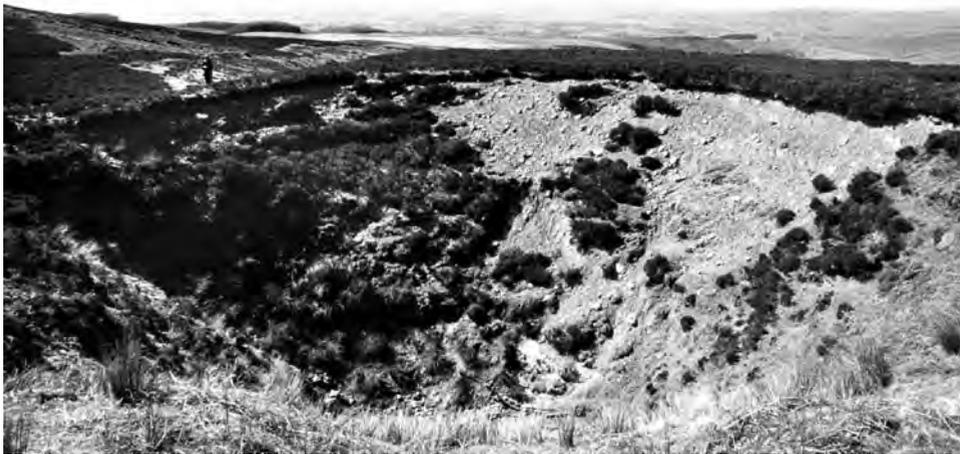
Figure 4.16. The deep and almost circular subsidence sinkhole known as Ashtree Hole that lies over a major joint in the Leck Fell limestone (see Figure 4.15).

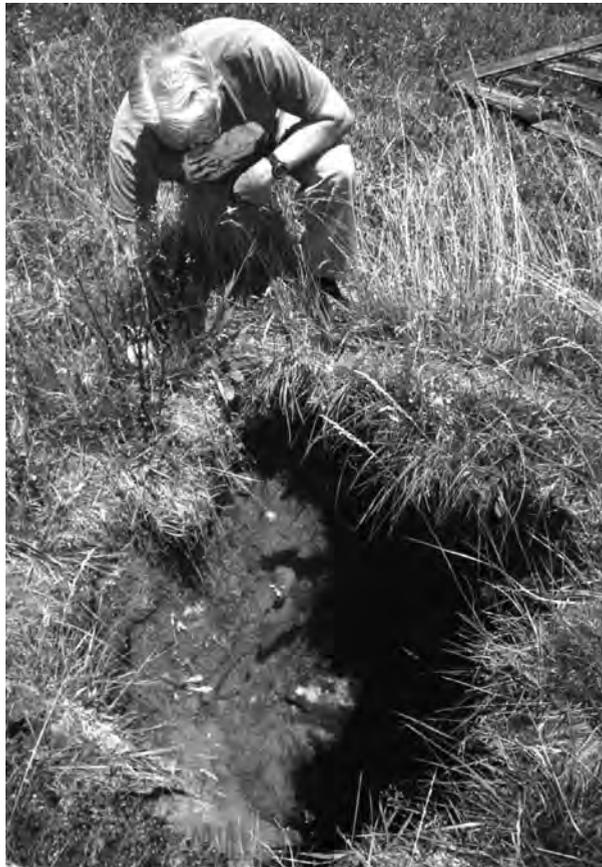
Figure 4.18. A new dropout sinkhole in the middle of a field on Kentucky's Sinkhole Plain; the top of a limestone pinnacle is just visible about 1 m down, but the open hole is 12 m deep within a fissure between the rockhead pinnacles.
TW.

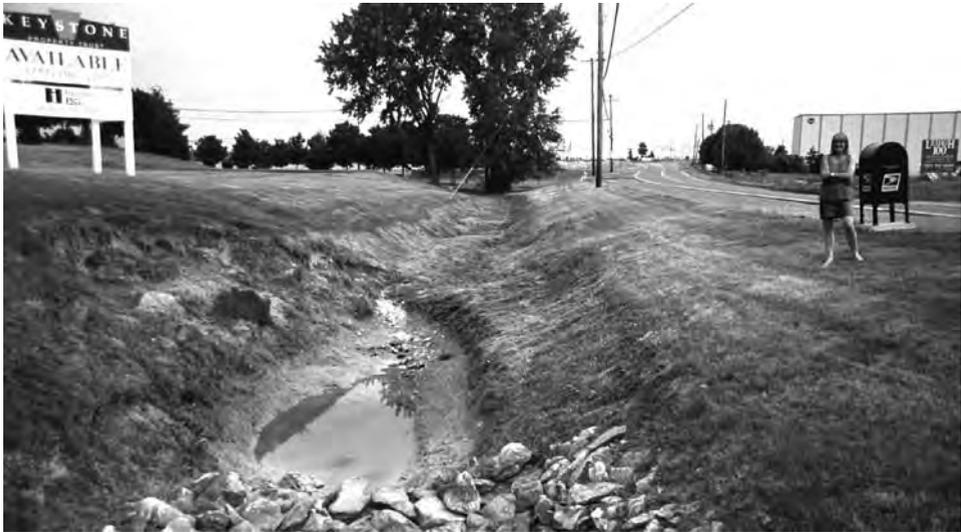
Figure 8.1. Early stages of a sinkhole developing in the untreated soil floor of a ditch beside a Pennsylvania highway; it is temporarily choked with clay, while the riprap in the foreground was placed to prevent erosion at a culvert outlet.

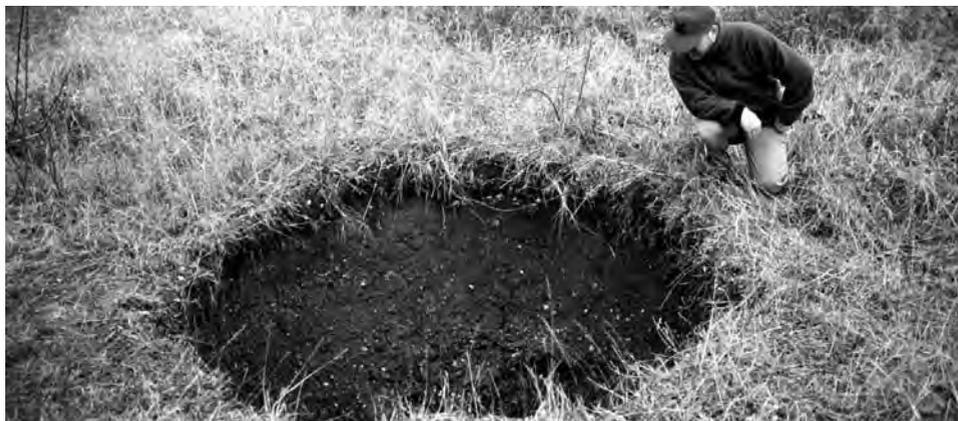
Figure 8.2. One of the cluster of subsidence sinkholes induced by a broken water main on the English chalk downs; there was no surface flow, but the dropouts developed above suffosion points in the soil over bedrock fissures.
TW.

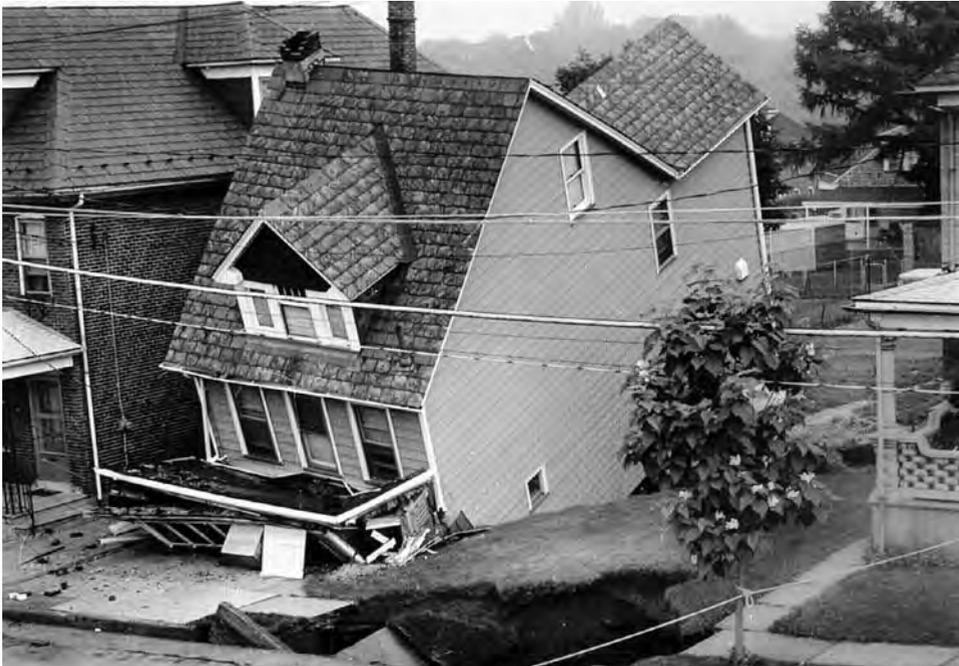
Figure 8.3. Terminal damage to a timber-frame house in Phillipsburg, New Jersey, caused when sinkholes developed underneath it and under the sidewalk after a water main burst beneath the street.

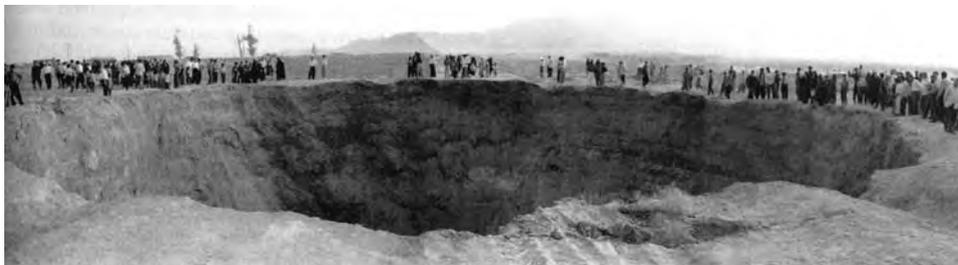
Figure 8.5. The very large subsidence sinkhole that developed in 1998 in irrigated farmland near Ekhtiyarabad, southern Iran.

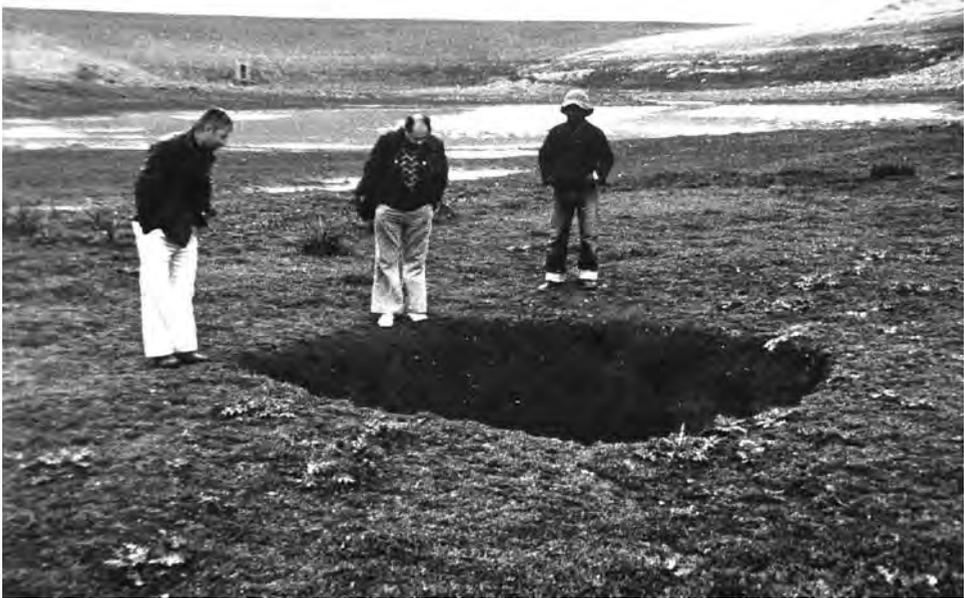
Figure 8.6. The Karrubah sinkhole, in Libya, that formed beneath the waters of the short-lived reservoir impounded by the Marj dam, visible in the distance.

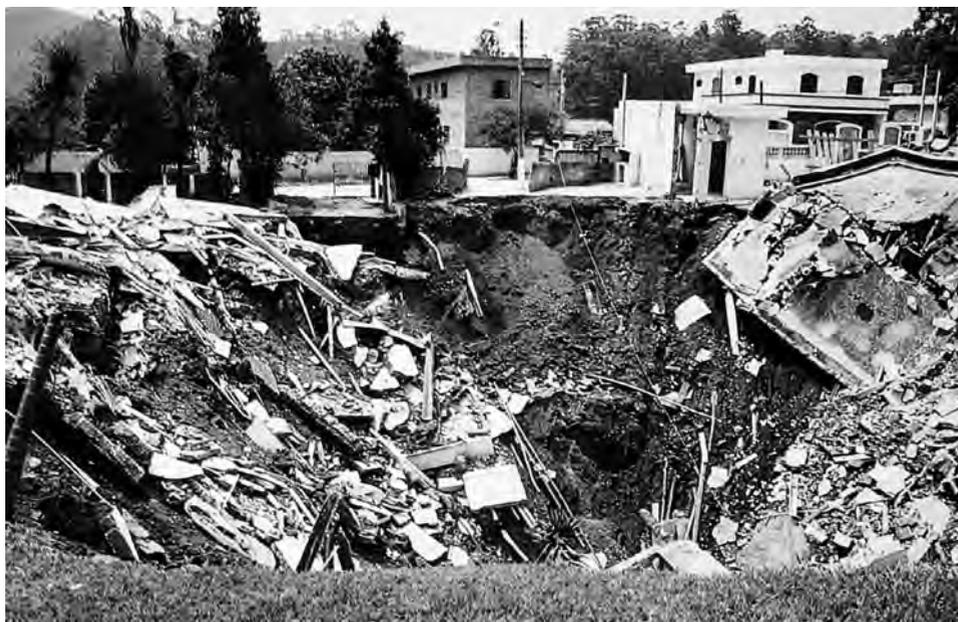
Figure 8.7. Collapse of a house in Cajamar, Brazil, in 1986 over a sinkhole induced in a thick soil cover by excessive groundwater abstraction at a nearby industrial site.

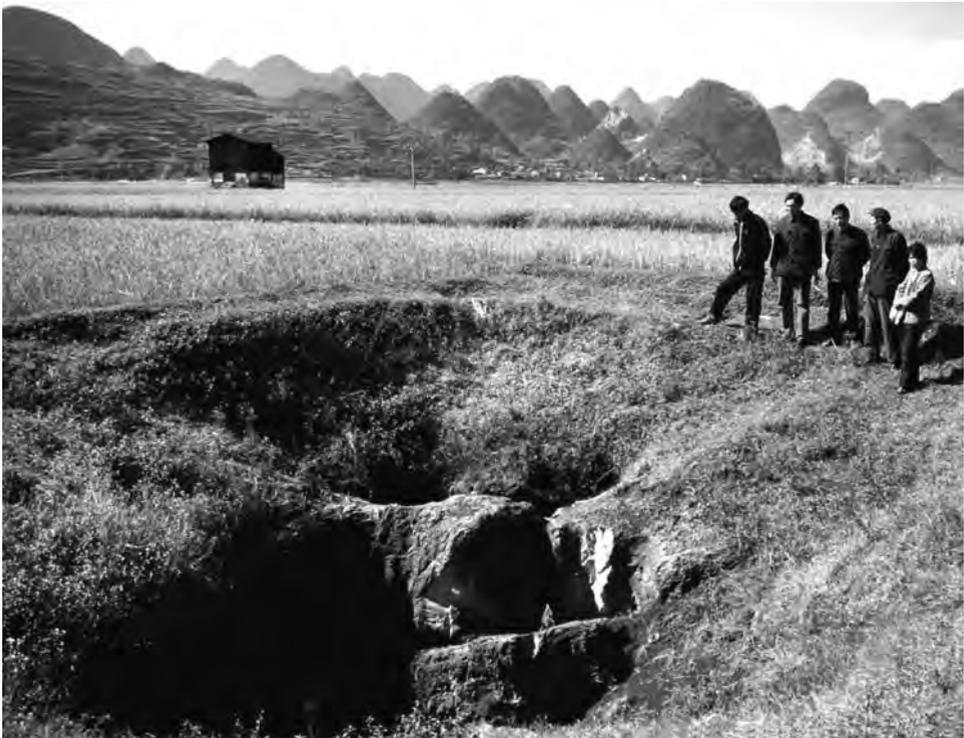
Figure 8.9. A subsidence sinkhole induced by water table decline as groundwater was pumped through the well house visible beyond, in the Shuicheng karst basin, China. The crest of a limestone pinnacle is exposed in the sinkhole only a metre below the original ground level. TW.

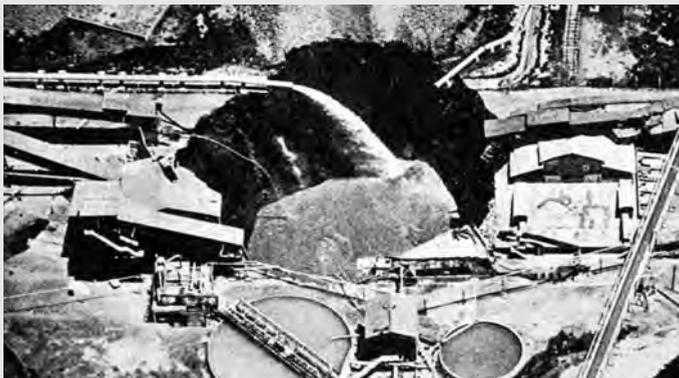
Figure 8.1.2. The subsidence sinkhole that engulfed the mine crusher plant in 1962. Photo: Consolidated Goldfields.

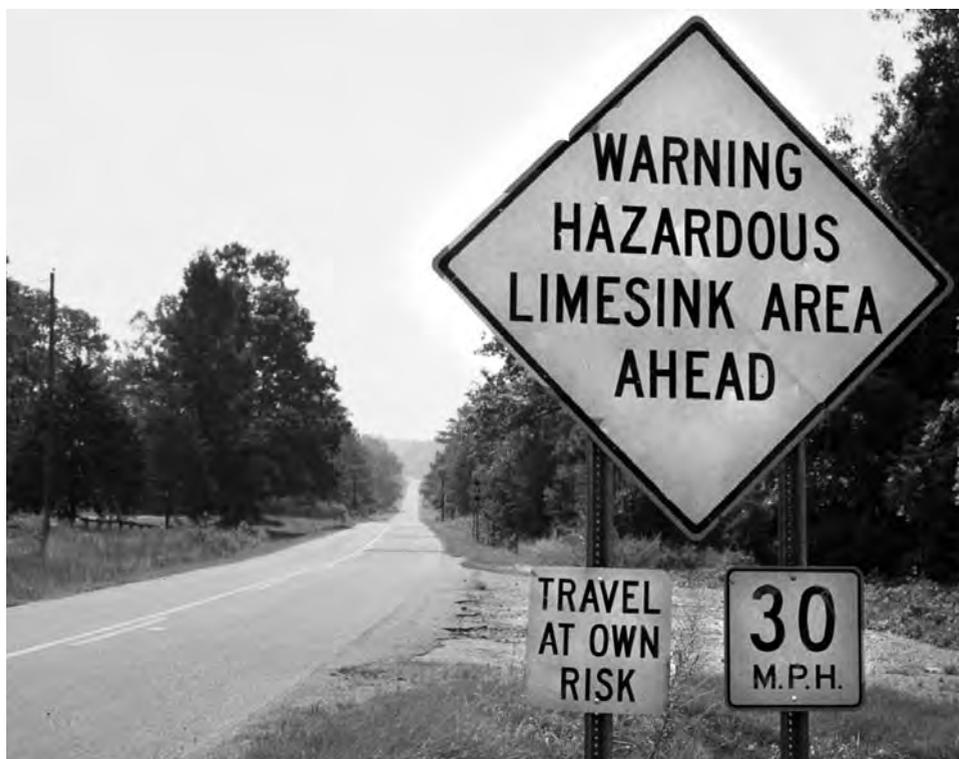
Figure 8.11. Road signs that warn of the ongoing hazard to a road across Alabama's Dry Valley, where sinkholes are induced in the soil by de-watering at a nearby limestone mine. TW.

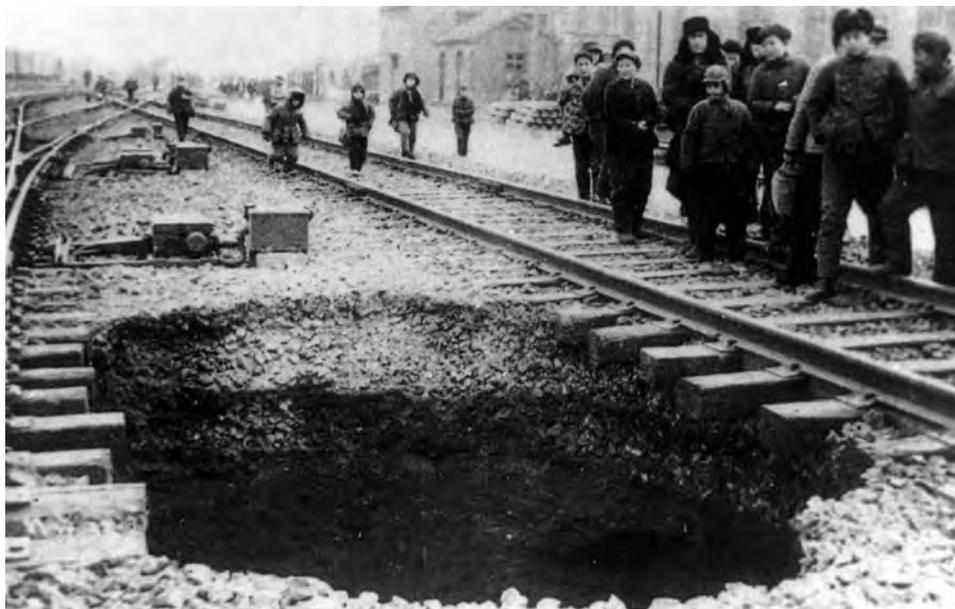
Figure 8.12. A dropout sinkhole 5 m deep between the railway tracks at Tai'an, eastern China, one of 24 sinkholes induced over a period of five years by water table decline in response in groundwater pumping.

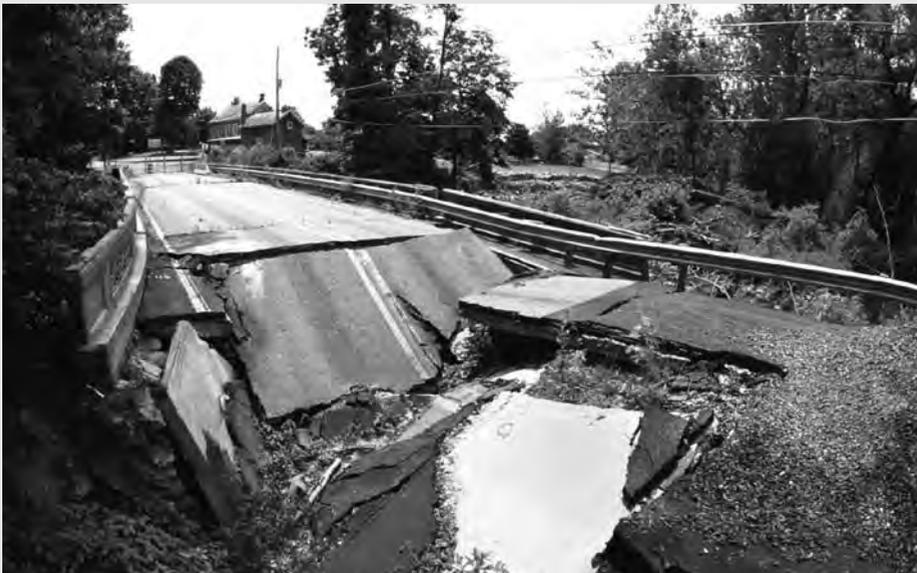
Figure 8.2.2. The bridge that carried Tatamy Road over Bushkill Creek, destroyed by an expanding and ever-changing cluster of sinkholes.
TW.
