Natural and anthropogenic rock collapse over open caves

T. WALTHAM¹ & Z. LU²

Abstract: Natural rock collapse that reaches the ground surface to form a collapse doline is relatively rare in limestone karst. The anthropogenic karst geohazard is posed by the possibility of rock collapse when additional loading is imposed by engineering works directly over a known or unknown cave. An intact rock-cover thickness that exceeds half the cave width appears to be safe in most karst terrains formed in strong limestone. Guidelines suggest that drilling or probing prior to construction should prove sound rock to depths ranging between 3 and 7 m in most of the various types of karst.

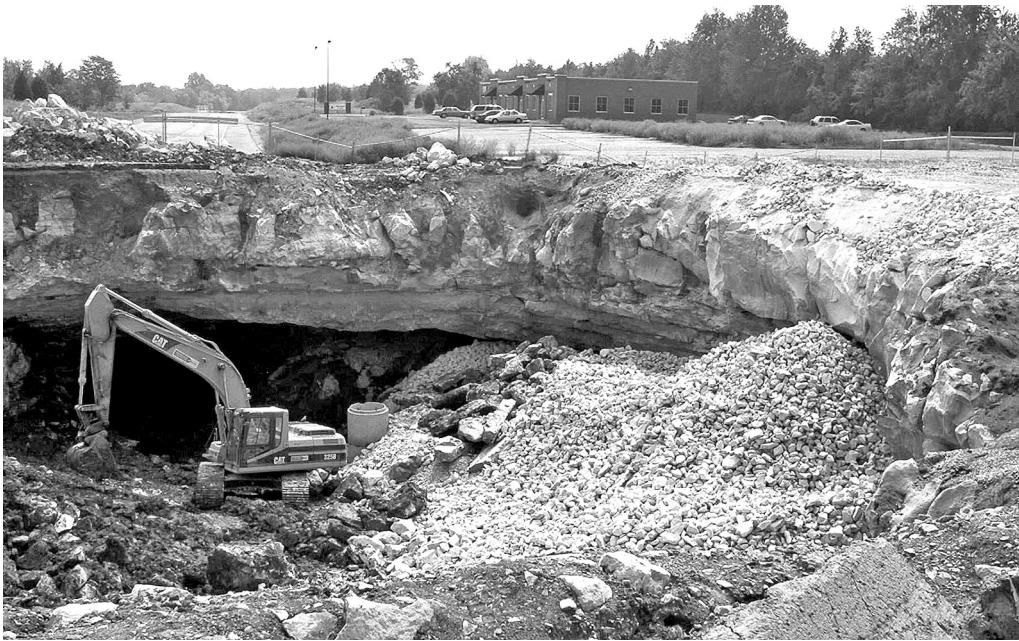
Fig. 3. The edge of the collapse doline that destroyed a road in Kentucky in 2002, viewed when remediation was under way; the broken edge shows the wide cave chamber spanned by a very thin roof, of which the upper half was a zone of soil-filled fissures between rockhead pinnacles.

dissolution is not normally significant, but greatly increased water flow could reduce stability by washing out fissure fills that had been contributing to the integrity of a compression arch within the roof rock. In the long term, the accelerated opening of fissures within the drainage zone beneath the floor of a solution doline is recognized as contributing to major rock failure over cave chambers to form the giant collapse dolines known as tiankengs (Zhu & Chen 2005). At a recent collapse event in Kentucky, rock failure appears to have been induced by impact loading created when soil arches collapsed over voids that had developed within the soil profile over fissures in the limestone (Kambesis & Brucker 2005), but this cave roof was already very thin (Fig. 3).

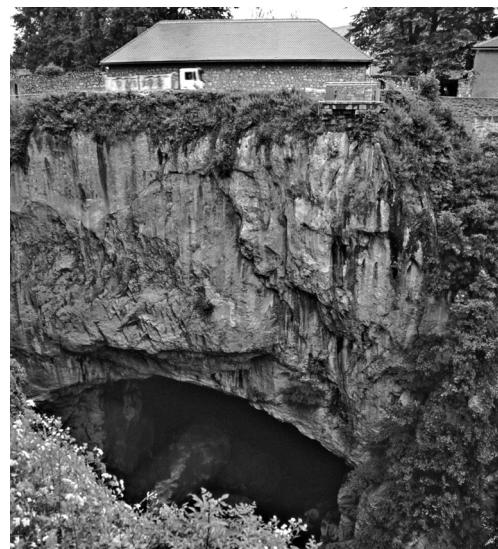
Fig. 4. Houses in the town of Ogulin stand in complete safety atop a thick arch of massive limestone that spans a wide cave passage in the inland karst of Croatia.

sinking rivers, but most of these rock arches are comfortably massive (Fig. 4).
