Control the drainage: the gospel accorded to sinkholes

Tony Waltham

Abstract: Karst is a terrain distinguished by its underground drainage, natural cavities and sinkholes. New subsidence sinkholes (both dropout and suffosion) formed within the soil cover constitute the main karst geohazard. Nearly all are induced by increased drainage inputs or by water table decline, and control of the drainage is the primary means of reducing their hazard. Cave collapse and the development of collapse sinkholes in bedrock are less common, and the stability of a cave roof that is thicker than its width means that only those caves at shallow depth create any hazard. Predictions of the locations of caves or potential sinkhole sites are next to impossible, geophysical searches have severe limitations and borehole searches can incur significant costs. Consequently, controlling the drainage on construction projects is usually the most cost-effective means of minimizing the karst geohazard.

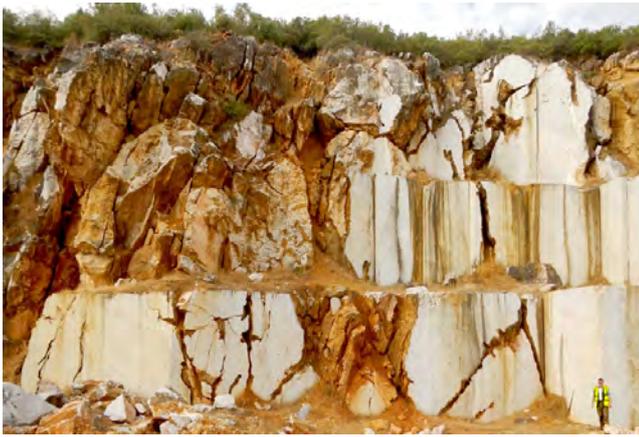
Fig. 1. Sawn faces in a small old quarry in Turkey expose dissolutional fissures that are typical of those in limestone karst, transmitting and enlarged by groundwater. Although most voids are aligned on fractures there is no pattern in how far each extends; they are all interconnected in the third dimension.

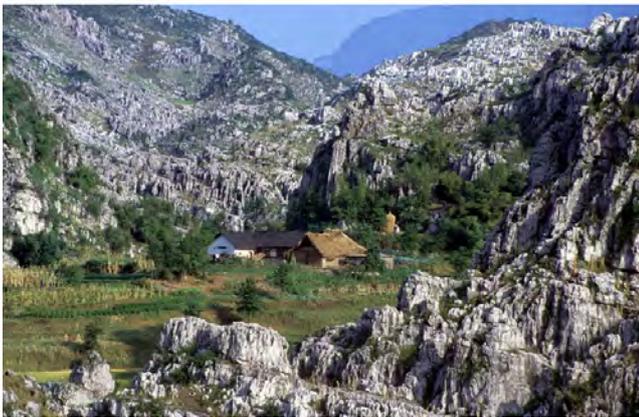
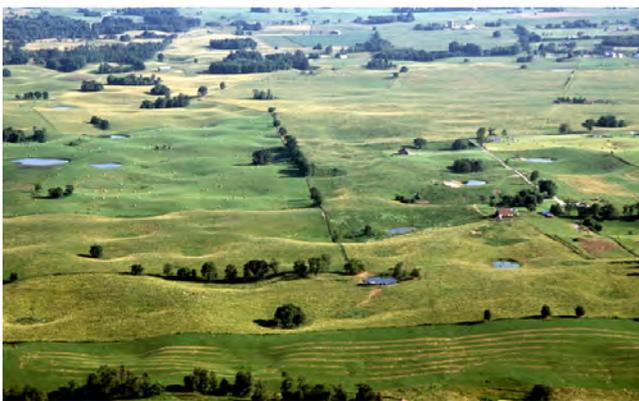
Fig. 2. Variation in karst terrain. (a) Mountain karst in Sichuan, China, with bare rock on the hillsides and soil floors within isolated depressions. (b) A lowland plain in Kentucky, USA, with numerous sinkholes in a soil cover that overlies cavernous limestone.

The landscapes of karst take on many guises. The fenglin towers of southern China, the conical hills of Jamaica's Cockpit Country, the Sinkhole Plain of Kentucky (Fig. 2), the bare limestone pavements of England's Yorkshire Dales, the rolling downlands of France's champagne region and the Nullarbor Plain in Australia are all variants of karst. There is an extensive literature on karst geomorphology; the standard reference is the book by Ford & Williams (2007), though the best introductory read is still that by Jennings (1985).

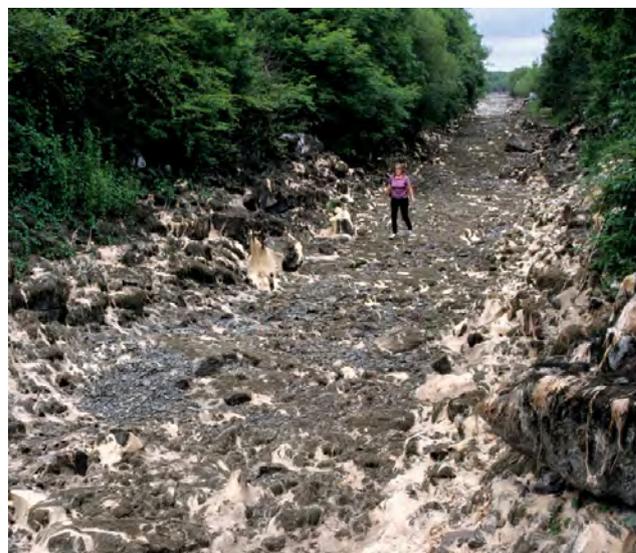
Fig. 5. Karst hazard. The Cong Canal in western Ireland that does not hold water because it was built on karst limestone.

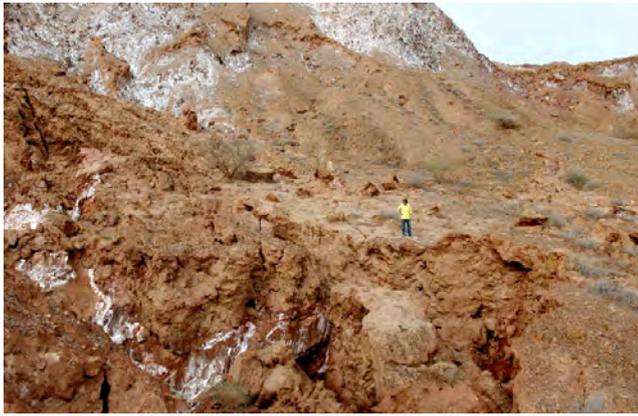
Fig. 6. Suffosion, soil loss and collapse in action, exposed in the side of a large dropout sinkhole on an exposed salt dome on Qeshm Island, Iran. Because the bedrock, visible below the dark red soil, is salt (halite), dissolution is very rapid and the karst is developing far more rapidly than in limestone, although the processes are essentially the same in both.

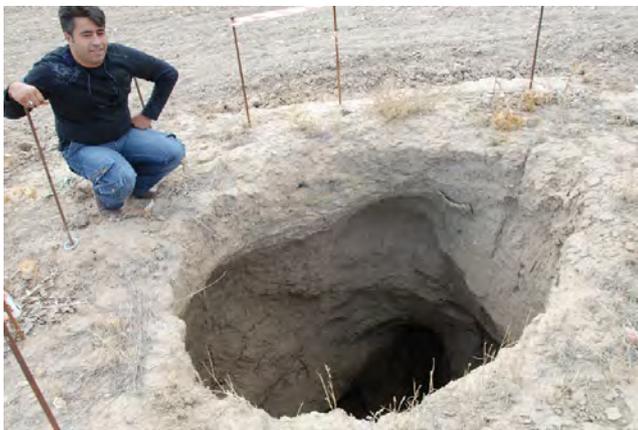
Fig. 7. A new dropout sinkhole in cohesive silty soil in Turkey. It formed adjacent to recent construction works that had disturbed the local drainage patterns.

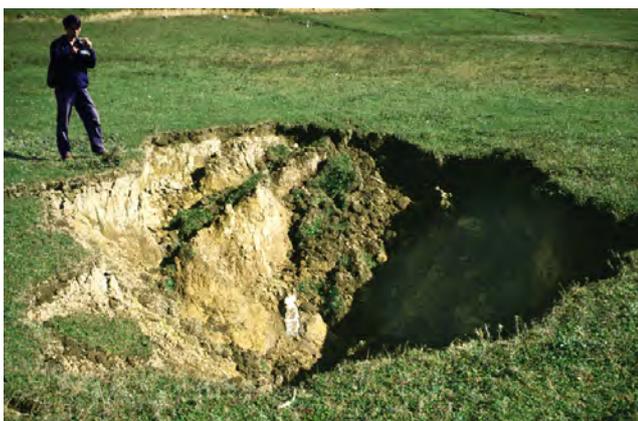
Fig. 8. A recent dropout sinkhole in clay-rich soil over limestone in Guizhou, China. It is still becoming larger: slices slump from its sides and the fallen debris is being washed away from beneath. The site is located downslope from a new highway, and the sinkhole was probably induced by a change in runoff pattern.

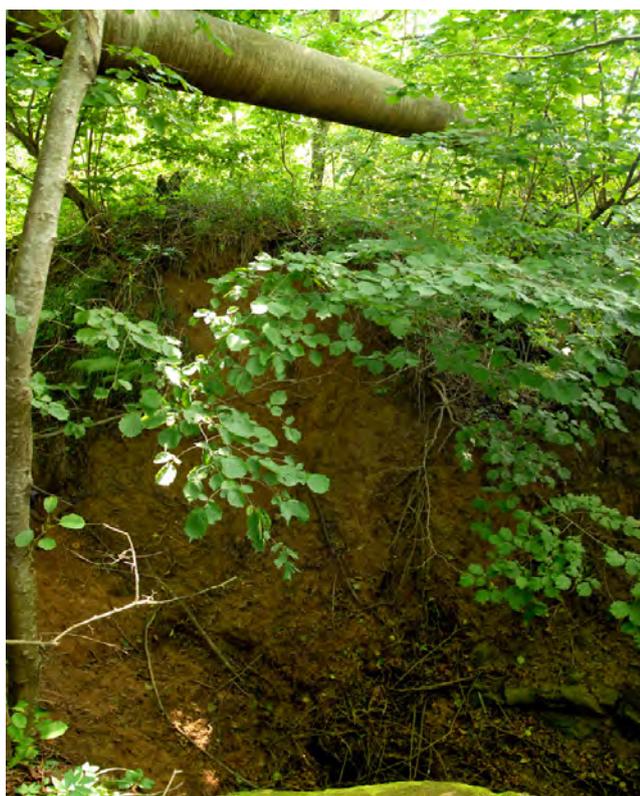
Fig. 9. An oil pipeline in Georgia is left with no support where it spans a sinkhole that developed beneath; this could have occurred soon after the inevitable drainage disturbance during construction, or subsequently owing to drainage water collecting in the trench-fill.

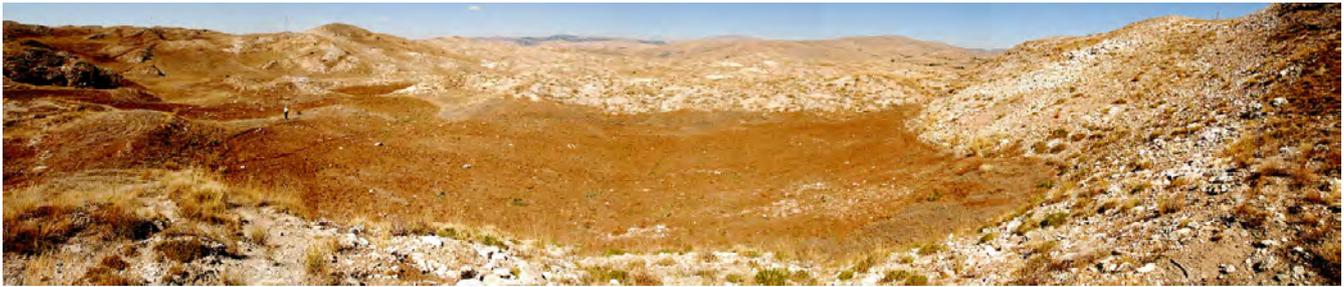
Fig. 10. A large solution sinkhole in the gypsum karst of Sivas, Turkey (note person on left for scale). The floor of clastic soils is typical of these sinkholes and is of unknown thickness. Commonly there are small subsidence sinkholes developed within the soil cover; there are none at this site, but small-scale suffosion may be indicated by settlement of a pipeline buried in the soil.

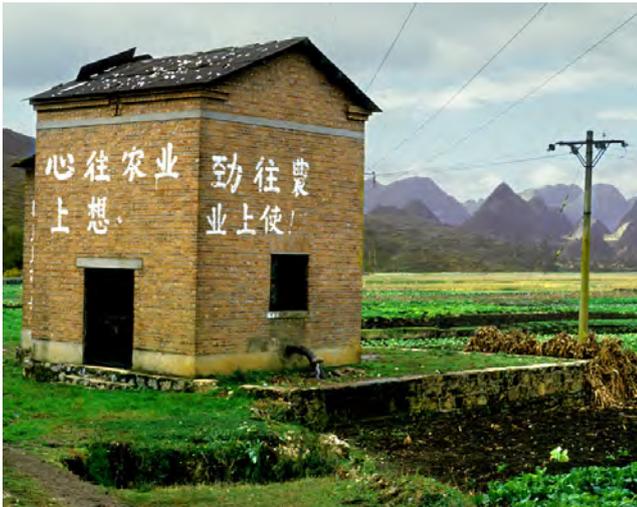
Fig. 11. One of the pump-houses over wells into the limestone of the Shuicheng basin in China. The small new sinkhole just metres from it has been caused by water and soil descending into the cone of depression, aided by leakage from the broken pipe where it emerges from the building.

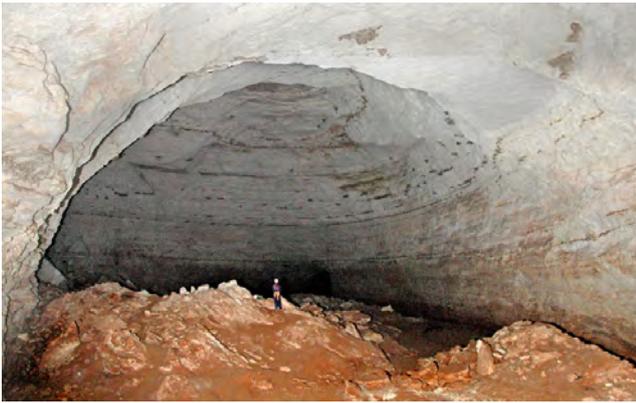
Fig. 12. A chamber in the Koonalda Cave, Australia, with a roof that has evolved into a relatively stable roof in the horizontal, bedded limestone, above a floor of breakdown blocks and in-washed red sand.

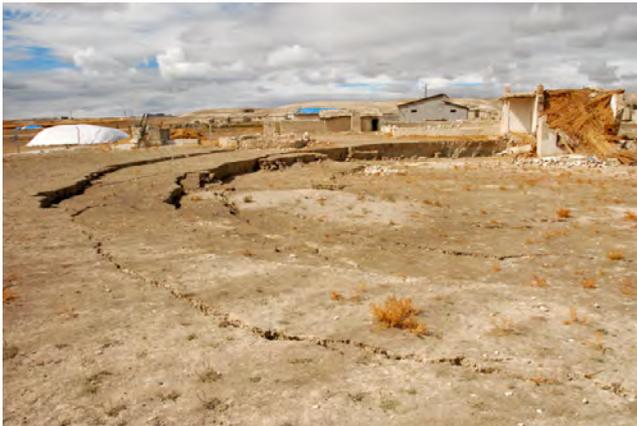
Fig. 15. A new caprock sinkhole in the Obruk Plateau of central Turkey. A circular zone nearly 50 m across has dropped by less than 2 m as it settled on the column of debris that lies beneath (compare with the breccia pipe in Fig. 13).

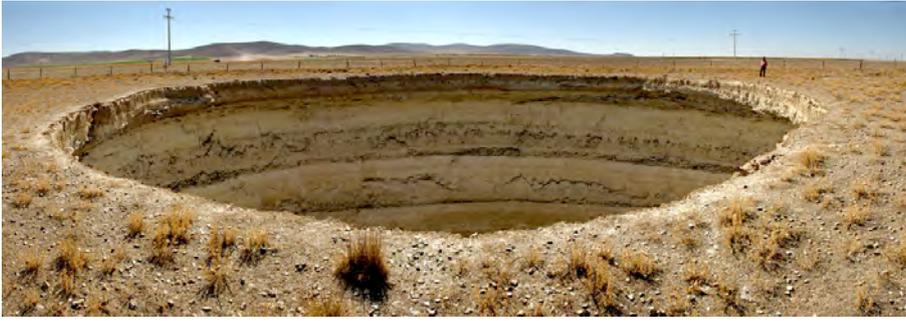
Fig. 16. The caprock sinkhole that appeared overnight near the village of Inoba, on the southern side of Turkey's Obruk Plateau. The hole has vertical sides to a depth of 35 m.

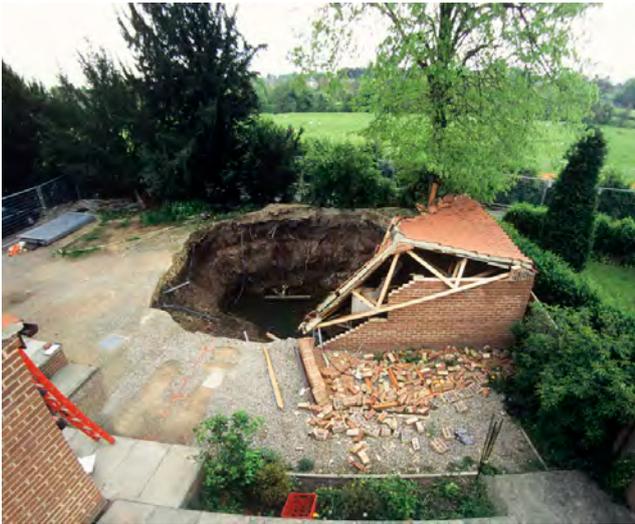
Fig. 17. One of the destructive caprock sinkholes formed by collapse over cavities in the gypsum that underlies the town of Ripon.

Collapse sinkholes can be more active and more common in gypsum karst, owing to the low strength of gypsum and its more rapid dissolution in water. The cluster of sinkhole events that continue to affect the Yorkshire town of Ripon are well documented (Cooper 1998, 2005). These originate by collapse into unseen, active, water-filled caves within the gypsum and about 50 m below ground level; lines of sinkholes may relate to major fractures or cave passages within the gypsum. Some failure events are due to settlement within the columns of debris and soils that form breccia pipes infilling old collapse features. These can be reactivated by incursions of surface water, so appropriate drainage control can reduce, but not eliminate, this geohazard (Fig. 17).

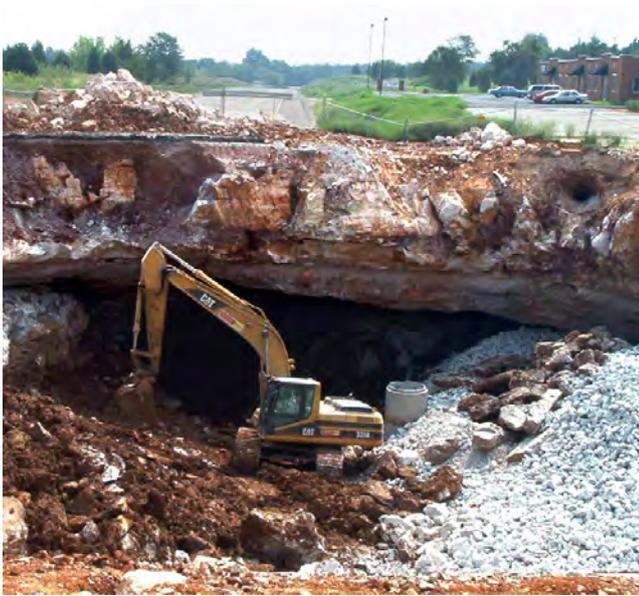
Fig. 19. The collapse sinkhole that destroyed Dishman Lane in Kentucky, with an initial failure where ground collapsed into the wide cave less than 5 m below the surface. This image was taken when collapse debris had been removed prior to installing a stable fill. The thin cave roof is exposed in profile, with some of the deep soil-filled fissures and miniature buried sinkholes visible above the arm of the backhoe (photograph by courtesy of Hilary Lambert).

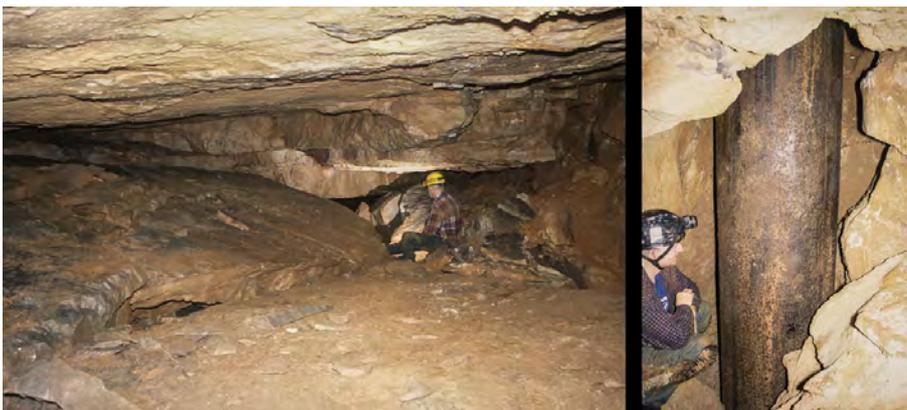
Fig. 20. Big Spring Cave, beneath the courthouse in Huntsville, Alabama. (left) Part of the width of the main passage, where beds of the nearly horizontal limestone have fallen from the roof, so that the open space is now on top of slabs stacked 5 m deep. (right) A steel-cased, bored pile that extends through the cave and debris fill, and carries its load to stable rock beneath the cave floor.

area to be stabilized. An alternative can be the installation of metre-diameter bored piles that pass through the cave into stable rock beneath (Fig. 20), as was the case to support the courthouse in Huntsville, Alabama (Waltham *et al.* 2005). The Yucatan Peninsula, Mexico, is a limestone platform with extensive networks of caves at shallow depth; these were formed at past positions of the halocline (freshwater–saltwater interface) when sea levels were lower during the Pleistocene. The main coastal highway successfully crosses above a number of these caves, utilizing pile foundations that pass through them where high point loads and thin rock covers dictate.

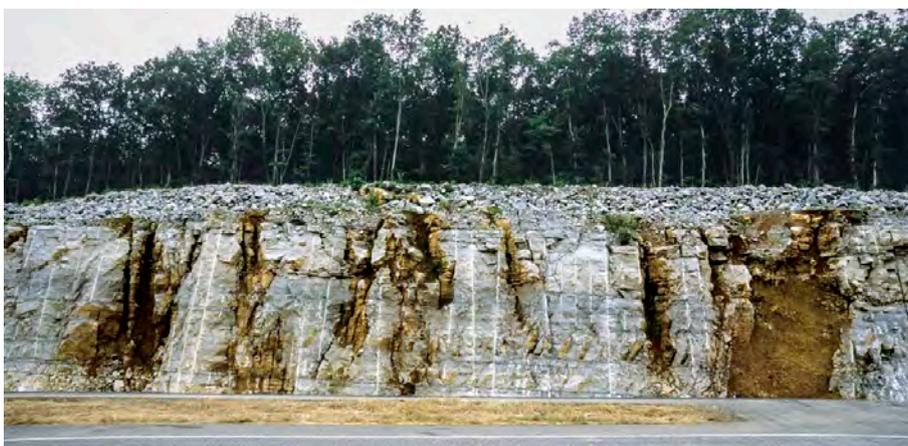
Fig. 22. Limestone exposed in a pre-split face about 5 m high alongside a road in Alabama, USA. Every few metres along the face there is a clay-filled fissure, a zone of narrow fissures or a buried sinkhole. All of these would have been potential sites for new subsidence sinkholes within the few metres of soil cover that has been removed along the crest (and replaced by the bank of limestone boulders).

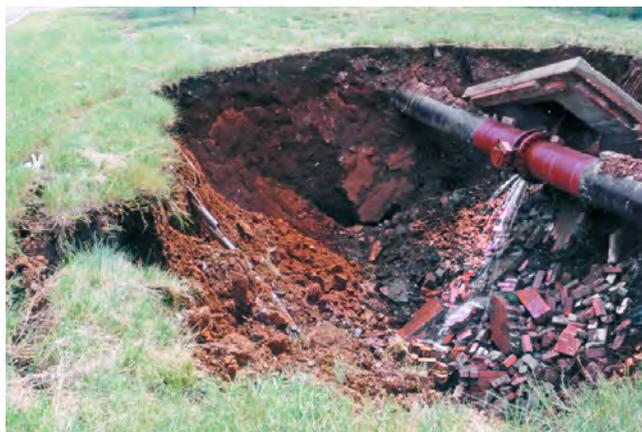
Fig. 23. A small, new subsidence sinkhole in soil-covered dolomite karst in South Africa, clearly induced by the leakage from the water pipeline that is now exposed (photograph by courtesy of the late Fred Bell).
