Man as geological agent

TONY WALTHAM & ALAN FORSTER

A Yorkshire landslide has been reactivated by man's activities.

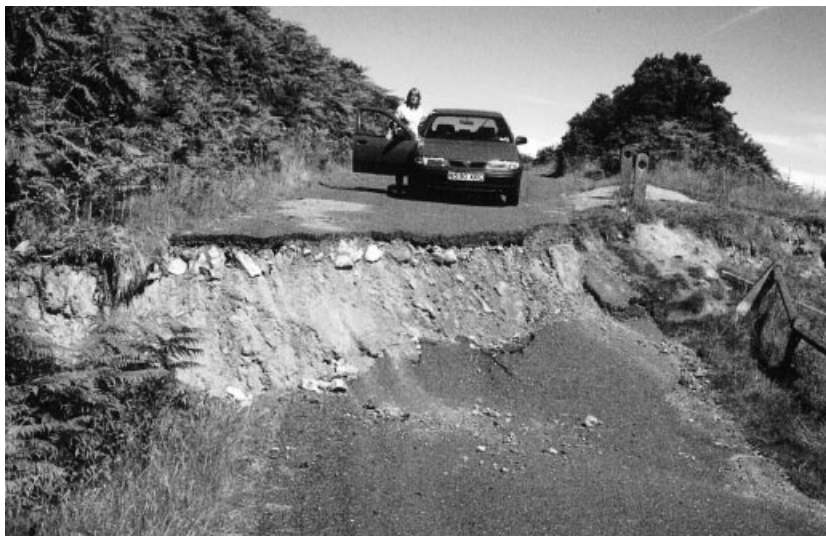
Fig. 1. Renewed movement on the landslide head scarp that has cut the road from Ainthorpe; the displacement of the road represents the downward movement of the graben across the head of the slide. (Photos by George Dowson and the authors.)

Early in 1999, a country backroad on the northern slopes of the North Yorkshire Moors was broken by a landslide that left a step over a metre high right across the road (Fig. 1 and front cover). Hardly a major event; but the Ainthorpe slide has proved to be a classic example of the role man plays as an agent of geomorphological process. That is how the geologist views it; to the civil engineer, it is yet another example of how destructive 'natural' events are so commonly unnatural, and are triggered by man's own activities.

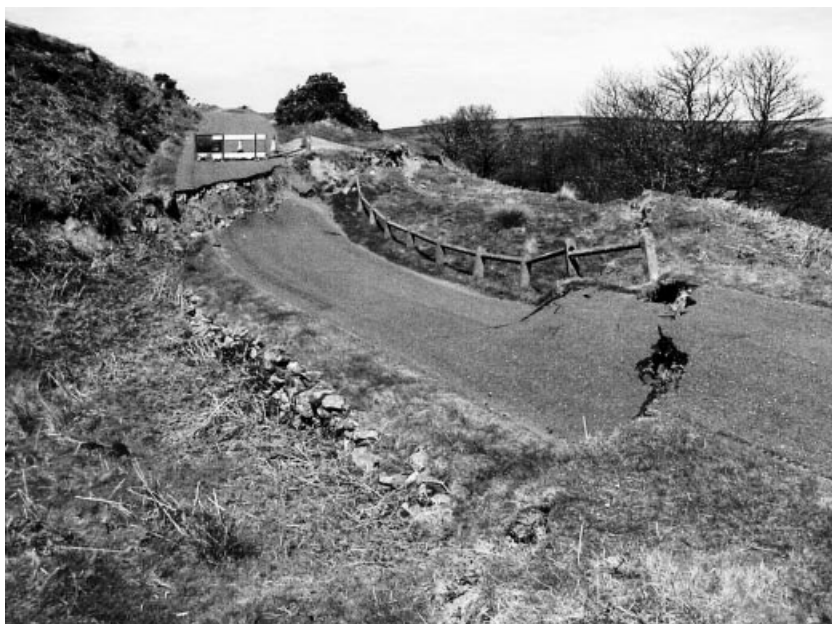
Fig. 3. (left) The graben across the road, with its higher margin on the left forming the landslide head scarp. The main slide mass on the right is moving downslope and away to the right.

The slide's most conspicuous feature is a splendid graben (Fig. 3) against the head scarp; this forms the western edge of the slide and crosses the road near its northern and lower end.

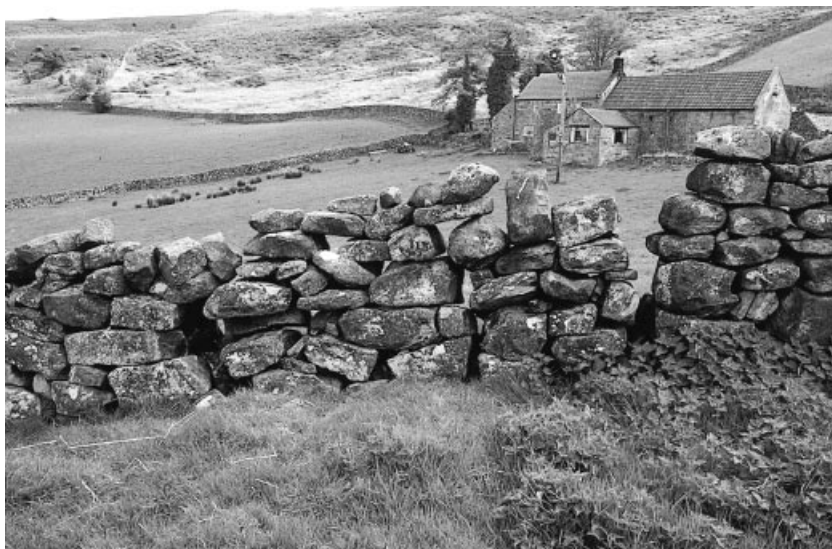
Fig. 4. (below left) A dry stone wall stretched across the shear zone on the edge of the landslide. Coombs Farm is in the distance.

The southern margin of the landslide is poorly defined along a zone of subsidence and *en echelon* shears that have displaced and stretched some dry stone walls (Fig. 4). In the toe area of the slide, towards the north-east, a complex of compressional ridges, rolls and bulges has developed, suggesting the presence of overriding soil nappes. Within the slide mass, subsidiary slumps have created various head scarps, regressive failures and small grabens, some of which break the road tarmac (Fig. 5). The main graben and most of the head of the landslide are in unimproved moorland with an extensive cover of bracken, while the toe of the slide below the road is grazed pasture.

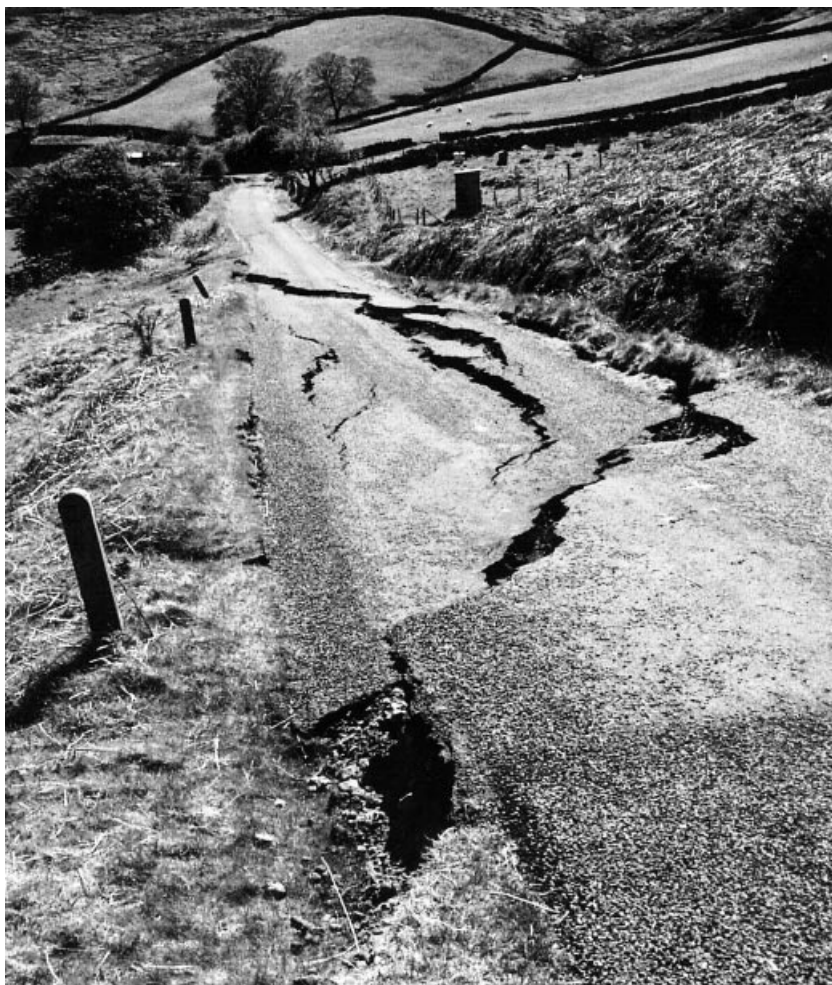
Fig. 5. Subsidiary movement within the landslide mass has created small steps in the road surface; a miniature graben has formed just below the head scarp.

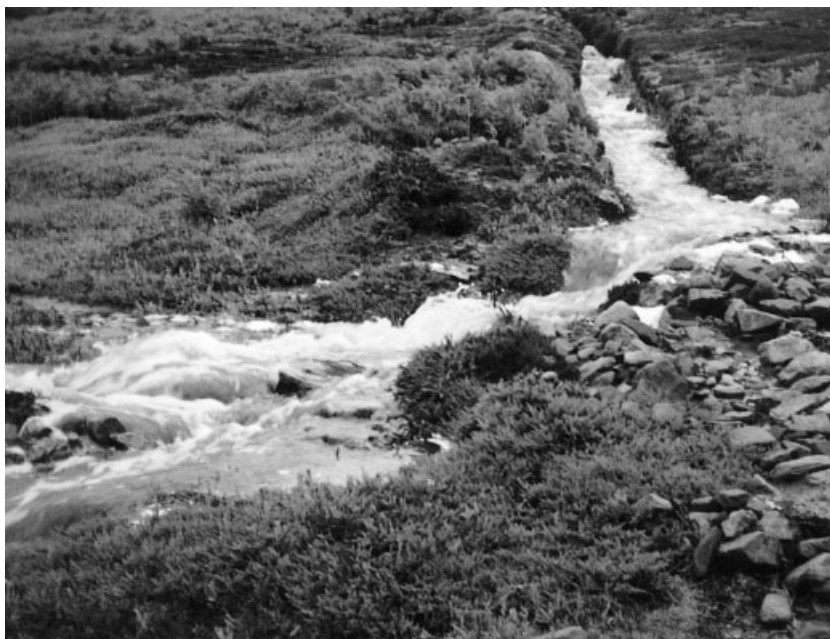
Fig. 7. (left) Water pours from the end of the 1993 ditch in the June 1999 flood event; it continues as surface flow over the moor down to the 1929 ditch.

The next month, an unlined ditch (Fig. 2) was dug to divert some of the surface flow away from The Coombs above the farm. Unfortunately, this carries the water across the hillside just above the landslide. Furthermore, the new ditch ends on the hillside directly above the landslide (Fig. 7); the ditch's water is allowed to flow down the hillside to the ditch that was dug after the 1929 slide movements. This old ditch is also unlined and has not been maintained, and any flood flow poured into it now continues down the hill into the landslide.

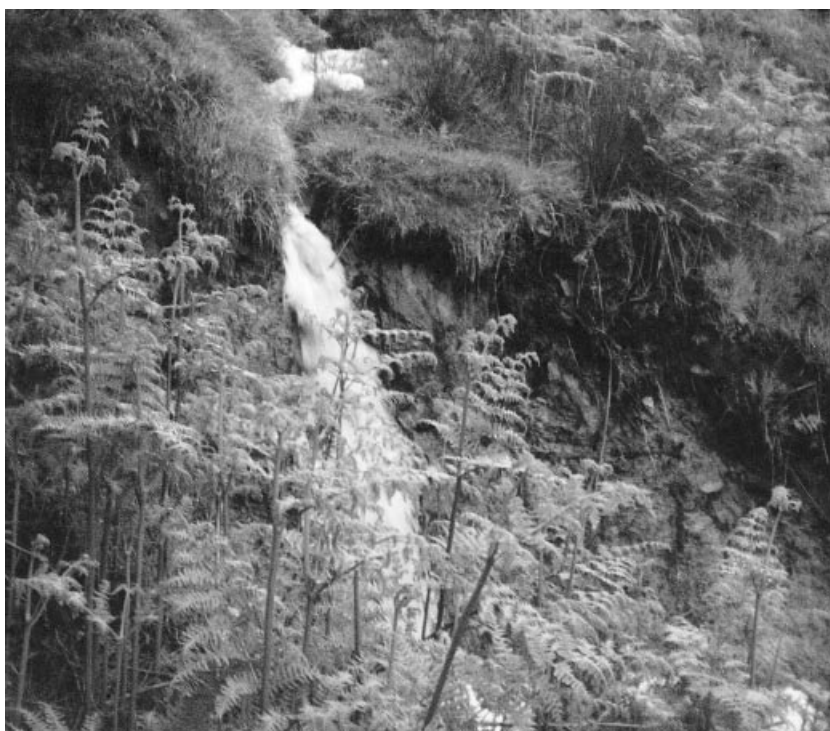
Fig. 8. (below left) Water cascades over the landslide head scarp during the June 1999 flood; it came from the open end of the 1929 ditch on the moor just above.

A storm flood on 10 June of the same year filled the drainage ditches, from where about 100 litres/second of water poured down the active head scarp into the graben (Fig. 8). All this water sank into the landslide, and re-emerged from fissures in the landslide toe below the road. But the generally dry state of the ground in summer ensured that this water input did not reactivate the landslide.
