Ground Subsidence

by A C Waltham

4 Subsidence and collapse on chalk

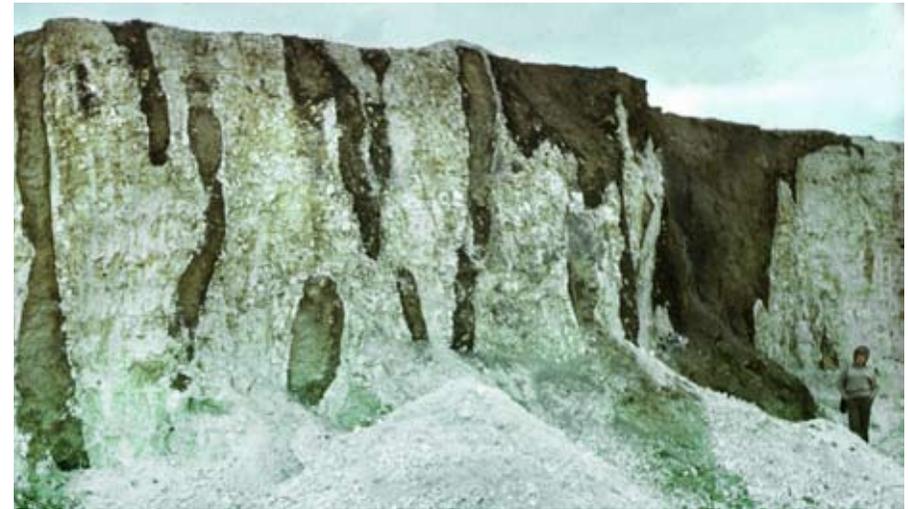
Figure 4.1 A group of clay-filled pipes in the chalk, exposed in a quarry near Water End on the southern slope of the Chiltern Hills. Some almost cylindrical pipes are intersected obliquely by the quarry face, while the clay behind the person on the right fills a larger buried sinkhole. The top of the face is close to the original surface.

Some areas of chalk contain numerous pipes, with loose fills of clay, sand and flint debris containing small voids. The pipes are conical or cylindrical, are normally a few metres across, and may reach depths of 30 m. They are essentially filled caves, and have formed where concentrated drainage has flowed into the chalk, normally near or just beneath outcrops of cover sediment and in areas of higher fracture density. Ground disturbance, by construction activity and drainage modification, caused a number of small collapses in a housing development on heavily piped chalk at Henley-on-Thames, and the housing units were mostly placed on raft foundations as a justifiable precaution (Edmonds, 1987). Most pipes have no surface expression, but their subsidence hazard is generally low, unless they are active; their main influence on civil engineering is often over quality control on cut-and-fill operations and the instability they create in cut slopes.

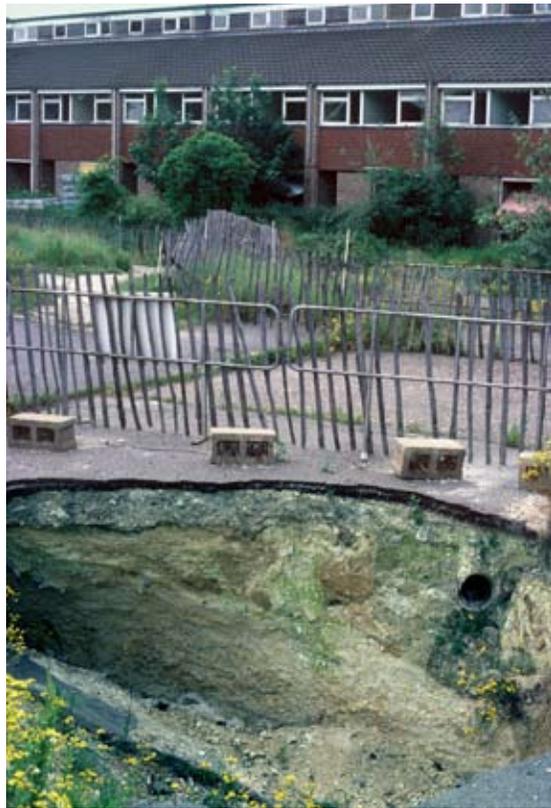
Figure 4.4 One of the collapses in Jacqueline Close, Bury St Edmunds, with the abandoned houses behind. The profile in the collapse reveals the tarmac on 30 cm of roadbase, with a broken drain on the right, on almost structureless putty chalk.
