Very large landslides in the Himalayas

Landslides are a major component of geomorphological processes on the steep slopes of the Himalayan mountains. Three slides in the Annapurna region demonstrate a sequence from large to very large failures.

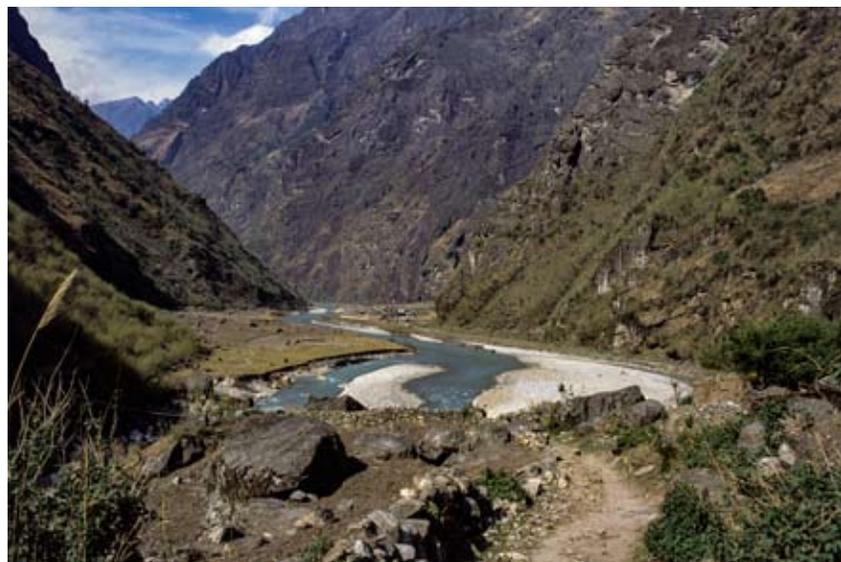
Fig. 2. The view upstream from the debris pile of the Tal landslide. Fractures recognizable in the steep right-hand slopes are parallel to those which defined the slide. Tal village stands on an alluvial fan near the head of the old lake flats.

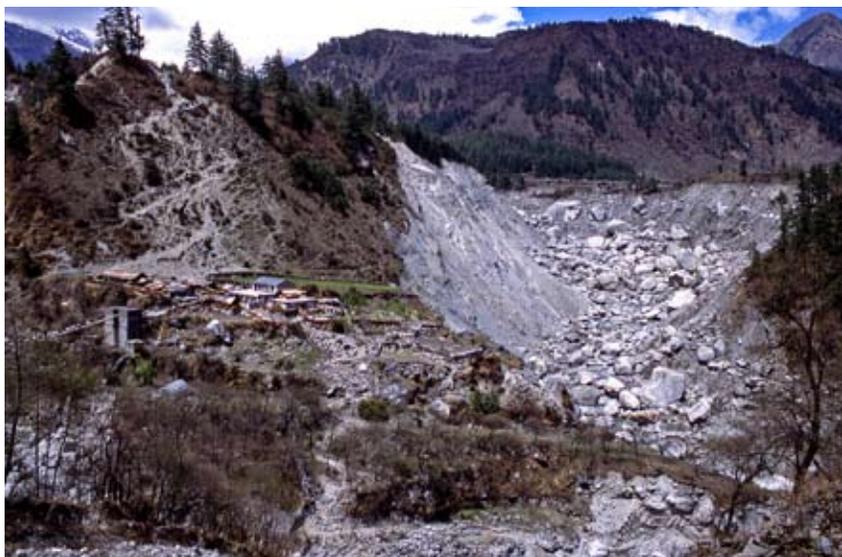
Fig. 4. The downstream end of the landslide debris forming the Lete terrace. On the right, the Kali Gandaki cascades down its freshly excavated gully, leaving a lag deposit of massive boulders in its bed.

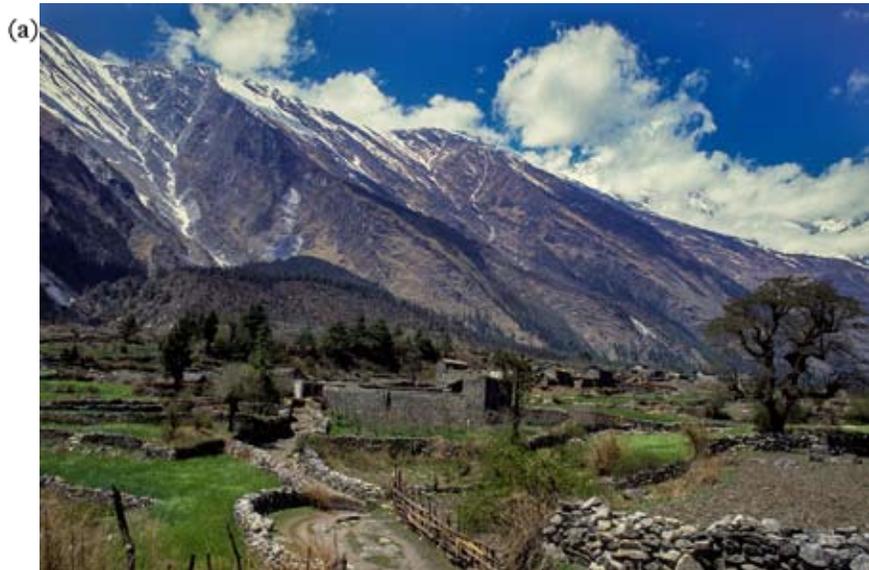
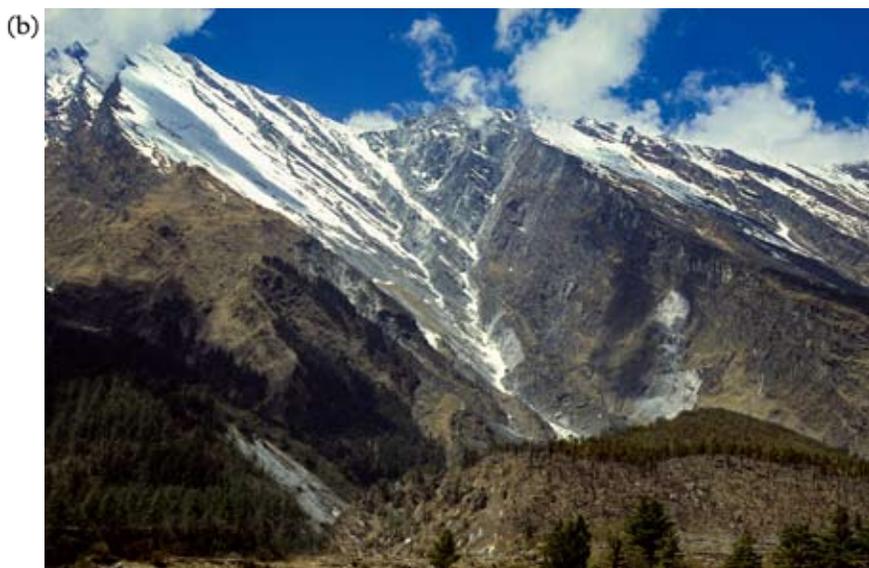
Fig. 5. (a) View along the Lete terrace, looking a little north of west. The fresh scar of the latest slide is at the extreme left, with its debris pile directly below. Dhaulagiri is behind the clouds, and the entrenched Kali Gandaki is off to the right. (b) A closer view of the late-stage slide at Lete. The wedge failure developed on the bedding plane which is still bare (partly covered in snow) and the steep fractures to its right; the debris pile in the foreground has partly exposed boulders and also a sparse tree cover.

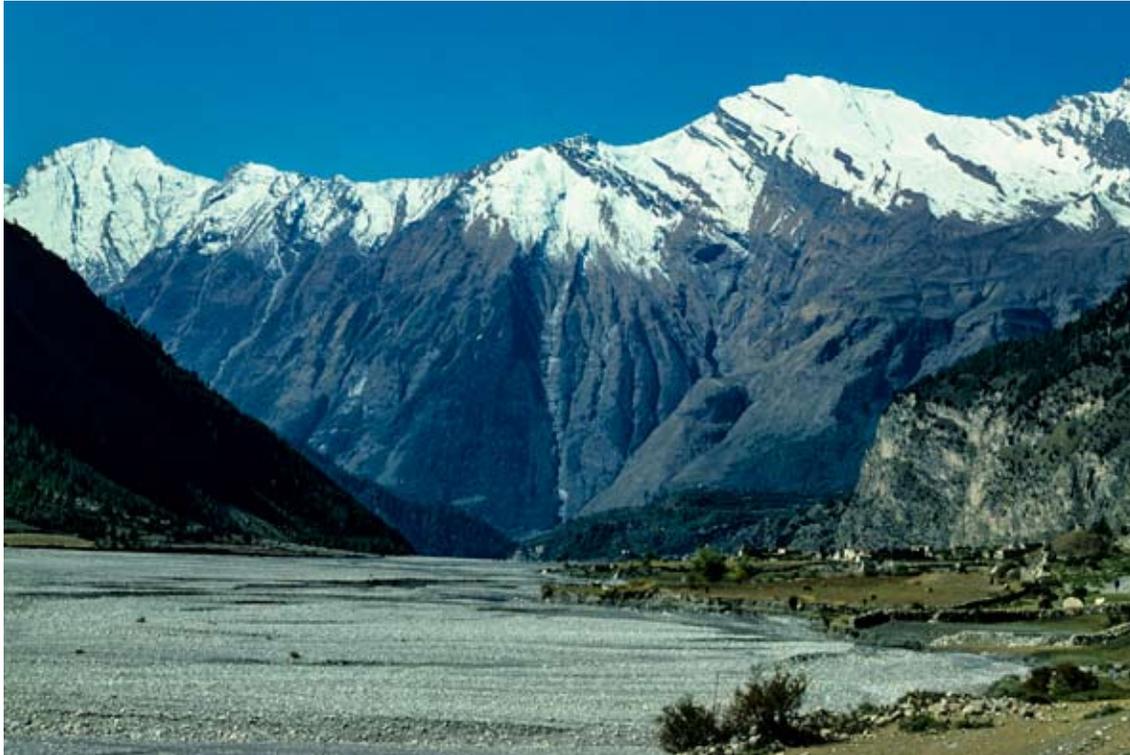
Fig. 6. Looking due south to the Lete slides. The bare gravel plain is the post-slide lake infill, with an alluvial fan intruding in the right foreground. Across the end of the gravels, the slide debris forms the rounded bank, with the river now cutting through its right side. The snow-covered slabs on the right are the main slide scars.

The Lete landslides blocked the Kali Gandaki Valley and impounded a great lake which has subsequently been filled by river gravels (Fig. 6). The lake flat extends 15 km back up the valley. It has not yet stabilized, and vegetation is not yet established, although it is beginning to encroach at the top end, north of Tukche. The braided channels of the Kali Gandaki on top of this lake fill are a conspicuous feature of this dramatic valley through the Himalayas. The date of the main Lete landslide event is unknown. Local folklore includes reference to a lake in the valley, and the features are fresh enough for an age of less than 1000 years; it may be contemporary with the Pokhara slides (see below). The age of the small late-stage slide is probably closer to 100 years.

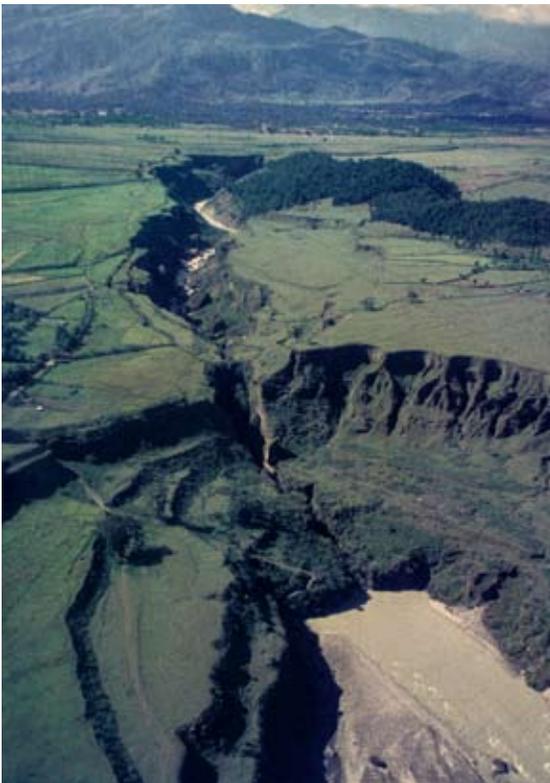
Fig. 7. (left) The flat floor of the Pokhara basin east of the city; the Seti Khola is entrenched through the thickness of the Pokhara Formation.

Pokhara, the second city of Nepal, sprawls across a flat-floored basin within the foothills south of Annapurna (Fig. 7). The Seti Khola drains through the basin, and is entrenched in

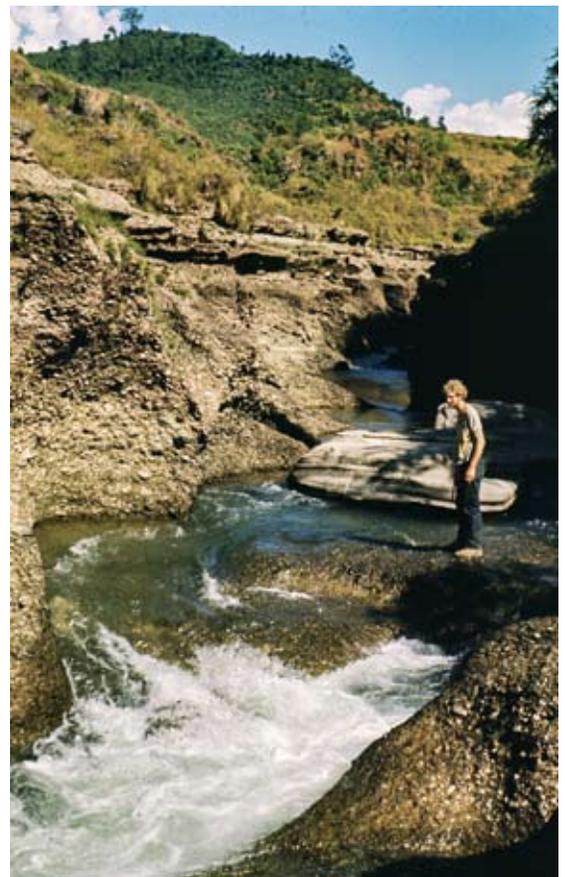
Fig. 8. (right) Limestone conglomerates which are the debris flow deposits of the Pokhara Formation, exposed in the river trench downstream of Phewa Tal.

The Pokhara sediment is crudely stratified, but it is poorly sorted, with many layers of coarse matrix-supported conglomerate (Fig. 8). It is composed largely of limestone fragments in a muddy matrix with some carbonate cementation; gneiss fragments are in the minor-
