Extract from News & Comment

New Orleans one year after Katrina

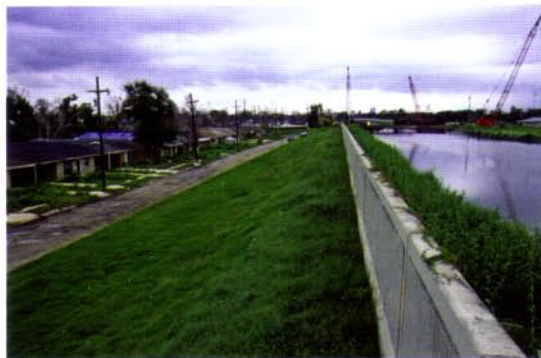
Fig. 8. An intact section of levee along the London Avenue Canal holding back water that stands well above the houses—which were flooded when water swirled round from a levee break below the distant crane on the left.

The levee breaks have been repaired, but only to their original height, and high concrete walls again loom over residential areas that are well below sea level (Fig. 8). Nearly all the flooded areas were dry within three weeks, except for some smaller re-flooding during Hurricane Rita just a month after Katrina. The streets were then cleared, and water lines, sewerage and electricity were restored across the flood zones within a month or two. Such was the immediate response by the city, but the rest was then left largely up to the homeowners. With 200 000 homes damaged or totally wrecked, this will take time.

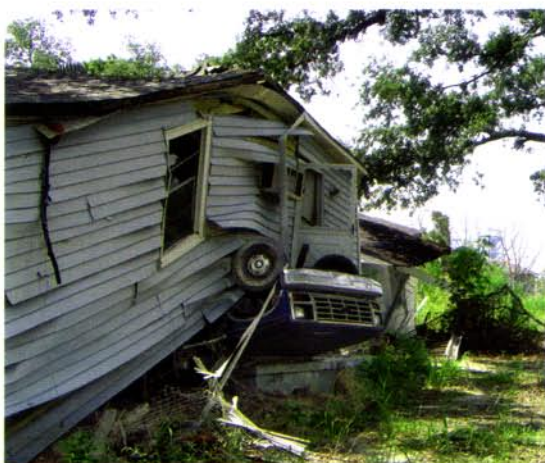
Fig. 9. Close to the levee break in the Ninth Ward, a timber house floated off its footings, to land on an upturned car that was already on the foundation slab of another house.

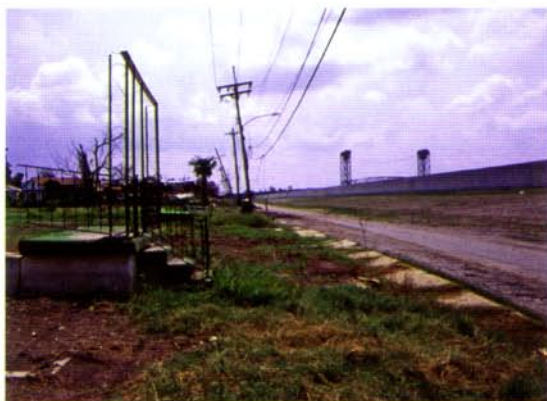
Fig. 10. The newly rebuilt levee along the Industrial Canal rises above a part of the Ninth Ward that was stripped of its houses by the inrush of water, except for the concrete steps that once led to a front veranda.

Still within the Ninth Ward, the area immediately in front of the Canal's levee break was much harder hit. For some few hundred metres, the torrent of water from the break tore everything before it. Wooden houses were ripped off their footings and smashed, even the few brick houses lost walls, and cars were tumbled around like toys. The streets are now clear, but most only lace across open space

where bare slabs of concrete were once foundation pads for homes (Fig. 10).

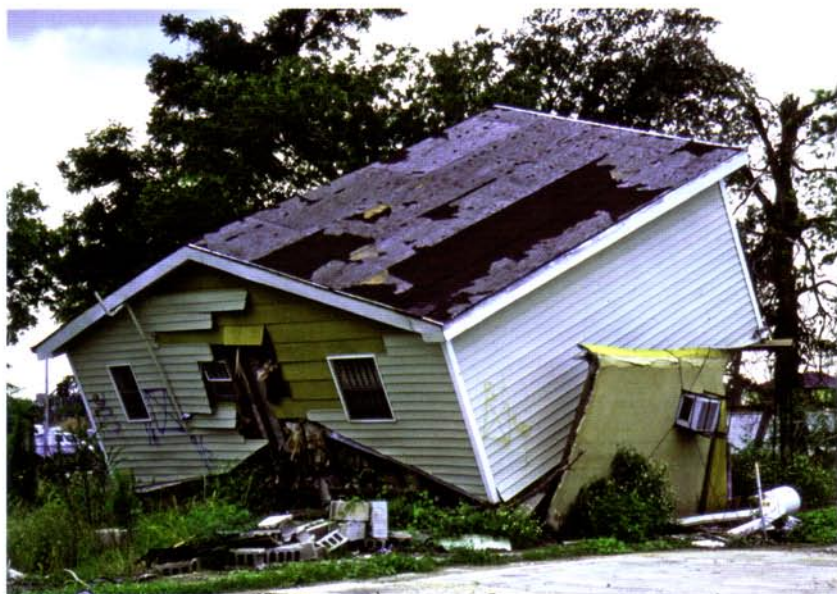
Fig. 11. A two-storey Lakeview house that lost most of its ground floor to the flood surge.

The Lakeview and Gentilly suburbs lie to the north, between the city centre and Lake Ponchartrain. They were completely flooded by the levee breaks along the Canals of 17th Street and London Avenue—canals that were created to drain water out of the city, and not feed it in. More affluent than the Ninth Ward, the northern areas have a greater proportion of residents that have already returned—though many of them still live in front-lawn caravans while they make their homes habitable. More of the houses have two storeys. Many of these sustained major damage to their ground floor, while the upper floors remained unharmed, unless they lost all their support (Fig. 11).

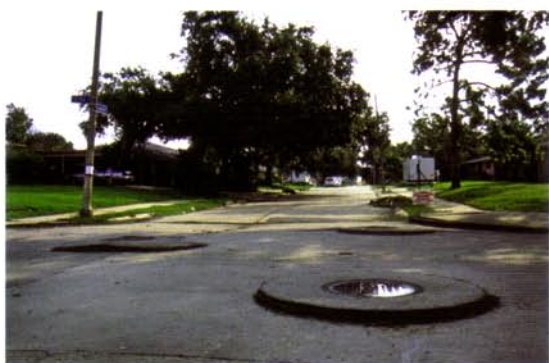
Fig. 12. In a Gentilly road near the London Avenue Canal, drain rings stand 50 mm above the subsided tarmac around them.

A feature in parts of Gentilly has been localized ground subsidence. Many of the roads are distorted by wavy profiles, and local height loss is indicated by manholes and drain covers that now stand proud by 50 mm or more (Fig. 12). Comparable ground movement is shown by some houses built on piles that now stand clear of the ground around them (Fig. 13). The soil profile in these areas has 3 m of very soft clays, over 1–2 m of peat, with more soft clay down to 12 m deep. Compaction of the peats and clays, due to water removal, had already caused the subsidence that took the ground below sea level, and further volume loss was not likely due to the flooding cycle of saturation and then drying. It is more likely that this ground subsidence was caused by the lateral flow of groundwater, as the Katrina flood pulse moved into the area. This would have carried soil away, in a miniature version of piping, and would have been directed by lateral variations in soil permeability—as along the strips of sub-base installed for road construction.

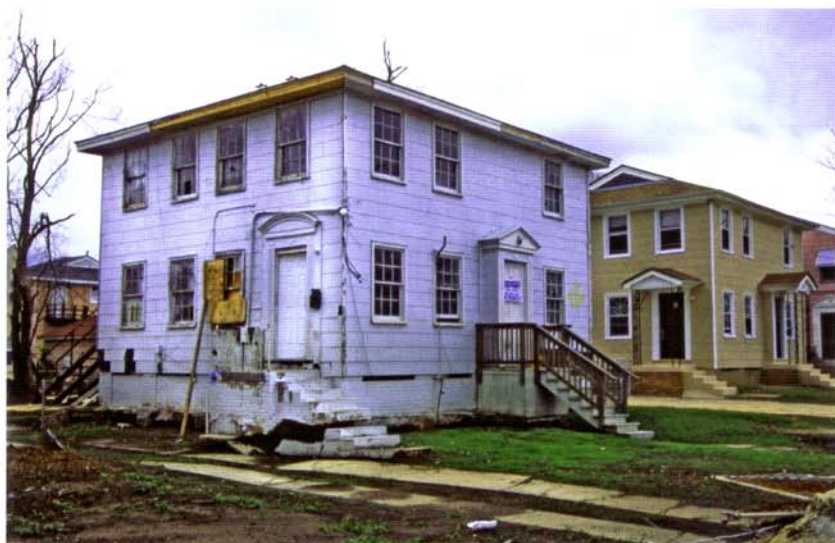
Fig. 13. A Gentilly house built on a piled box that now stands about 150 mm clear of the ground that has subsided, with a very visible gap through the broken steps.

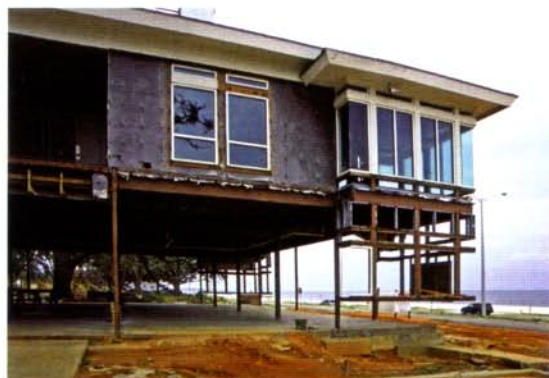
Fig. 14. An office building at Gulfport had its ground floor ripped out by waves on the storm surge even though it stands well back from the sea.

Wind damage in the city was relatively minor, because it was hit only by weakened winds that came from inland due to the storm's rotation. But the coast towards and beyond Gulfport received the full force of the winds directly off the open sea. The combination of howling winds and pounding waves on top of some metres of storm surge was lethal. The entire coast was devastated. Waves reached high enough to wreck the first three floors of the harbour-front Gulfport Casino. A little further inshore, buildings had their ground floors torn out, and the upper floors only survived on strong frames (Fig. 14). Beyond the worst of the water impact, wind caused most of the damage (Fig. 15).

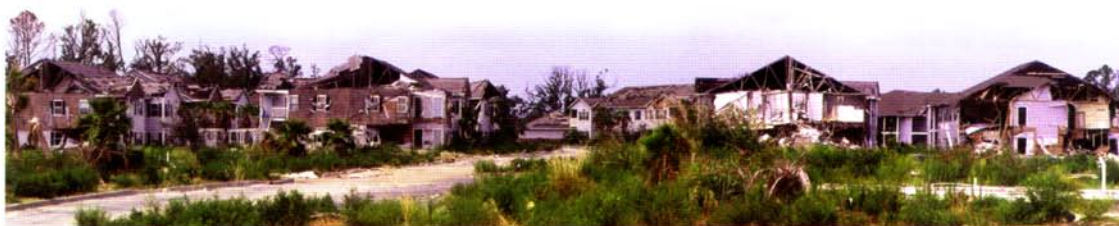
Fig. 15. The storm surge through the ground floors and wind damage to the upper floors, wrecked an estate of new houses in from the shore near Gulfport.
