# Unloading joints and rockfalls in Norway's fiordlands

**Tony Waltham**

When overburden is removed by erosion, rock relaxes towards the surface and develops new fractures. These are then the focus of slope failures that are common and sometimes disastrous in Norway's mountain regions.

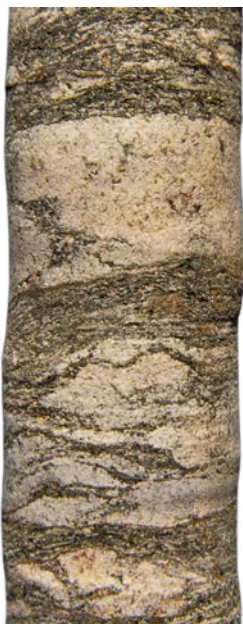
**Fig. 1.** A borehole core (40 mm diameter) of highly stressed gneiss extracted from great depth in Namibia. It has deformed from its original perfect cylinder as a result of uneven relaxation since being unloaded by being brought to the surface.

Rock relaxation is a measurable process. When information is needed for tunnel design, engineers can cut slots into rock and physically measure the rate of closure as the destressed rock deforms towards the slot. Core from deep boreholes may be seen to expand and deform when it is brought to the surface (Fig. 1). New

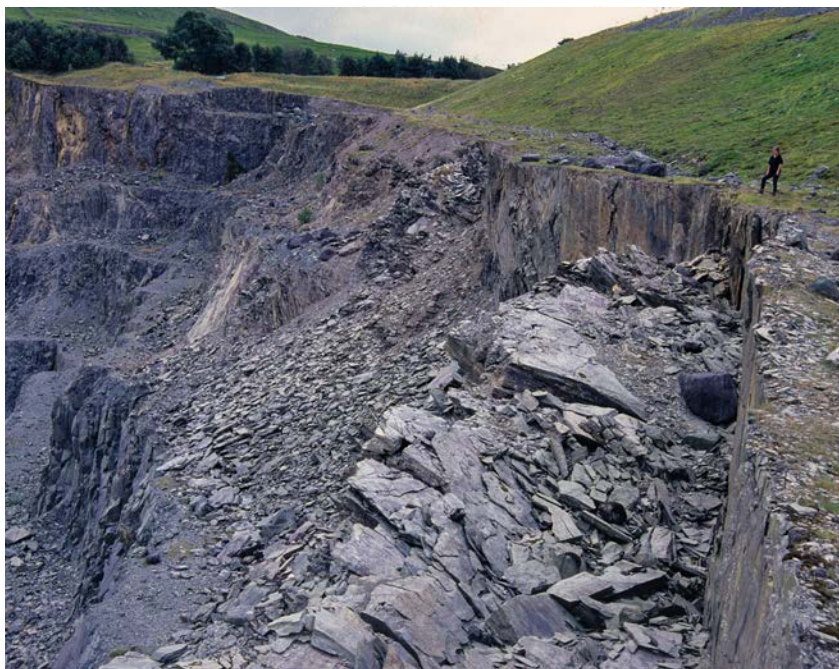
**Fig. 2.** An old face of a Yorkshire greywacke quarry, where unloaded slate has sprung outwards since horizontal stress was released. Slabs have further peeled away from the vertical by the combined action of water pressure, ice expansion and then gravity.

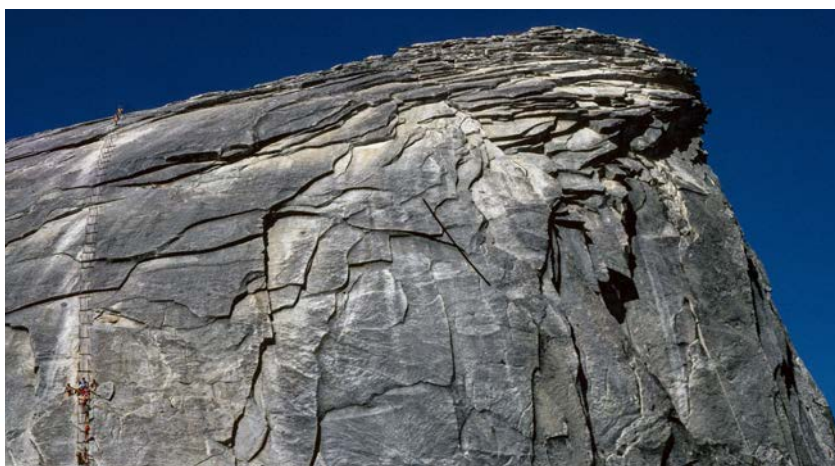
**Fig. 3.** Curved sheets of granite separated by unloading joints on the exfoliation dome of Half Dome in Yosemite Park, California. Scale is given by people on the cable ladder on the extreme left.

tion domes that are particularly famous in California's Yosemite Park. The domes are exposed as the unloaded sheets fall away, and the curved joints of the next failures are clearly seen at some sites (Fig. 3). Although this sheeting is a conspicuous feature of homogeneous granite, the process also occurs in other rocks but is masked by the patterns of existing structural weaknesses. It is, however, totally different from spheroidal weathering (which is a much smaller scale of chemical degradation where shells peel away in an onion-style owing to hydrolysis expansion of feldspars to clays, and not due to unloading).

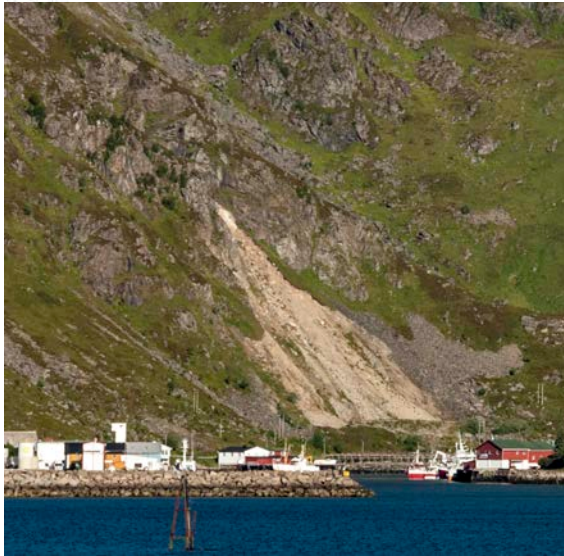
Fig. 4. A small rockfall on the Lofoten Islands, defined by unloading joints and contributing to the talus slope below.

angles of  $60^\circ$  or more in the fiordlands and on the northern mountains, continuing slope degradation is the natural process, and the dominant mechanism is a succession of rockfalls. Most events are small, so that the fallen debris merely lands on the talus ramp at the foot of the face (Fig. 4). But larger events (involving over 250 000 tonnes, or 100 000 cubic metres, of falling rock) produce debris run-outs onto the valley floors (Fig. 5), and are fatal to anyone who happens to be in the wrong place at the wrong time.

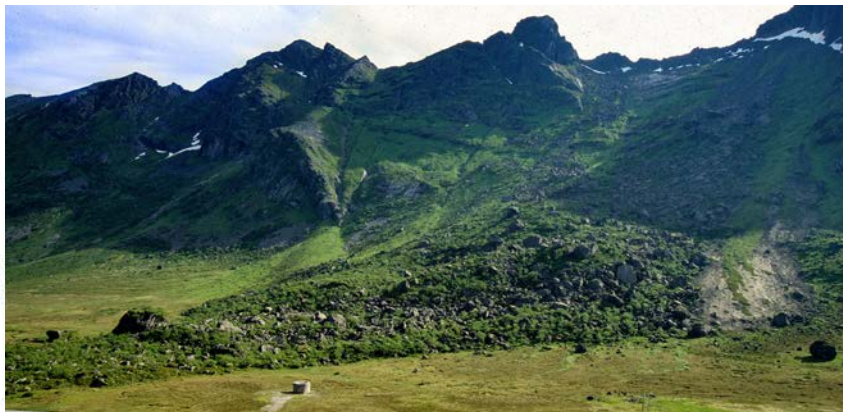
Fig. 5. The Skjelfjord rockfall on the Lofoten Islands, with the later road curving round the end of the debris flow run-out on the valley floor.

A very fine example of a larger rockfall can be seen at the head of Skjelfjord in the Lofoten Islands (Fig. 5), even though the event dates back a few hundred years and the debris is now partly covered by shrubs and bushes. The top of the head scar of the fall stands 600 m above the valley floor, and the debris run-out reaches 1400 m from the head. The rock is a relatively massive granite, and its fracturing by stress relief since the Pleistocene glacial unloading was a major factor in the failure of a shallow slice off the slope surface. This rockfall landed on dry ground on a watershed, but others have landed in valleys where the debris dams the river and creates a new lake. Such landslide-dammed lakes are common in Norway; Langstoylvatn was formed after a rockfall in the lovely Norangsdal (Fig. 6) in May 1905, and the remains of stone houses drowned by the new lake can

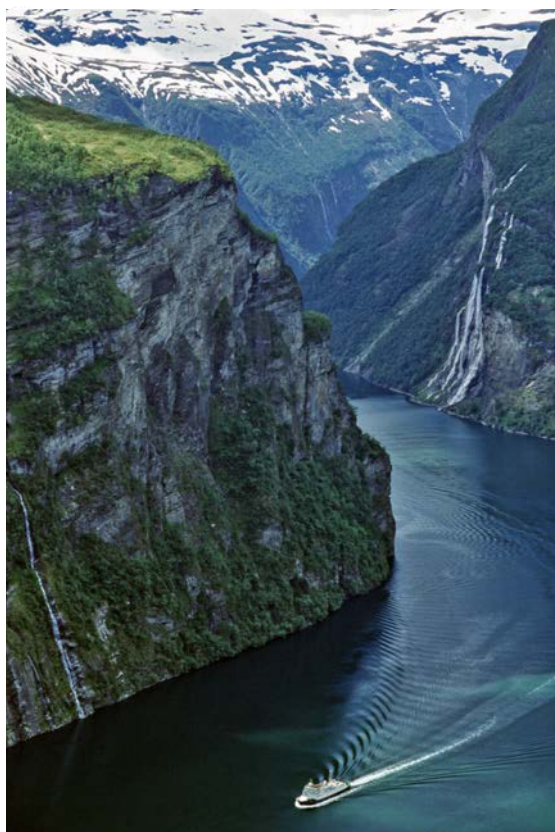
Fig. 7. The precipitous walls of Geirangerfjord, with the scars of ancient rockfalls largely defined by unloading joints.

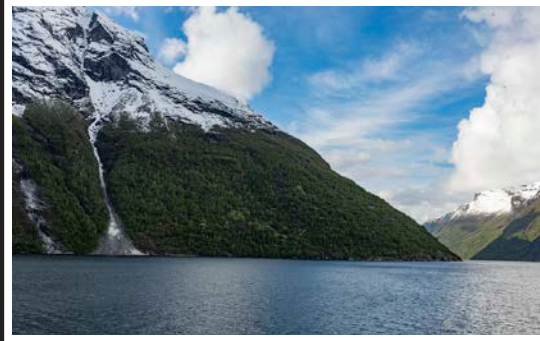
**Fig. 11.** The scar of the Lovatn rockfalls, with the bar on the right showing the approximate heights of the three major falls. Most of the debris is now covered by trees, as is the Nesodden peninsula in the right foreground.

In January 1905, about 800 000 tonnes of rock fell from the face of Ramnefjell. The failed slab was about 100 m high, 50 m wide and 10 m thick, and came away 500 m above the lake (Fig. 11). The rock is Archean gneiss with a foliation dipping at about 50° across the face, and the failure developed on massive unloading joints that lay across this foliation. The debris landed in the lake to create a wave that wrecked the farm villages of Bodal and Nesdal, drowning 61 people. Waves also carried the lake steamer *Lodalén* 30 m high onto the low rock peninsula of Nesodden, leaving it stranded 250 m from the shore. A few very minor rockfalls followed, and the survivors rebuilt their farms. This was unfortunate, as Bodal was at a particularly bad site on an alluvial fan that gave the maximum scope for destructive wave run-up.

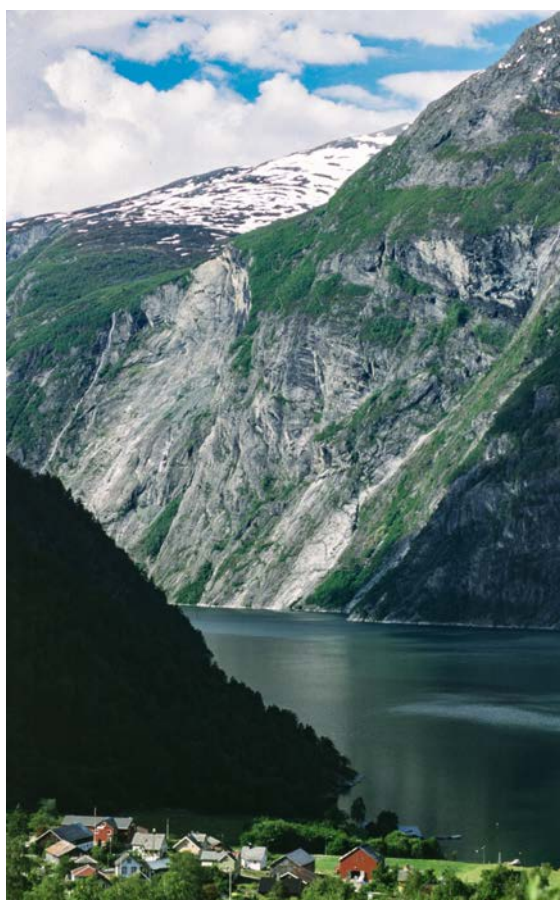
**Fig. 12.** The view along Tafjord from the south-east. The scar of the 1934 rockfall is the zone of lighter rock below the distant snowfield. In the foreground, the houses of Tafjord village stand higher above the shore than those that were destroyed by the rockfall wave.

Forming the farthest tip of Storfjord, Tafjord is very similar in proportions to Lovatn, but is just a little smaller (Fig. 9). It, too, occupies a glaciated trough cut into biotite gneisses, and its northern wall drops over 900 m on a slope of more than 60° straight into the deep fiord waters (Fig. 12). In April 1934 over four million tonnes (1500 000 m<sup>3</sup>) of rock broke away from high on the face, and fell into the fiord. The wave was 62 m high beside the fall, reached 37 m high on the opposite bank, and killed 41 people in the villages at each end of the fiord, most of them in the fishing village of Fjora (Fig. 9).
