Crown hole development in the sandstone caves of Nottingham

A. C. Waltham

Civil Engineering Department, Nottingham Trent University, Nottingham, NG1 4BU, UK

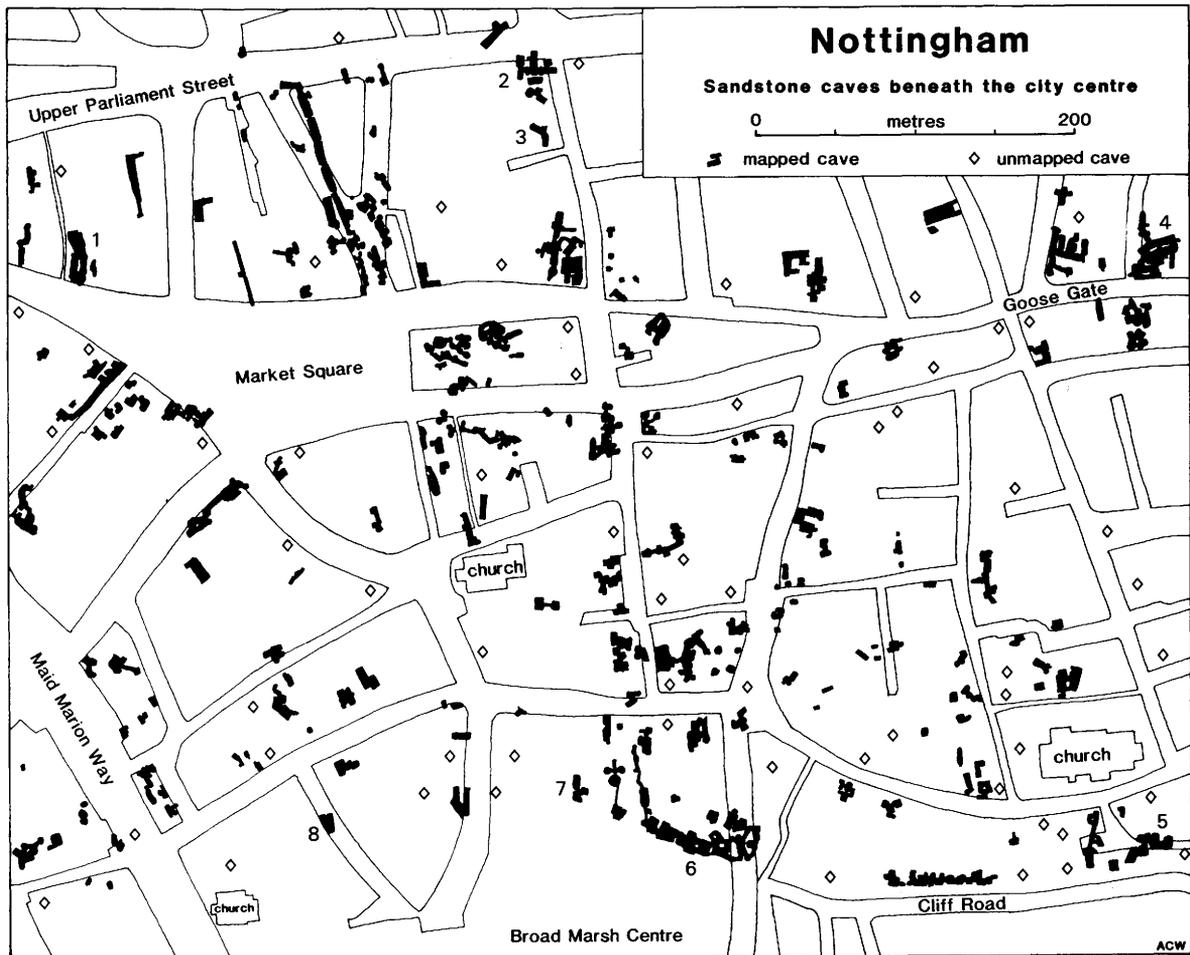
FIG. 2. Distribution of the known 'caves' beneath the city centre of Nottingham. Numbered sites are referred to in the text. 1: Pearsons; 2: Corner Pin; 3: Crystal Palace; 4: Adams Brewery; 5: Commerce Square; 6: Broad Marsh; 7: Black's Head; 8: Stanford Street.
