### **Collapse of an old mine shaft, near Walsall, England**

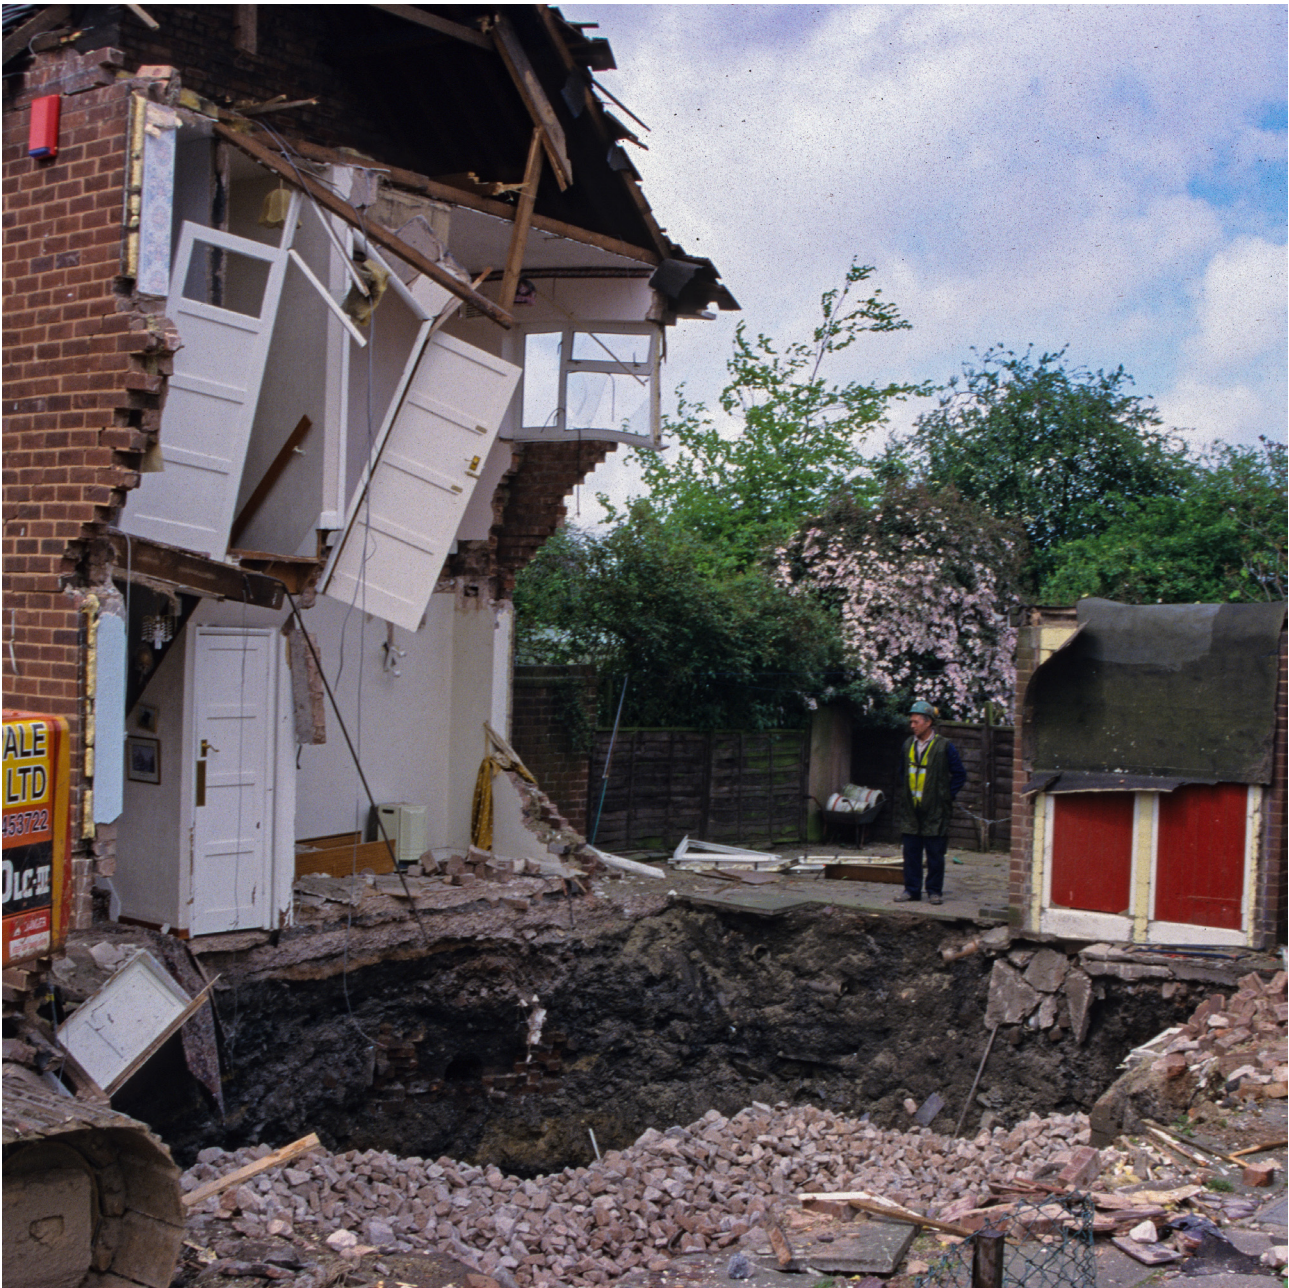
A 50-year old house collapsed into a forgotten mine shaft near Walsall in the English Midlands. It was sited at the heart of what had been the South Staffordshire Coalfield. A colliery had closed down in the mid-1800s, and its 90-metre-deep shaft was abandoned. It was probably backfilled, but only loosely, and might have been capped, but rather inadequately, in the days before any regulations were being applied. Some time later, the old colliery site was landscaped with re-distributed mine waste. The shaft was forgotten, leaving no sign, memory or adequate record. Then in the post-war mid-1900s, terraced council houses were built across the site. After 50 years in the same end-of-terrace house, the sole resident woke one morning to see new cracks in his walls. He called the council, which sent an engineer, who was most concerned to see the house's cracks that were already noticeably larger. He had to telephone to arrange re-housing for the tenant, but there was no phone in the house. So they went to use the engineer's mobile, which was in his car. While out on the road, they heard a rumbling sound and turned to see most of the house collapse into the shaft (not having a home telephone seemed to have been a lifesaver in this case, but is hardly valid as a general safety measure). It is likely that a poorly compacted backfill in the old shaft had run in, and flowed into some of the old mine workings, though why this had happened, and culminated at that time, is unclear. It was only a partial run-in, as the debris of the house and its contents were still visible, resting on remaining backfill a few metres below ground level. However, the open shaft was soon backfilled to prevent it flaring out in the made ground above rockhead and thereby endangering adjacent houses.
