## HOLIDAY GEOLOGY

### Ground subsidence in Mexico City

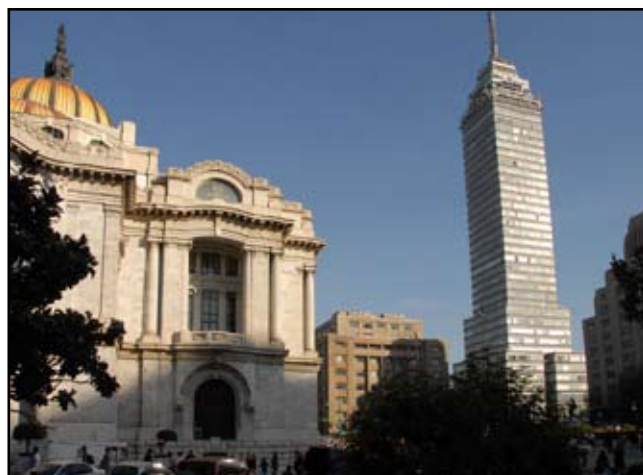
*The Torre Latinoamericana rising beyond the profile of a corner of the Palacio de Bellas Artes.*

Probably the winner in the subsidence stakes is still the Palacio de Bellas Artes, a huge marble edifice that is essentially the national museum at the eastern end of the Alameda. When its construction started in 1904, subsidence was anticipated, so it was placed on a thick concrete raft (though this significantly added to the total weight of the structure). It has subsided more than three metres below street level, and is still going down. The current entrance is into what was once the first floor, and the original entrance hall is now the basement.

A clever foundation design was employed in building the Torre Latinoamericana, a tall office building just across the street intersection from the Palacio de Bellas Artes. Basements reduce its load, but it also has deep piles. These were taken down only to an intermediate sand horizon. The intention was that loading compaction of the clay beneath the sand would match the de-watering compaction of the clay above, thereby keeping the building's entrance at street level. The plan has almost succeeded, but not quite, as the adjacent pavement is now distorted where it has subsided just a little faster than the building. Along with the shear cracks where an adjacent building has subsided more on its un-piled raft, this buckled pavement makes another worthwhile location on a geological walking tour of Mexico City's remarkable ground subsidence.

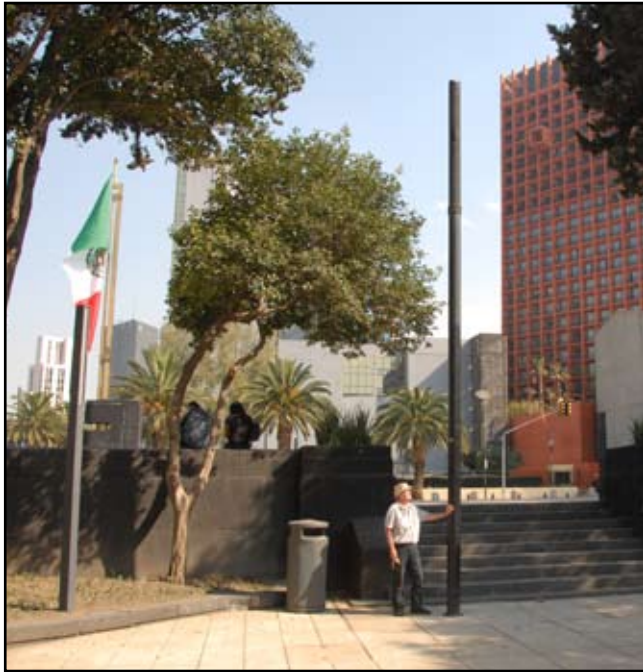
*The protruding well casing in Plaza de la Republica.*

The ground surface has subsided beneath the whole city centre, taking all the roads, buildings, infrastructure and services with it. Everything that is, except the well casings. These rigid steel tubes have not moved, because they are effectively founded in the sands around 100 metres down, where they are below most of the compacting clays. So the adjacent ground has subsided, and has left them protruding from the surface. The classic example is a single, old well casing that has been left untouched, without its protruding top being repeatedly cut off. It stands near the southeastern corner of the Plaza de la Republica, the second most important square in Mexico City, a short walk west of

the Alameda. This unique well casing just looks like an anonymous street pole, more than seven metres tall, and most people pass by without knowing the story behind it, as an explanation board is sadly lacking. But it is a geological classic, as one of the world's most spectacular demonstrations of ground subsidence. And it is still getting taller. Continuing ground movement is indicated by the unpainted bit which was below ground level when it was last painted. Controls on water abstraction have now reduced the city's rate of subsidence, but have not stopped it.

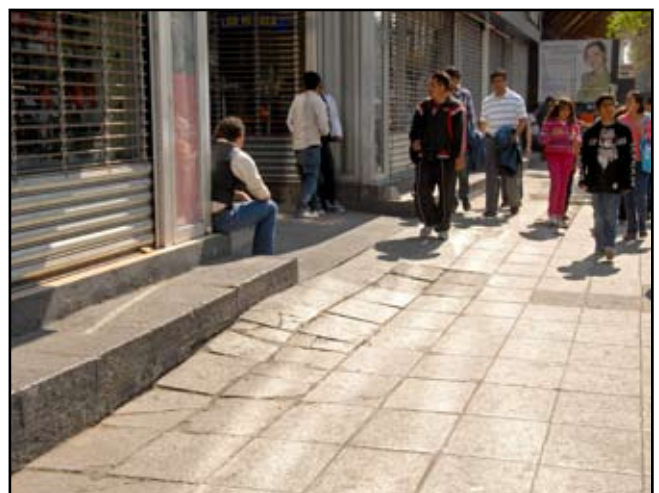
*The subsided and distorted street pavement alongside the relatively stable Torre Latinoamericana.*
